State of Utah
Department of
Environmental Quality

Division of Radiation Control
Dane L. Finerfrock
Director

July 29, 2008

**SUBJECT: Denison Mines (USA) Corp. (DUSA)
White Mesa Uranium Mill Cell 4A Operation
Record of Telephone Conversations and Request for Information**

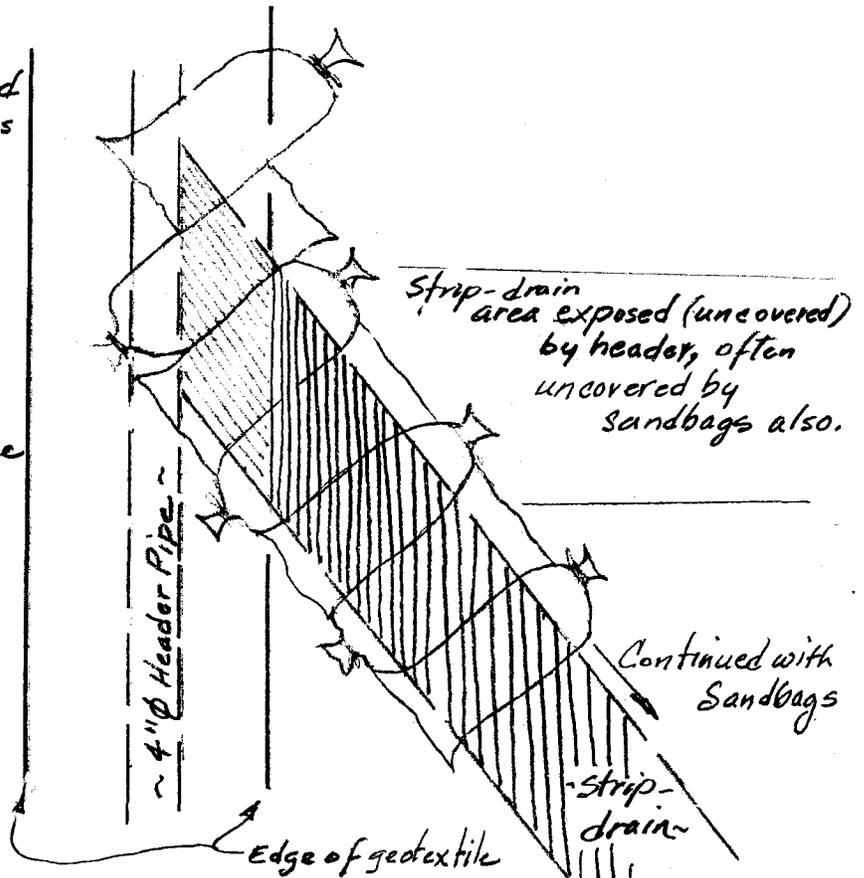
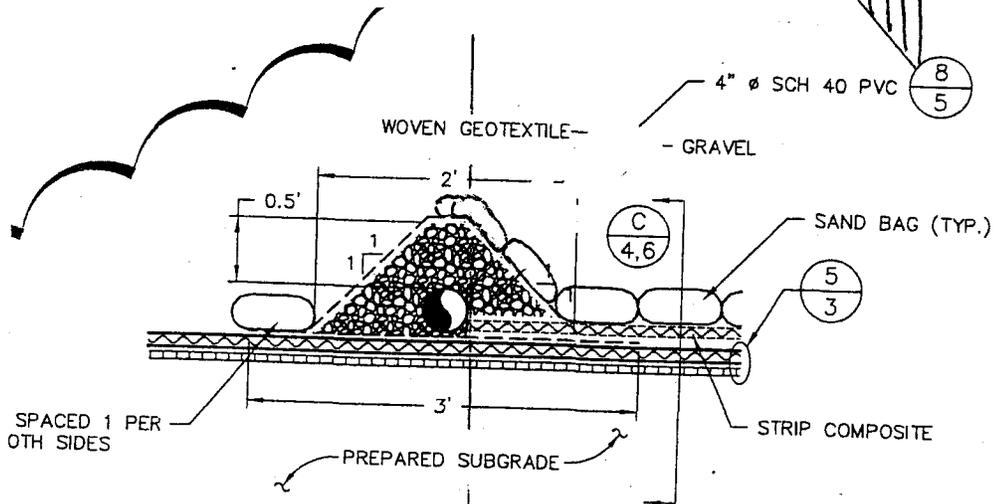
SECTION
SLIMES DRAIN HEADER
SCALE: 1" = 1'

Strip-drain Area currently to be covered by sandbags for filter as req'd by specs.

Strip-drain area to be covered by sandbags and header envelope

- a.) Sandbag Cover over the Strip-drains:
 - 1.) Sandbags which expose the strip-drain need to be adjusted to cover the same at all locations.
 - 2.) The exposed strip-drains at their junctions with the slimes drain header need to be properly covered with sandbags.
 - 3.) Sandbags need to be extended onto the slimes drain header windrow to cover and be in alignment above the slimes drain sections that are installed within the slimes drain header envelope of geotextile and gravel drain rock. See attached DRC sketch dated July 25, 2008.

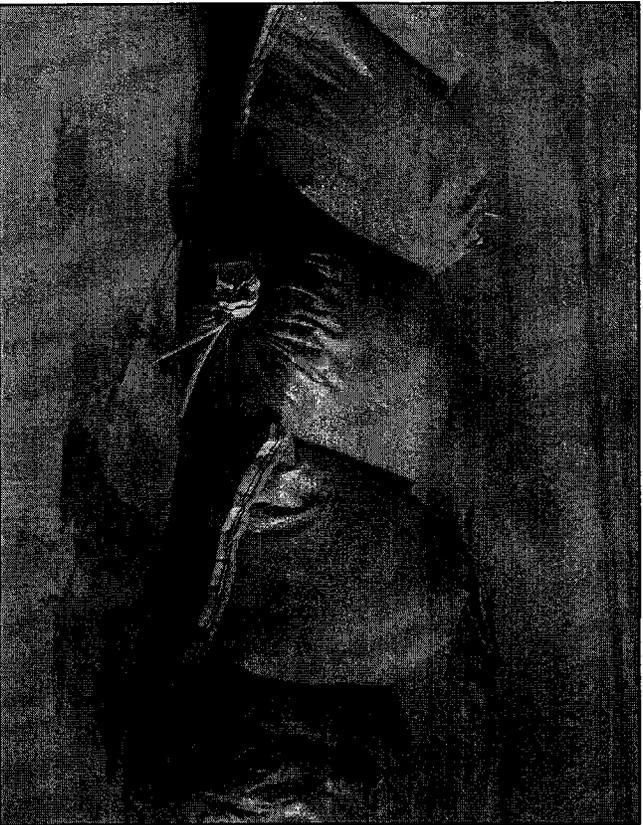
Photo 3. Realigned sandbags. Note gaps at underside between the two center bags.

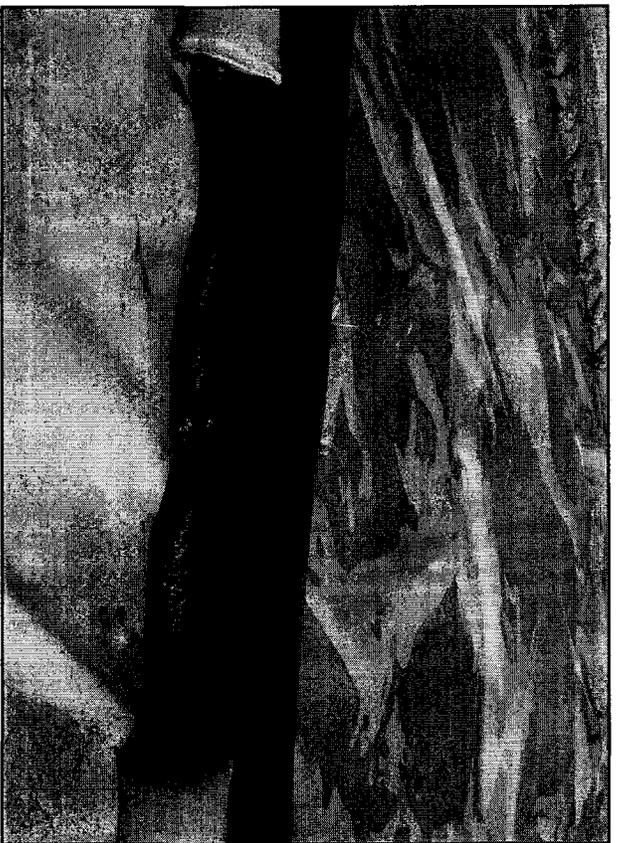
Photo 2. Connection of fabrics between sandbag ballast, slimes drain backbone. Note rock exposed, but not on the liner.

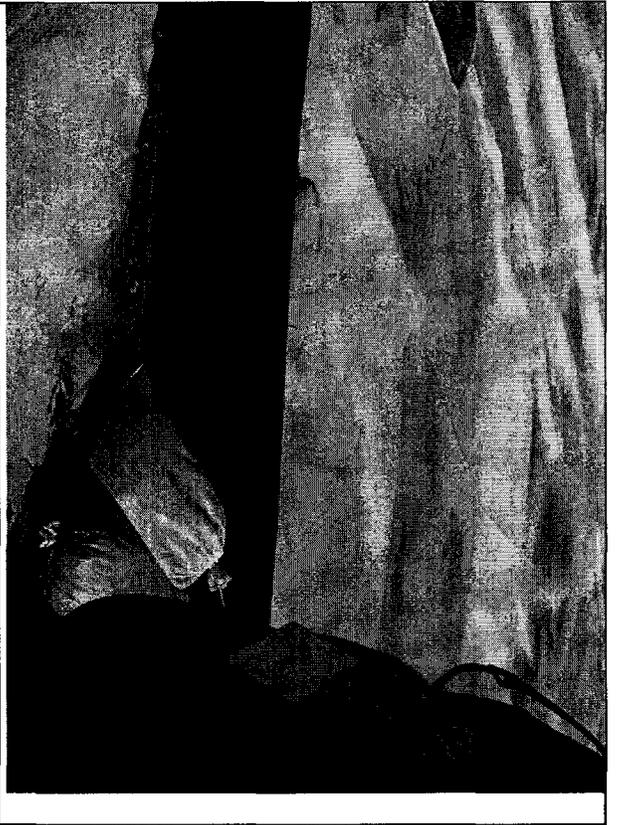
Photo 5. Note opening in black fabric slimes drain header allowing small amount of drainage rock to escape. Escaped rock needs to be removed or enveloped in fabric.

- c.) Drainage Rock for the Slimes Drain Header (Spine or Central Collection Pipe):
 - 1.) Drainage rock outside the geotextile envelope and on the cell liner needs to be removed.
 - 2.) In numerous locations, drainage rock in the header is exposed, yet cupped in the geo-fabrics of the slimes drain header (per attached photographs). This configuration does not conform to the original design drawings. A new aspect on this problem, not discussed with you on July 28, is that these openings to the drain rock will allow fines to flow into the slimes drain header, and plug or reduce the permeability of the slimes drain. Please change this configuration to conform to the original design, or propose an approvable remedy to eliminate the drain rock exposure to the tailings.

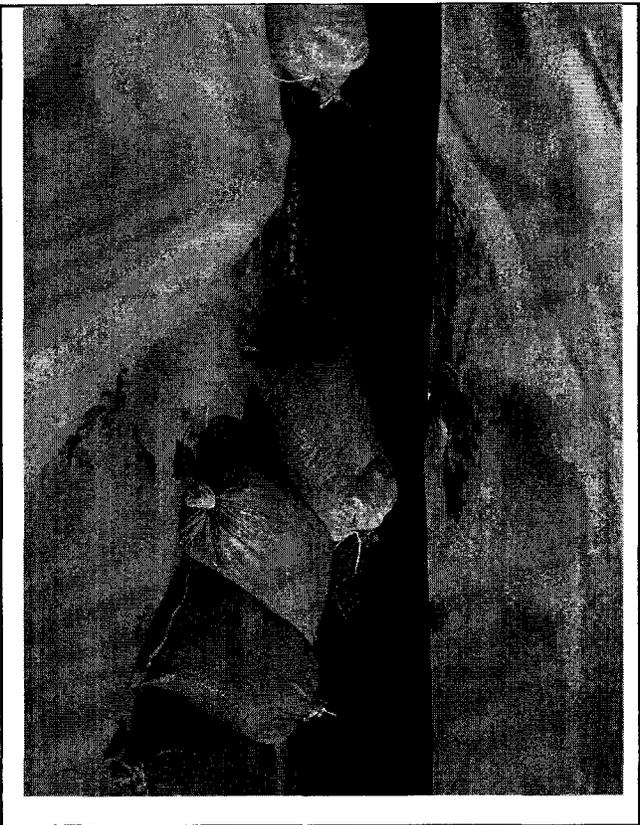
Photo 7. Not enough bags to cover exposed strip-drain... Use of additional bags to cover and filter the slimes moving vertically through the header to the strip-drain within the black envelope was discussed. Also see photo 6 and 8 for rough idea.

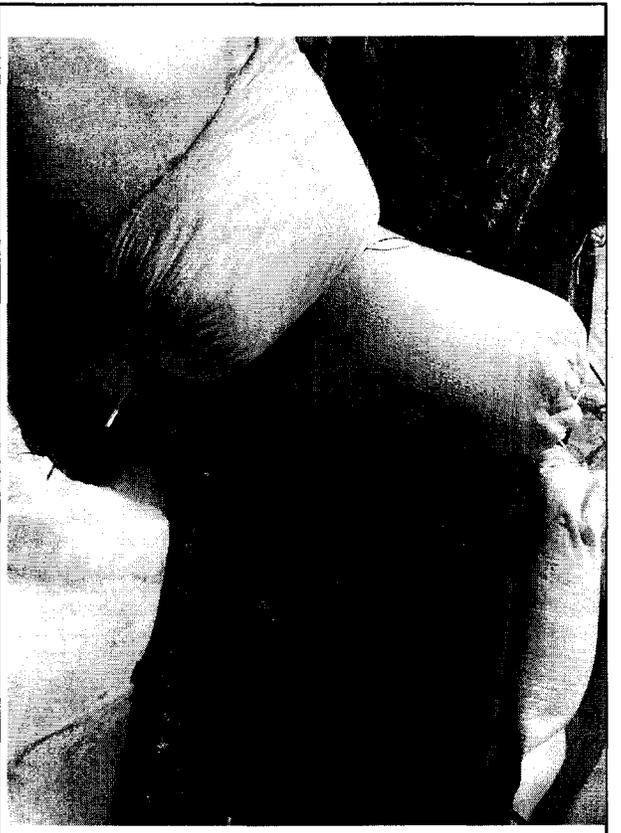
Photo 6. Note exposed strip-drain. Use of sand bags to cover and filter slimes moving vertically through the header to the strip-drain within the black envelope was discussed. See photos 7 & 8.

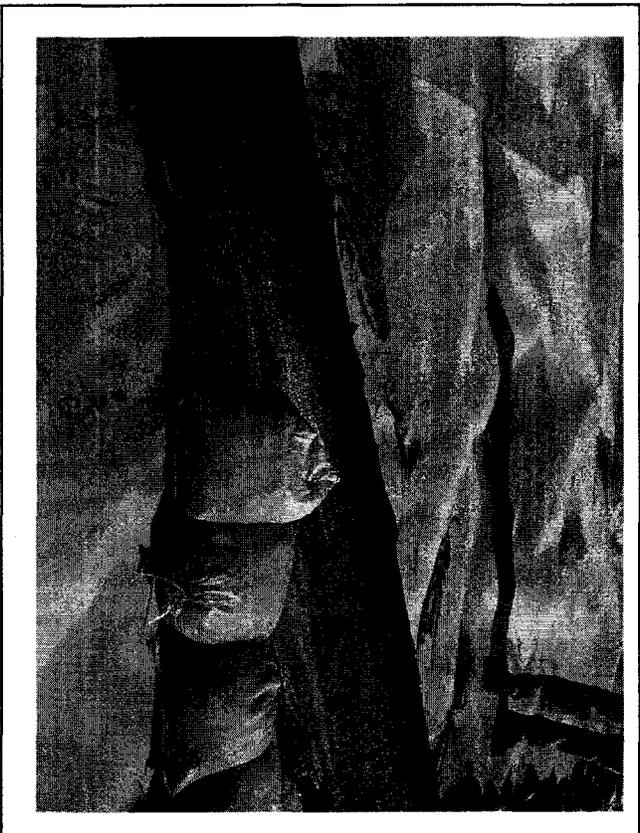
Photo 8. Similar to previous. Drawing showing coverage of strip drain within the header by sandbags above the black header is provided separately.

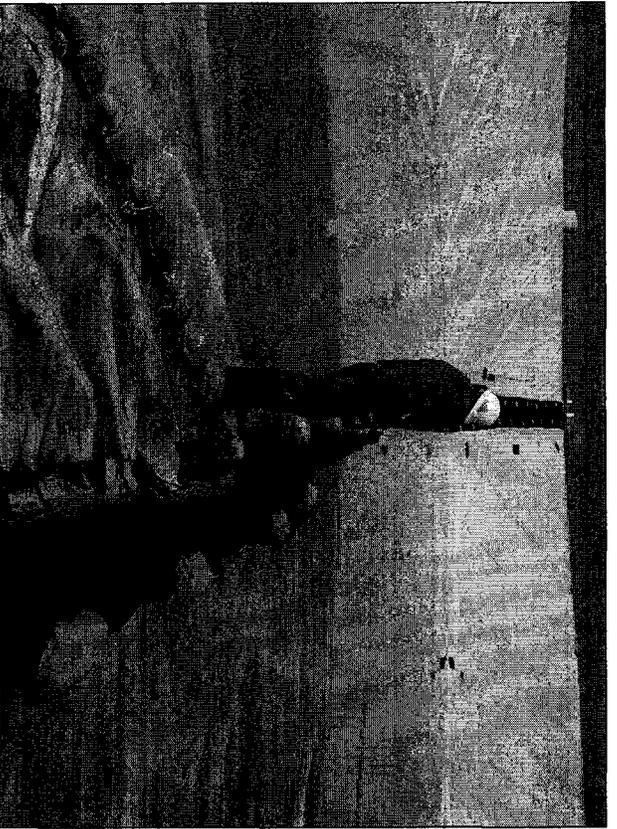
Photo 9. Similar problem. Bags not covering strip-drains all the way to junction. Note storm water collected in S.W. corner of tailings cell.

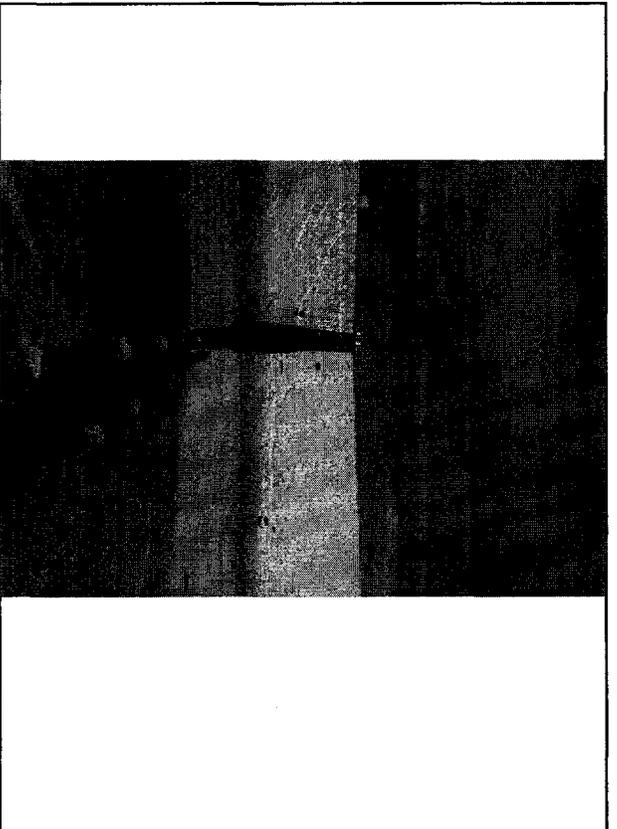
Photo 10. Black header drain daylighting from storm water.

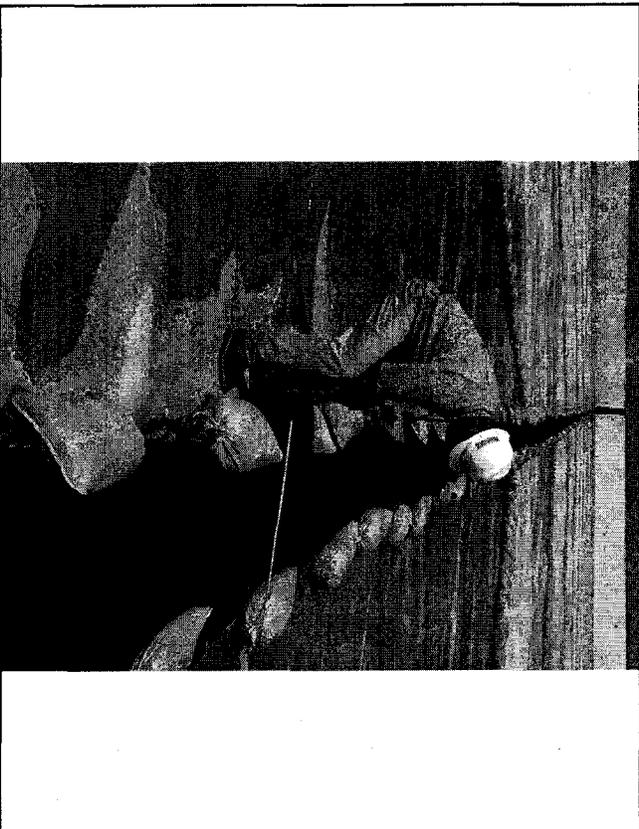
Photo 12. Black fabric envelope width meets the specifications, but the specified rock configuration cannot always be contained completely by the envelope.
