DRC-2010-006304

December 9, 2010

SUBJECT: November 30, 2010 DRC Cell 4B Construction Inspection, Denison Mines (USA) Corporation (DUSA) White Mesa Mill Facility; November 24, 2010 DRC Letter, Regarding Cell 4B Construction; Construction Deficiencies Noted from Photographs

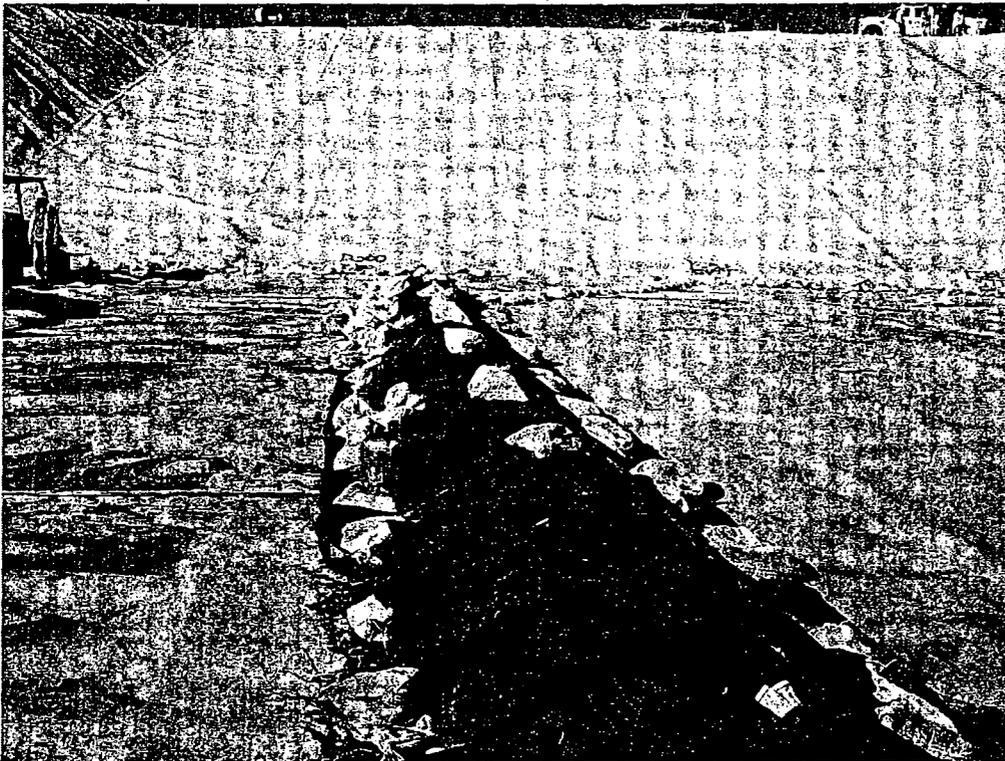
- a. *Improper Exterior Geotextile.* See Photo No. 1. This photo shows a portion of the slimes drain header. Cushion or non-woven geotextile is shown as the exterior cover of the slimes drain header. Conversely, woven geotextile is the required exterior fabric for the slimes drain header, per drawing sheet 6 of 8, Section B-7.

Photo 1. View to the NW corner of Cell 4B. This photo shows cushion geotextile on exterior of slimes drain header. Woven geotextile is the exterior fabric requirement for the slimes drain header, per drawing sheet 6 of 8; Section B-7. [Photo P1010028].

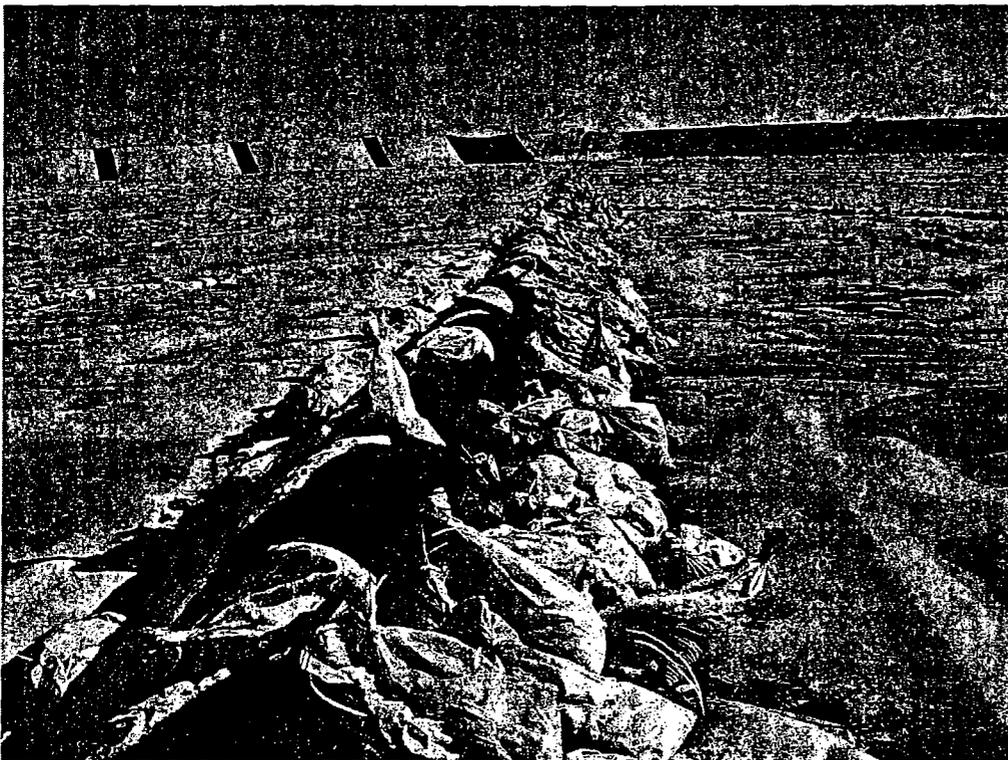
Photo 2. View to the SE corner of Cell 4B. Note woven geotextile cover over slimes drain header, in contrast to the above photo. [Photo P1010029].

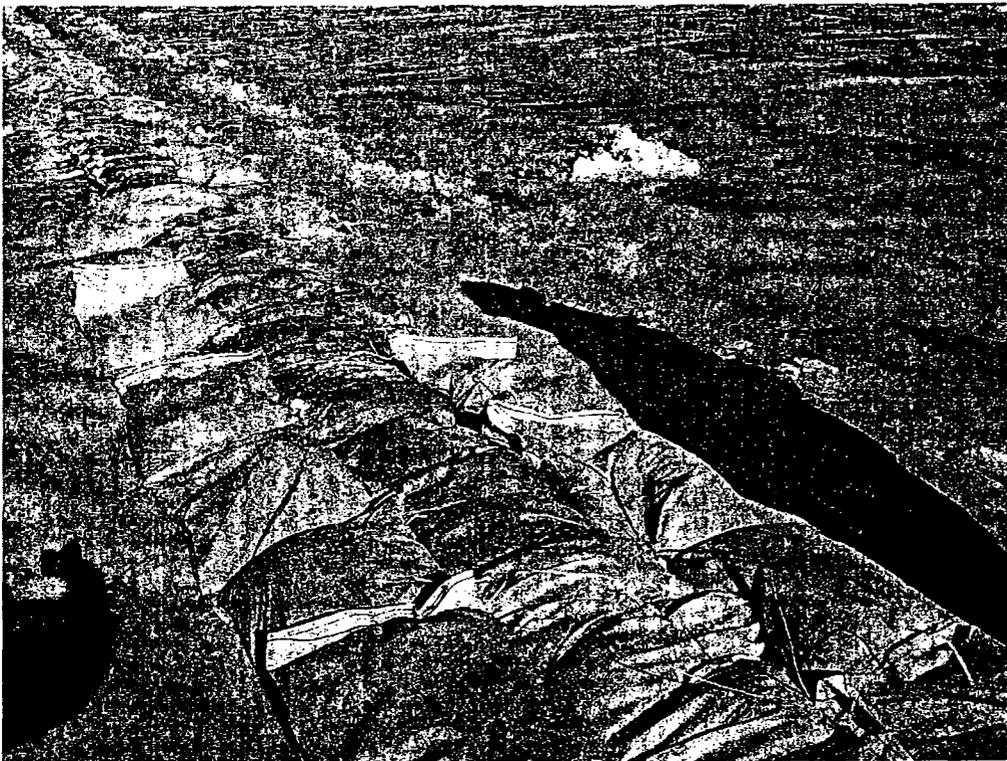
- a. *Using Larger Bags to Seal-off the Voids Created from the Piggy-backing of Smaller Bags.* See Photos 3, 4, and 6. Mr. Carlson of GeoSyntec proposed to Mr. Goble of DRC, that the larger bags could be used to seal off voids, created from use of the piggy-backing method used during installation of the smaller bags.

- b. *Piggy-backing of Larger Bags.* Photo No. 6 shows a longitudinal view of a strip-drain, which shows piggy-backing of larger bags onto smaller bags clearly. Also see Photo Nos. 3 and 4. Notwithstanding the issues discussed above, these photos show that many of the larger bags placed are actually being piggy-backed onto the existing smaller piggy-backed bags, preserving the void pathways to the slimes drains.

Photo 3. West side of Cell 4B. Some of the larger bags, in this case, have been placed on only one side the slimes drain. Note: Some bags have been "piggy backed" onto the smaller bags. [Photo P1010041].

This proposal conflicts with the approved plans and specifications and DUSA's letter of October 8, 2010 regarding the correction of sand bag placement errors, committing that, "All sandbags will be in full compliance with the thickness and strip composite coverage requirements outlined in the approved plans and specifications upon completion of the liner installation."

If DUSA wishes to pursue DRC acceptance of this method, DUSA must submit a demonstration, for approval, that this method would be effective. Mr. Goble discussed this issue with Mr. Snyder on November 30, 2010.

These deficiencies noted above must be corrected prior to DRC authorization for use of Cell 4B. Please provide written documentation, with dated photographs, certified by a Utah-licensed Professional Engineer, that demonstrates completion of the needed corrections to the items describe above. If you have any questions, please contact me.

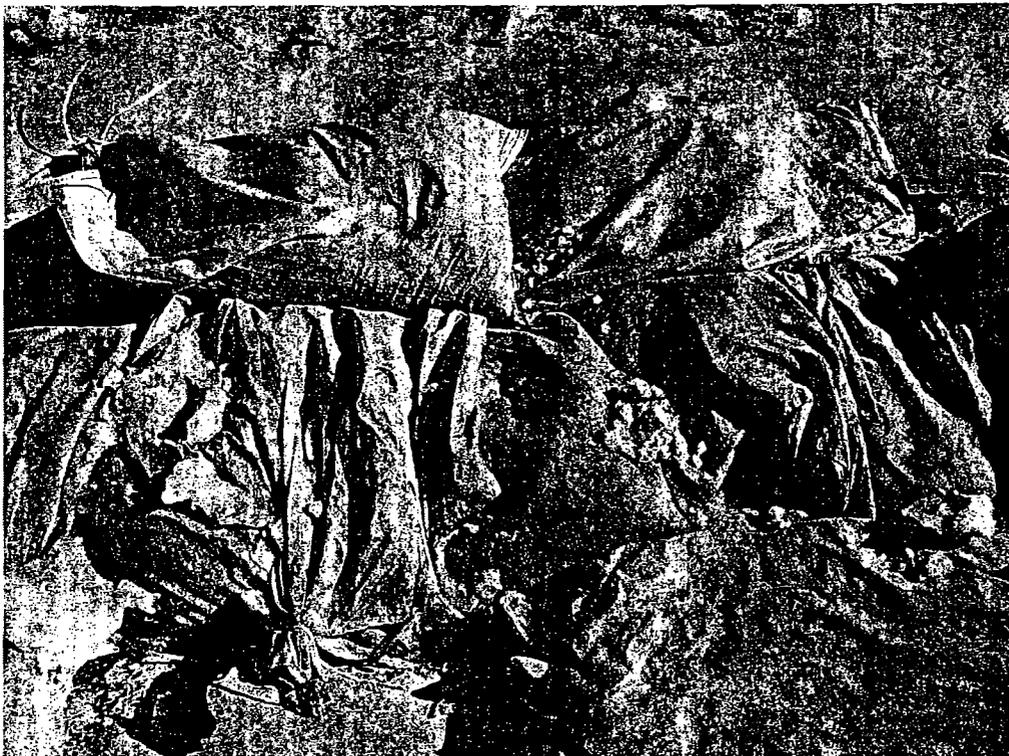
Photo 4. West side of Cell 4B. Possible "piggy-backed" larger bags are shown here. Note bags are Not always on both sides of the slimes drain. This method was proposed in the field for masking voids created by the smaller bags being "piggy-backed" as well. This photo is provided as an example, that this piggy-back type of placement is quite common in the other photos and observations made on 11-30-2010. [Photo P1010039].

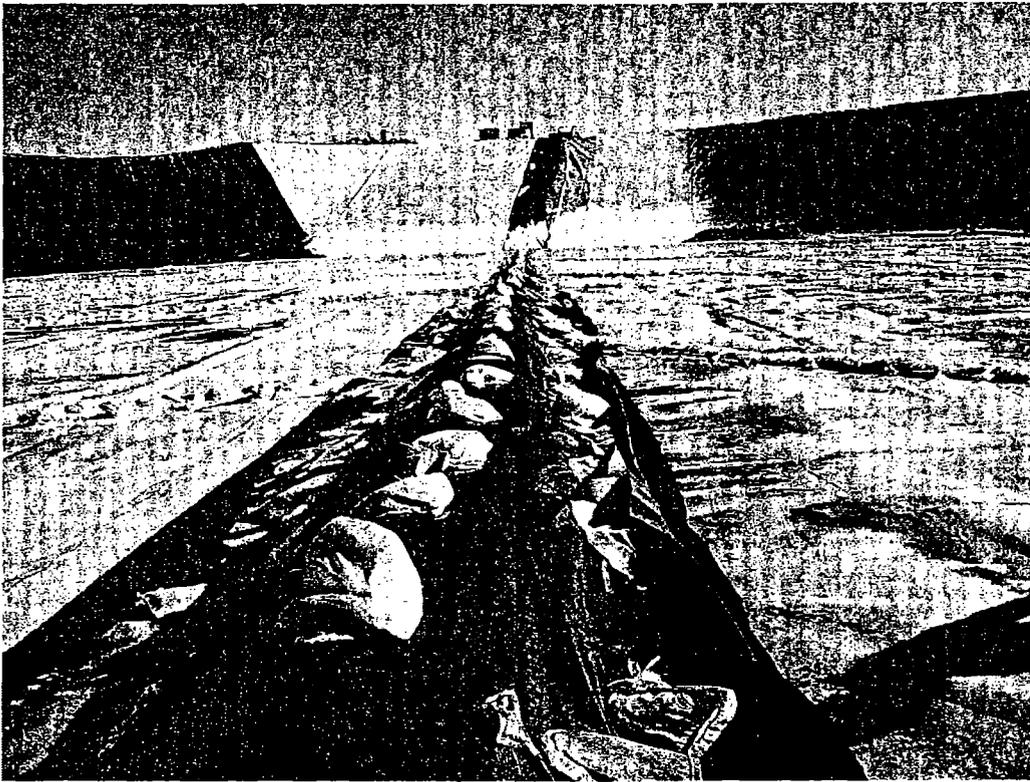
- b. *Inadequate Lateral Ballast on Slimes Drain Header.* See Photo No. 5 in the attached photos. The side flaps of the geotextile materials are not sand bag ballasted adequately, because the sand bags are not placed over the entire flap width, as required by drawing sheet 6 of 8, Section B-7. Note the contrast in the windrow header ballasting with this and with Photo 1. Photo 1 shows the geotextile laying flat on the upper FML. Please fix these situations as illustrated in Photo 5, by adjusting sand bag placement and /or adding additional sand bag ballasting as needed.

Photo 5. View to the SE corner of Cell 4B. Flaps of the geotextile materials on right side are not sand bag ballasted adequately, per drawing sheet 6 of 8; Section B-7. Note flaps on right are uplifted. The drawing shows ballast over entire flap width. Flaps of the geotextile materials on left side also appear to not conform to drawing sheet 6 of 8; Section B-7. Bags also appear to be too sparse to be adequately ballasted. [Photo P1010064].
