# SITE STATUS UPDATE

March 2, 2010

## TOP STOP PETROLEUM RELEASE SITE GUNNISON, UTAH

Morgan Atkinson – Division of Environmental Response and Remediation, Project Manager

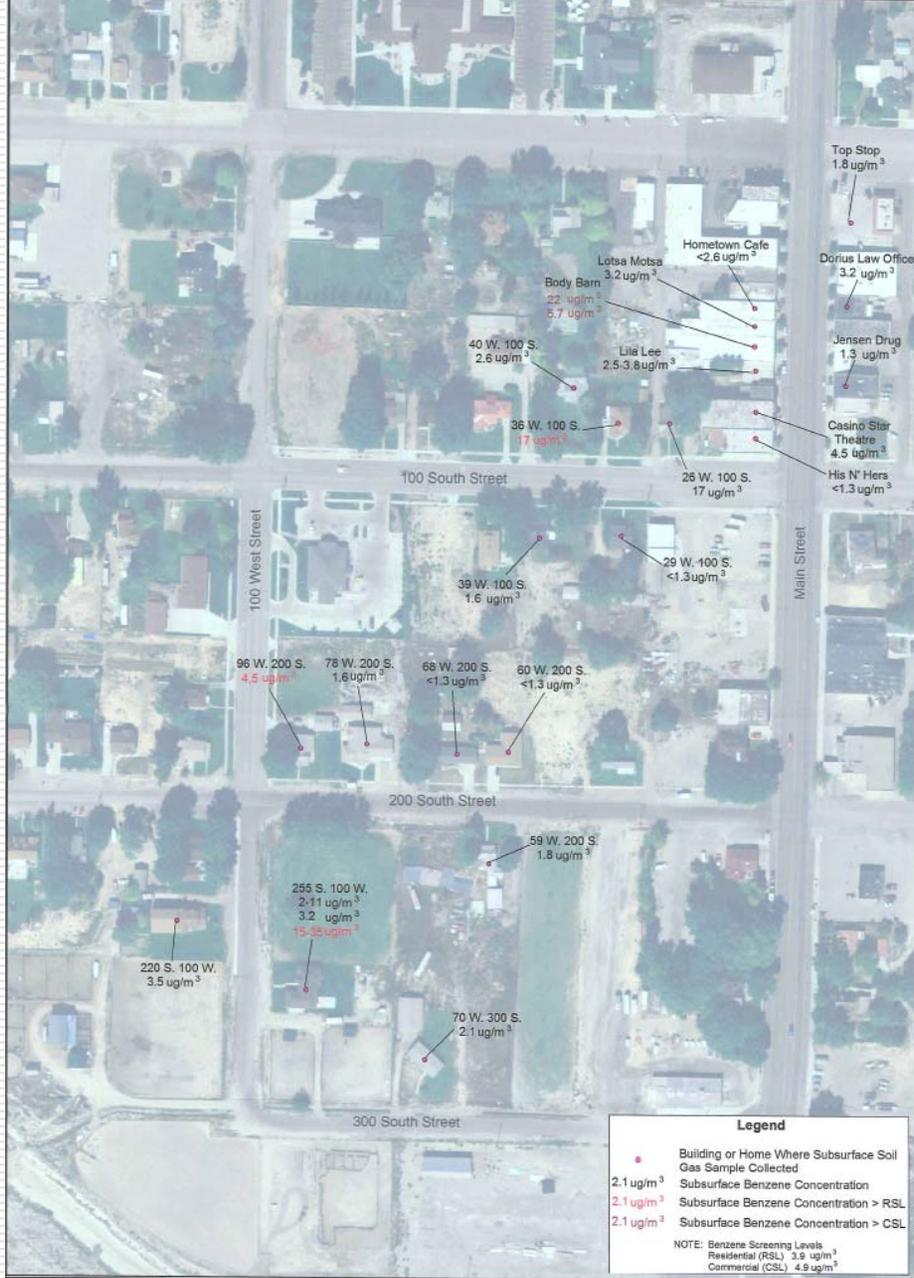
Subsurface Benzene Concentrations		
Gunnison, Utah		
PROJECT NO.	DRAWING DATE	FIGURE
1241-026A	September 11, 2009	2

NOTE: Benzene Screening Levels  
 Residential (RSL) 3.0 ug/m<sup>3</sup>  
 Commercial (CSL) 4.0 ug/m<sup>3</sup>

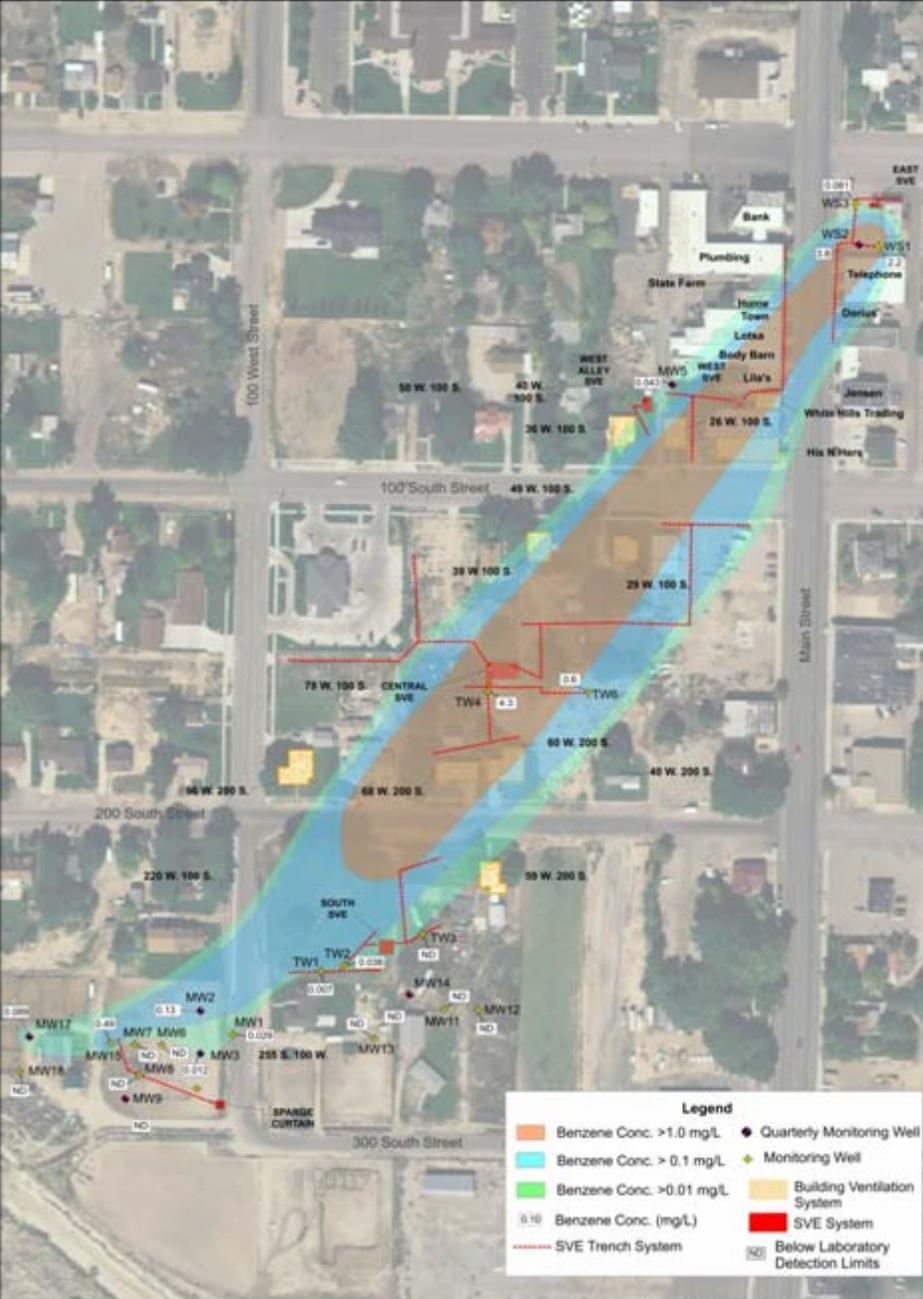
Estimated Benzene Concentration in Groundwater February 2008 - June 2008		
Gunnison, Utah		
PROJECT NO.	DRAWING DATE	FIGURE
1091-0204	September 8, 2009	2

- Groundwater concentration maps prepared by Wasatch Environmental and Lance Hess display Benzene concentrations over time
    - Maps do not include soil contamination – requested to be in the CAP Addendum
-

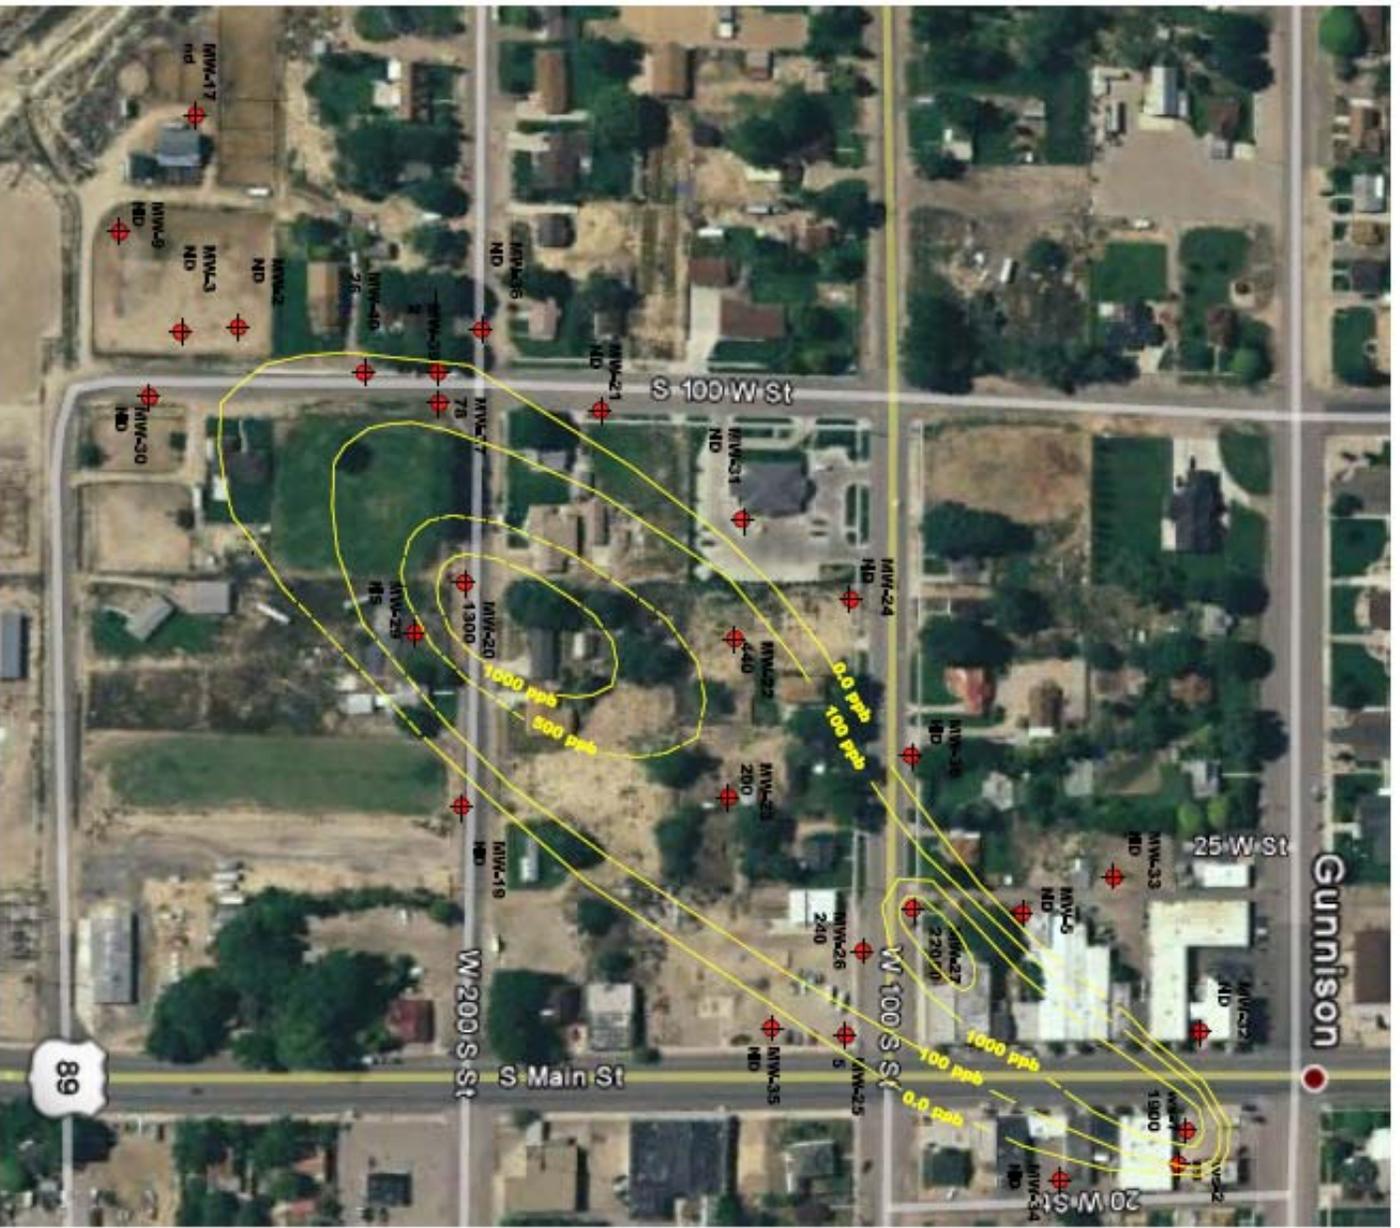
**November 2009 Benzene Concentrations  
In Ground Water (ppb or ug/l)**

- 3 additional monitoring wells installed around 100 West 200 South
    - Groundwater plume appears to be well defined at this time

- Data gaps may exist within the plume boundaries (WS-2 to MW-27) and some assumptions are made about the plume
    - Soil, groundwater and soil vapor data must indicate the release is completely cleaned up across the entire plume area – including areas where previous sampling has not been conducted
-
