## *Upper Sevier Watershed Management Plan*

**An issue identification approach involving  
federal, state, and local stakeholders  
to identify resource opportunities within the  
Upper Sevier River Basin  
South-Central, Utah**

**June 2004**

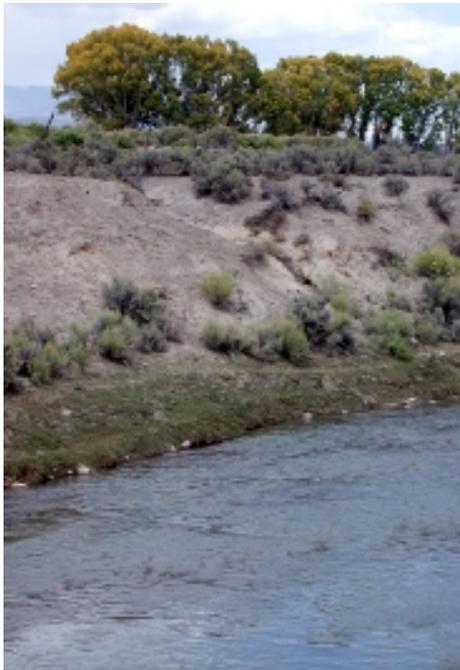
*Bank erosion has resulted in higher width/depth ratios along many stream corridors.*

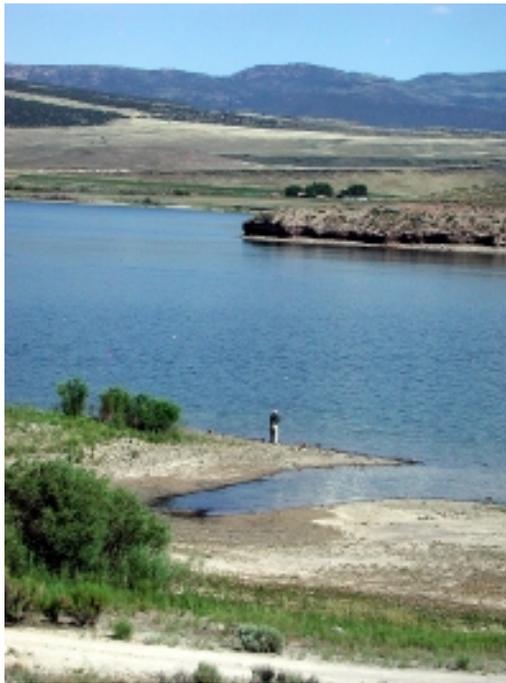
*In winter, much of the East Fork is dewatered along Kingston Canyon to maintain flows in Otter Creek and Piute Reservoirs.*

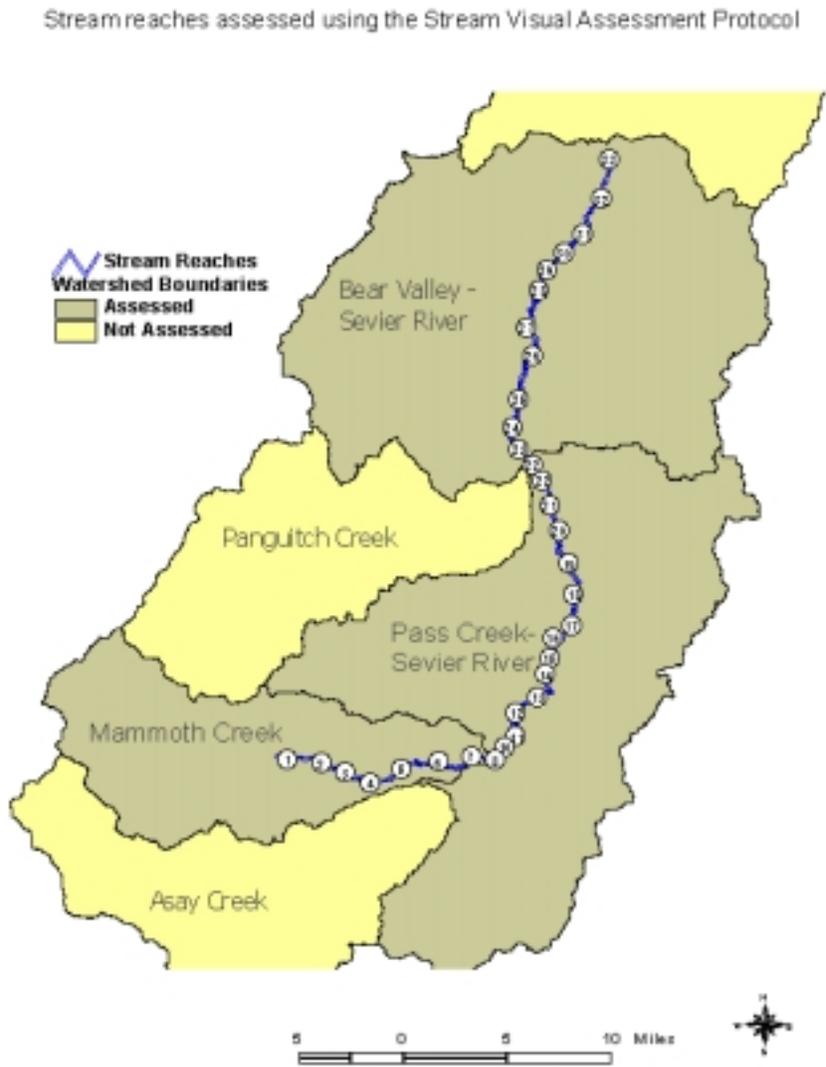
Fig. 5-4. Stream reaches assessed using the Stream Visual Assessment Protocol (SVAP).
