CONSTRUCTION REPORT  
SECOND PHASE  
TAILINGS MANAGEMENT SYSTEM

White Mesa Uranium Project  
Energy Fuels Nuclear, Inc.  
March, 1983

SUA-1358, Docket 40-8681

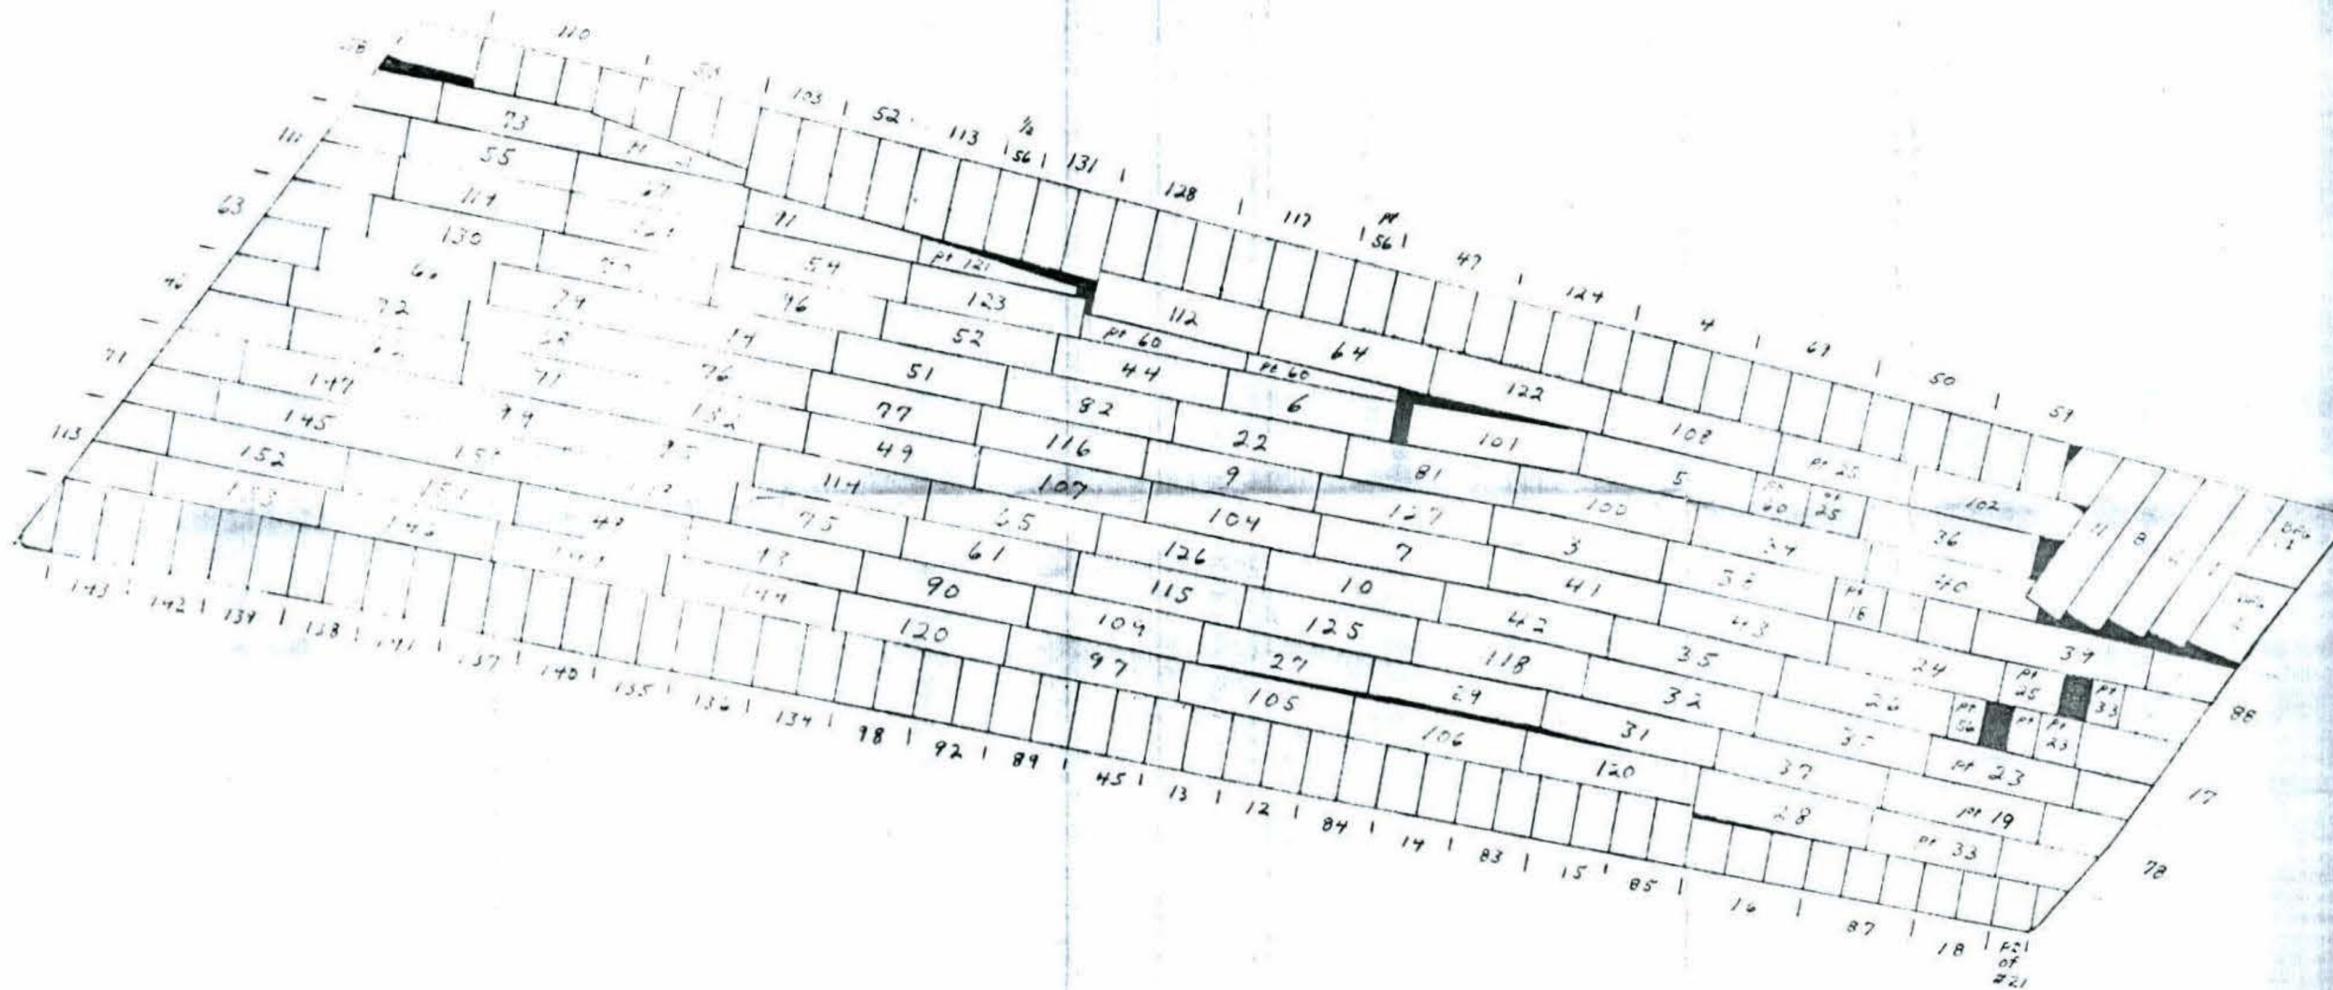
FIGURE 3

30 MIL PVC LINER  
PANEL NO. LAYOUT

SHADED AREA = REMNANTS USED  
PT. = PART OF A PANEL

factory seam tests, quality control tests and field seam tests for the liner used in Cell 3 are presented in Appendix B. In addition, Figure 3 shows the numbered panel layout of each specific panel in order to correlate the test results to the actual installed location of a specific panel.

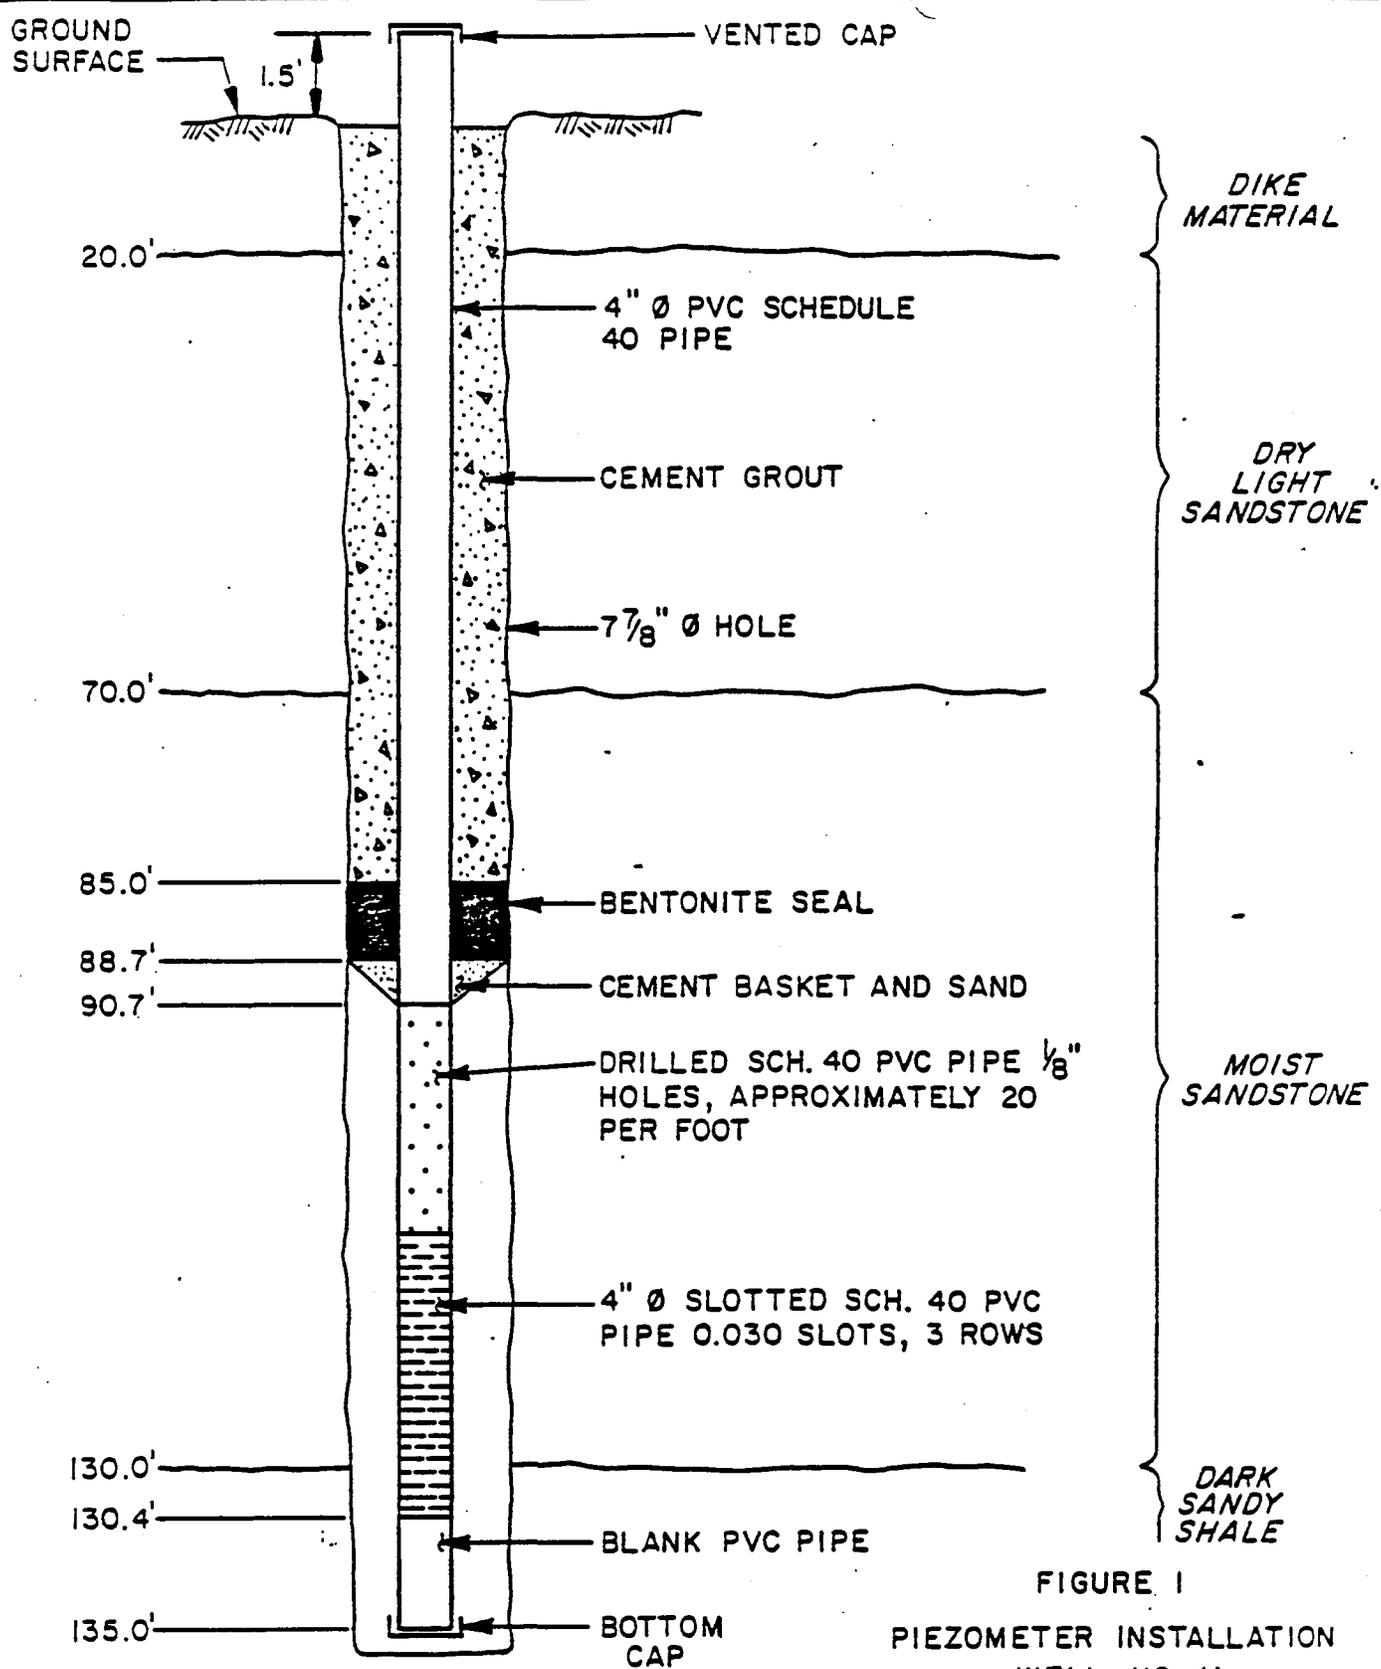
FIGURE I  
PIEZOMETER INSTALLATION  
WELL NO. II  
CONSTRUCTION DETAILS  
PREPARED FOR  
ENERGY FUELS NUCLEAR, INC.  
DENVER, COLORADO

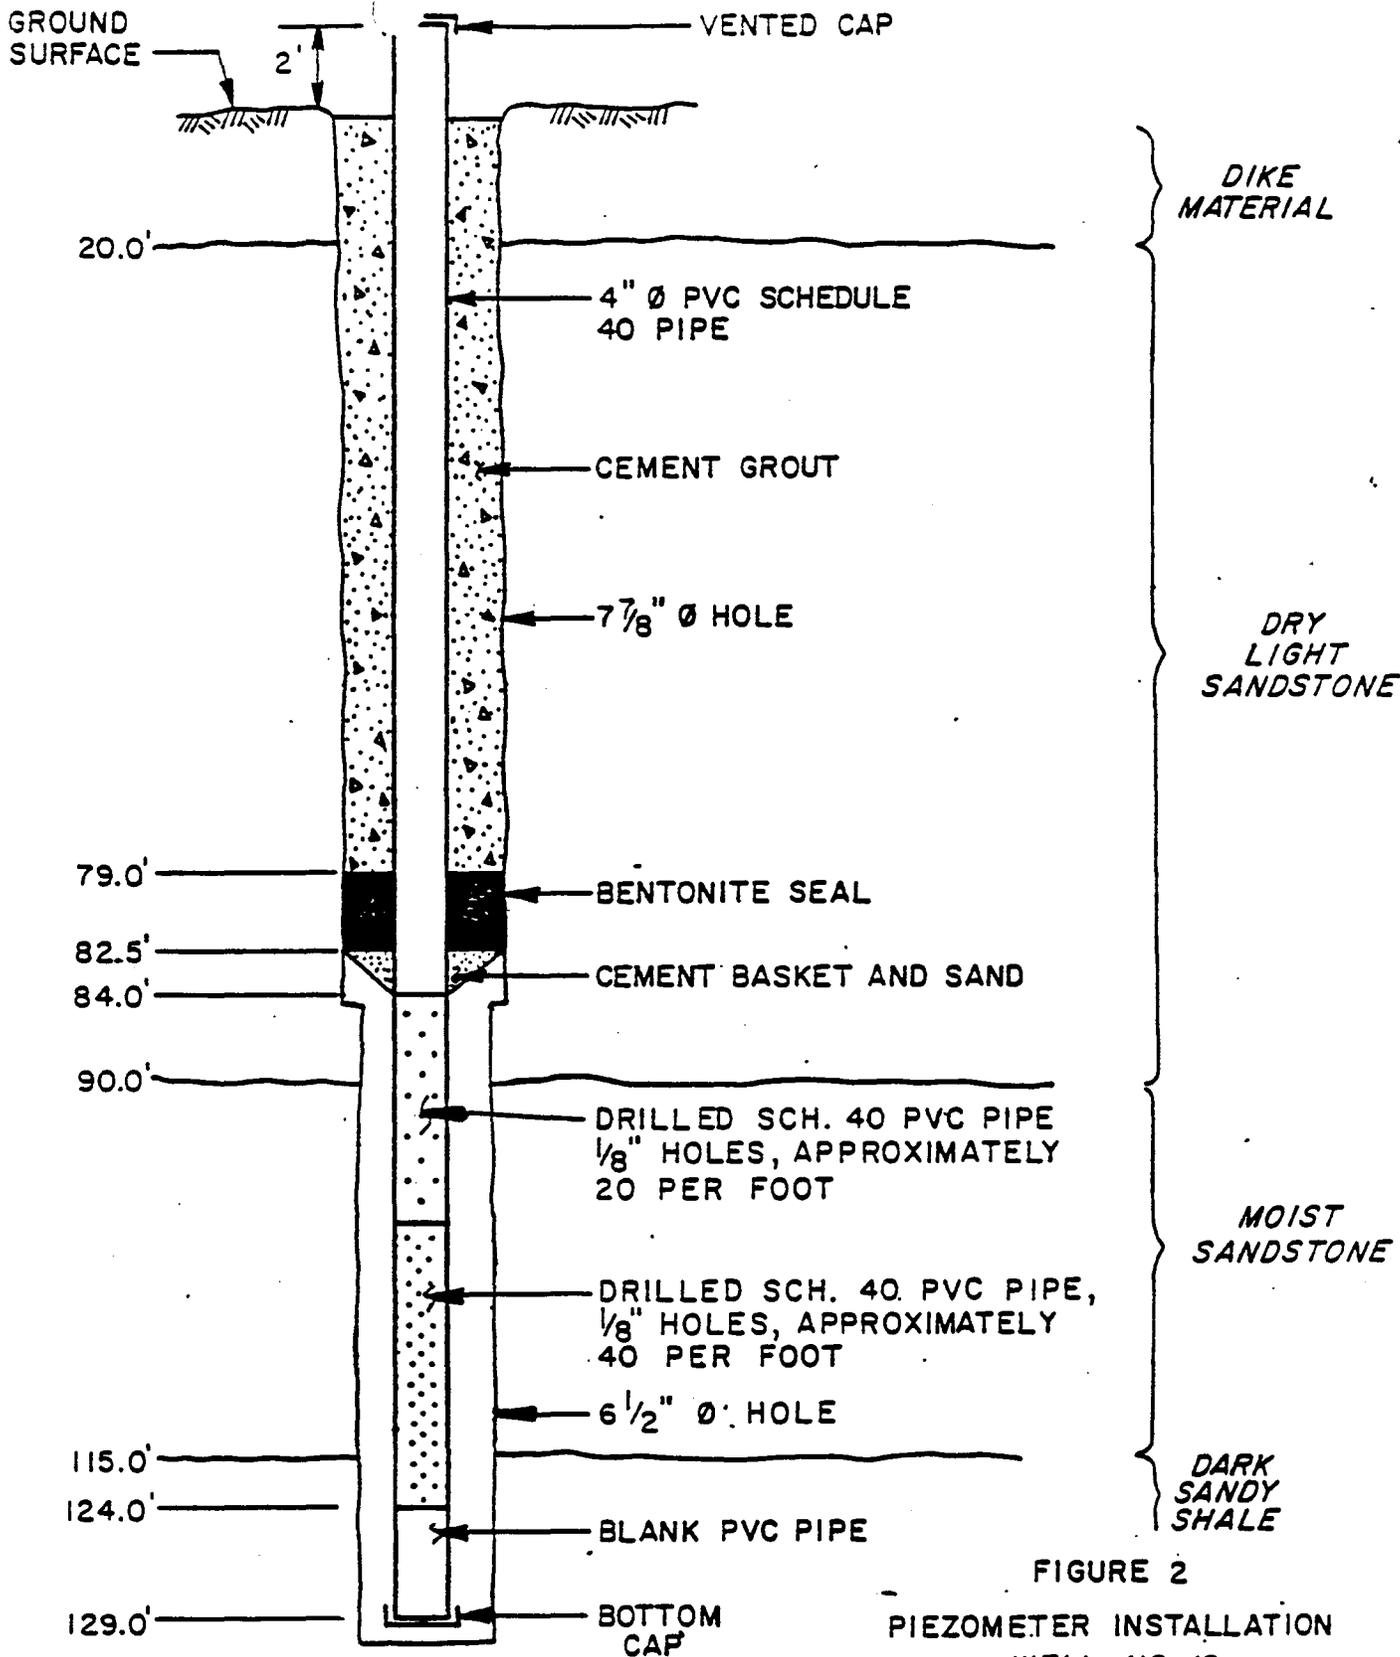
FIGURE 2  
 PIEZOMETER INSTALLATION  
 WELL NO. 12  
 CONSTRUCTION DETAILS

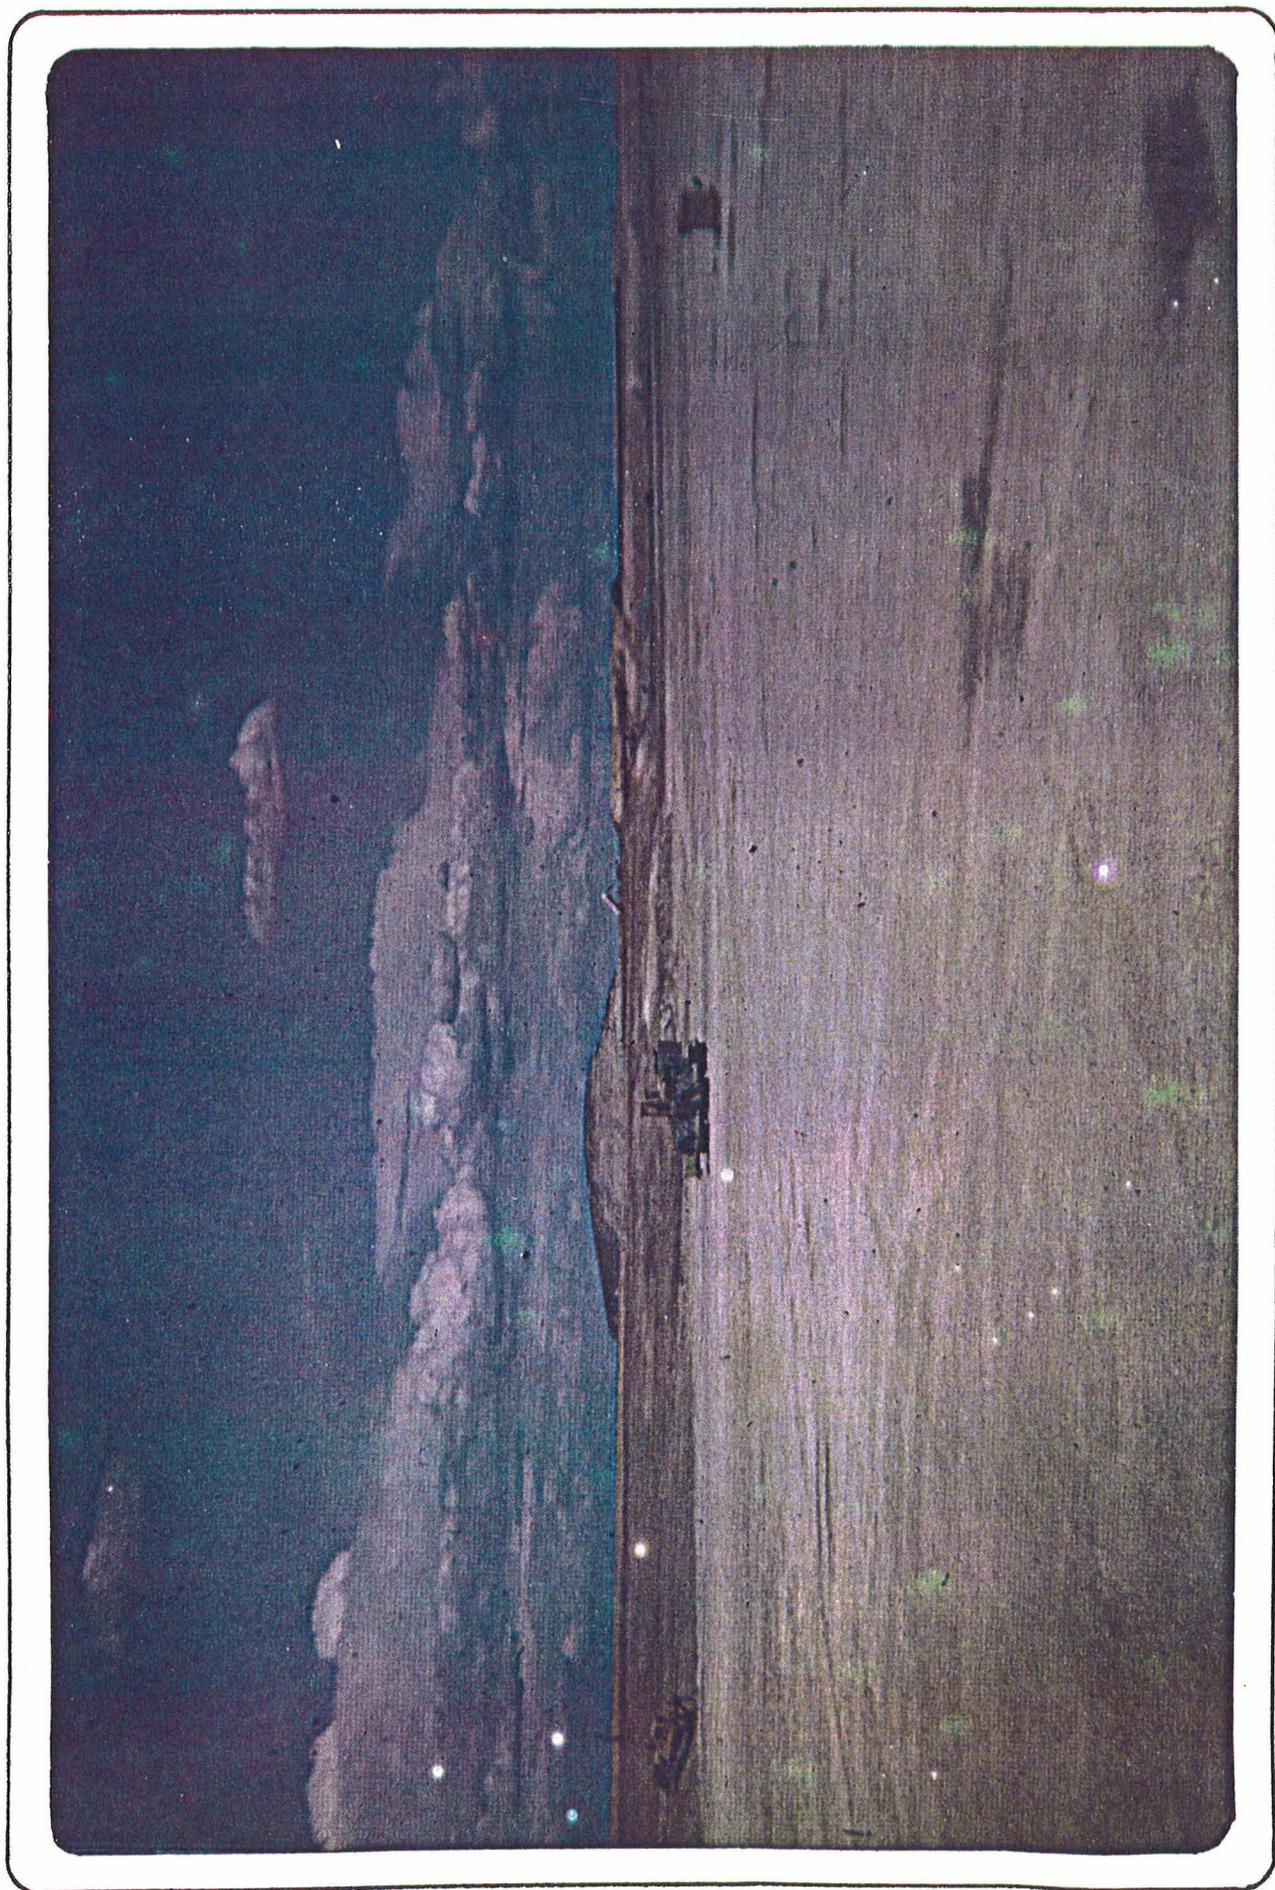
Cell 3 Tailings Pond - Bottom Preparation

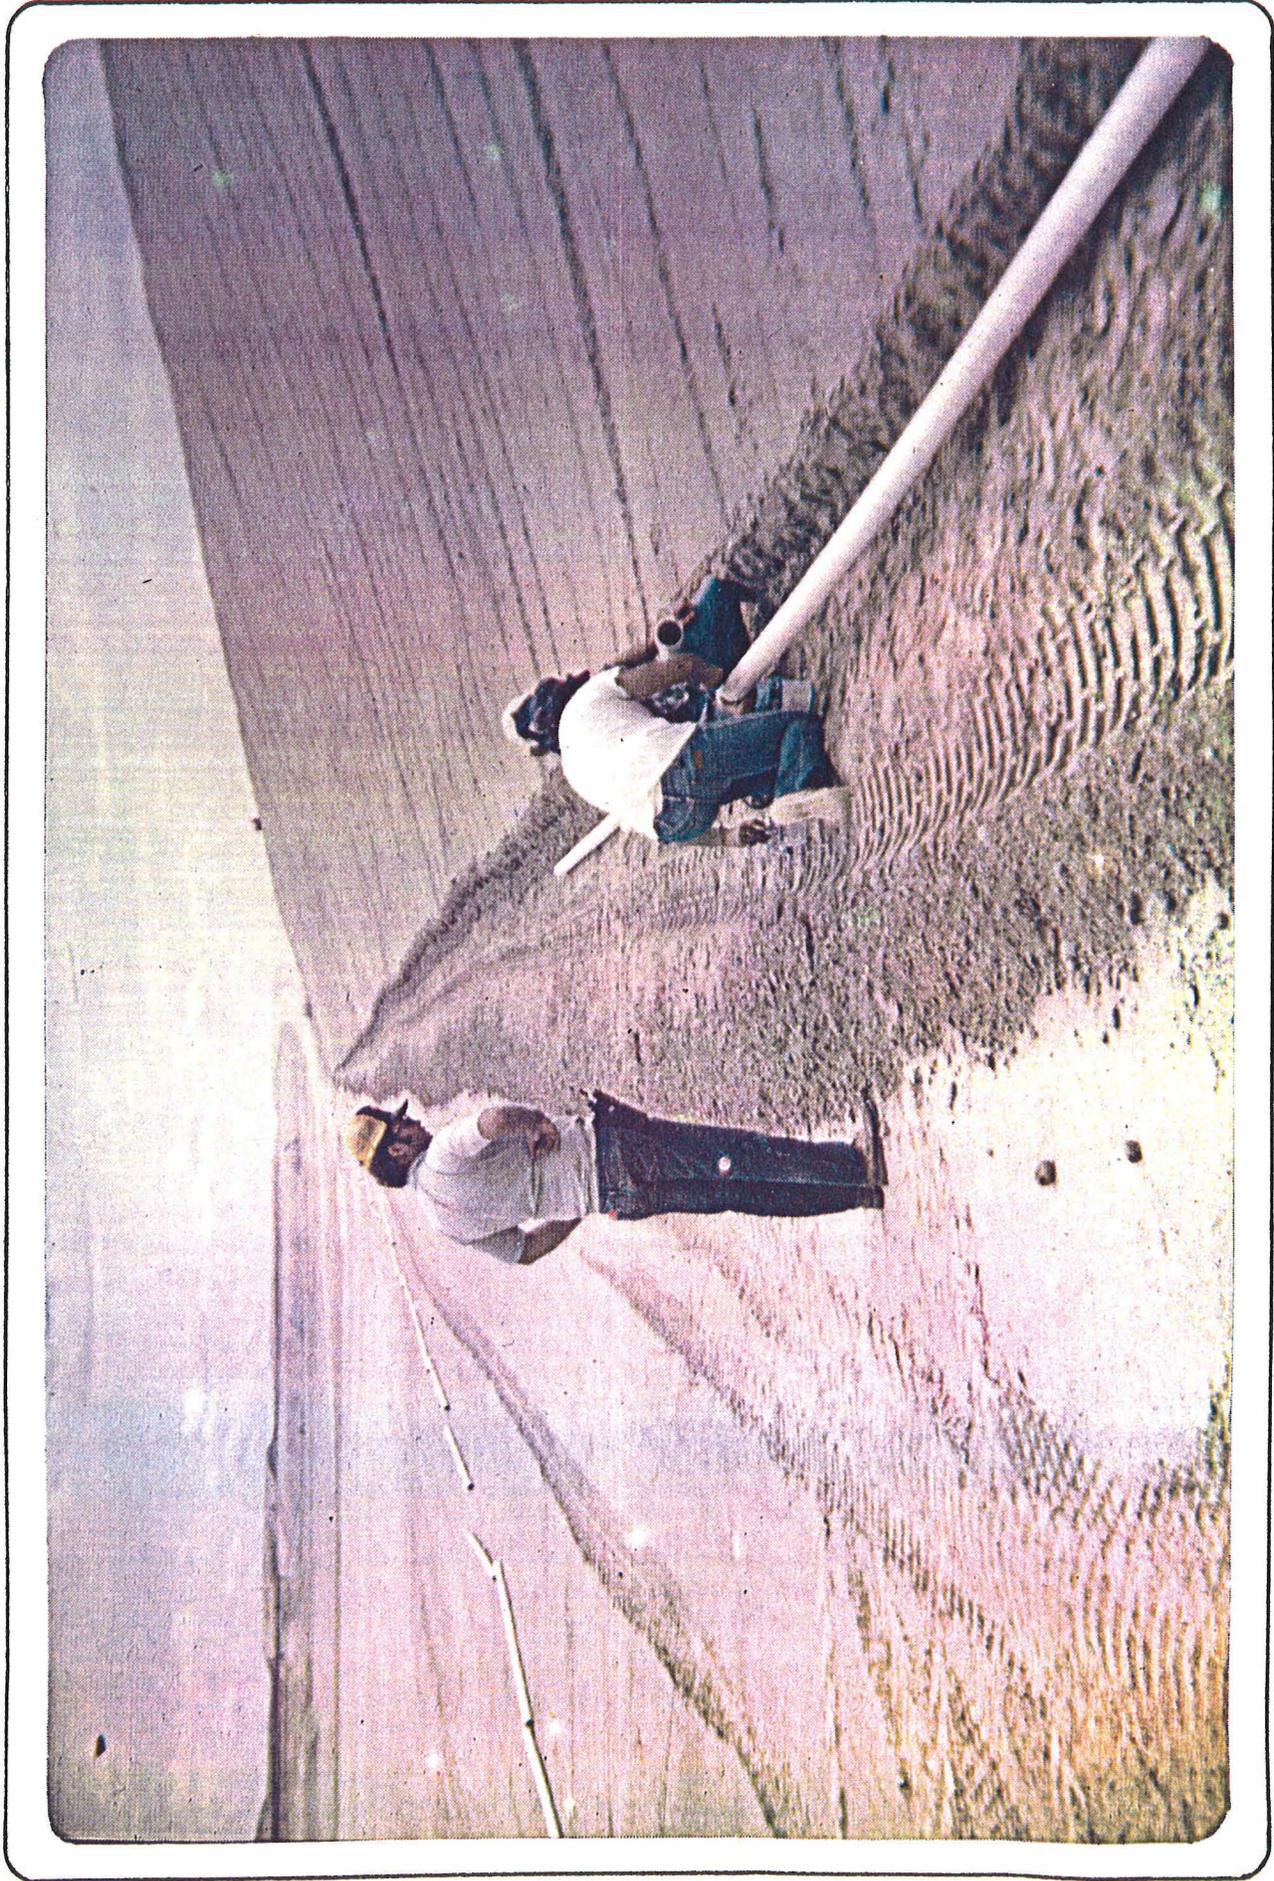
Cell 3 - Underdrain Installation

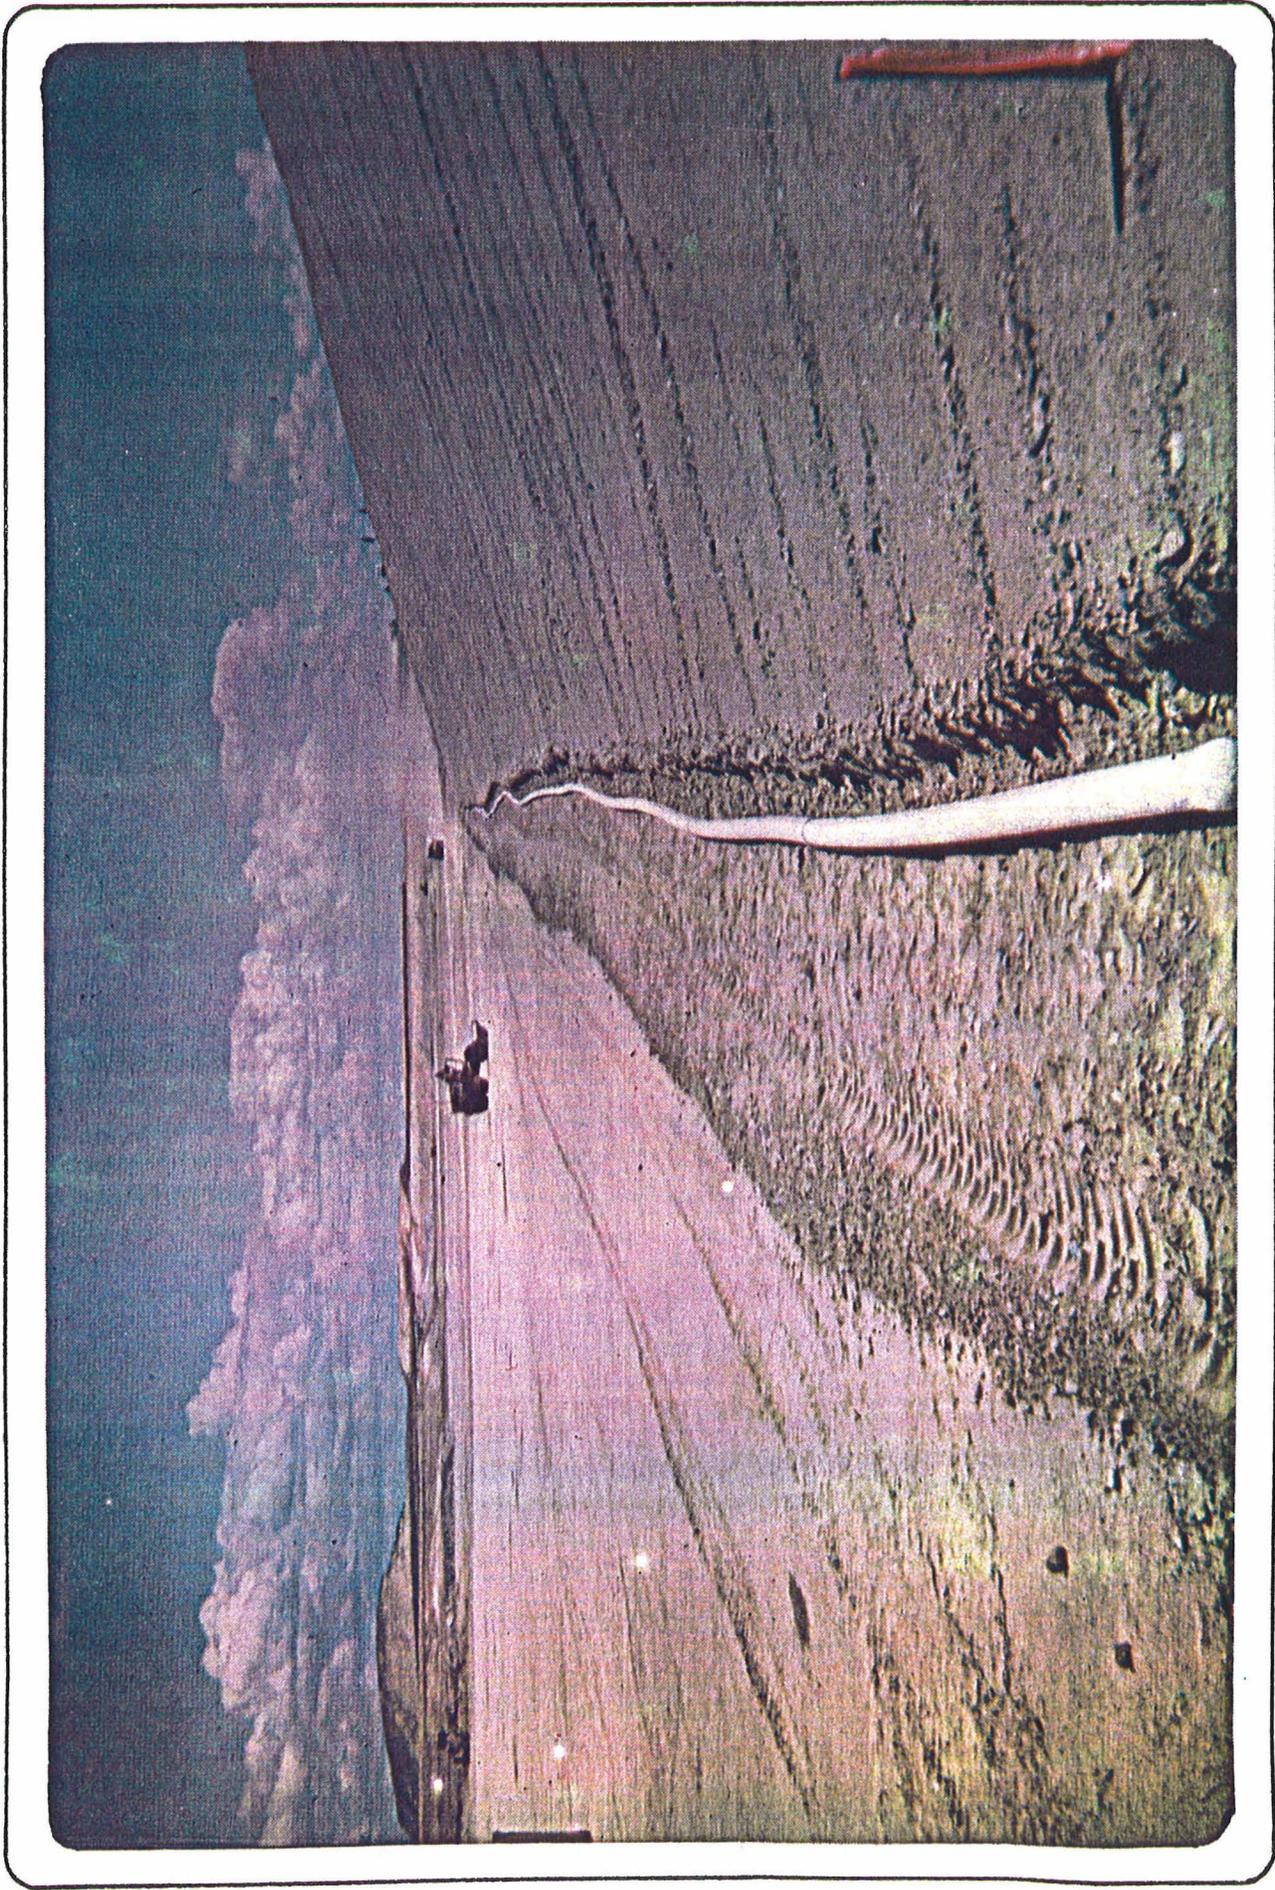
Cell 3 - Underdrain Installation and Bottom Preparation

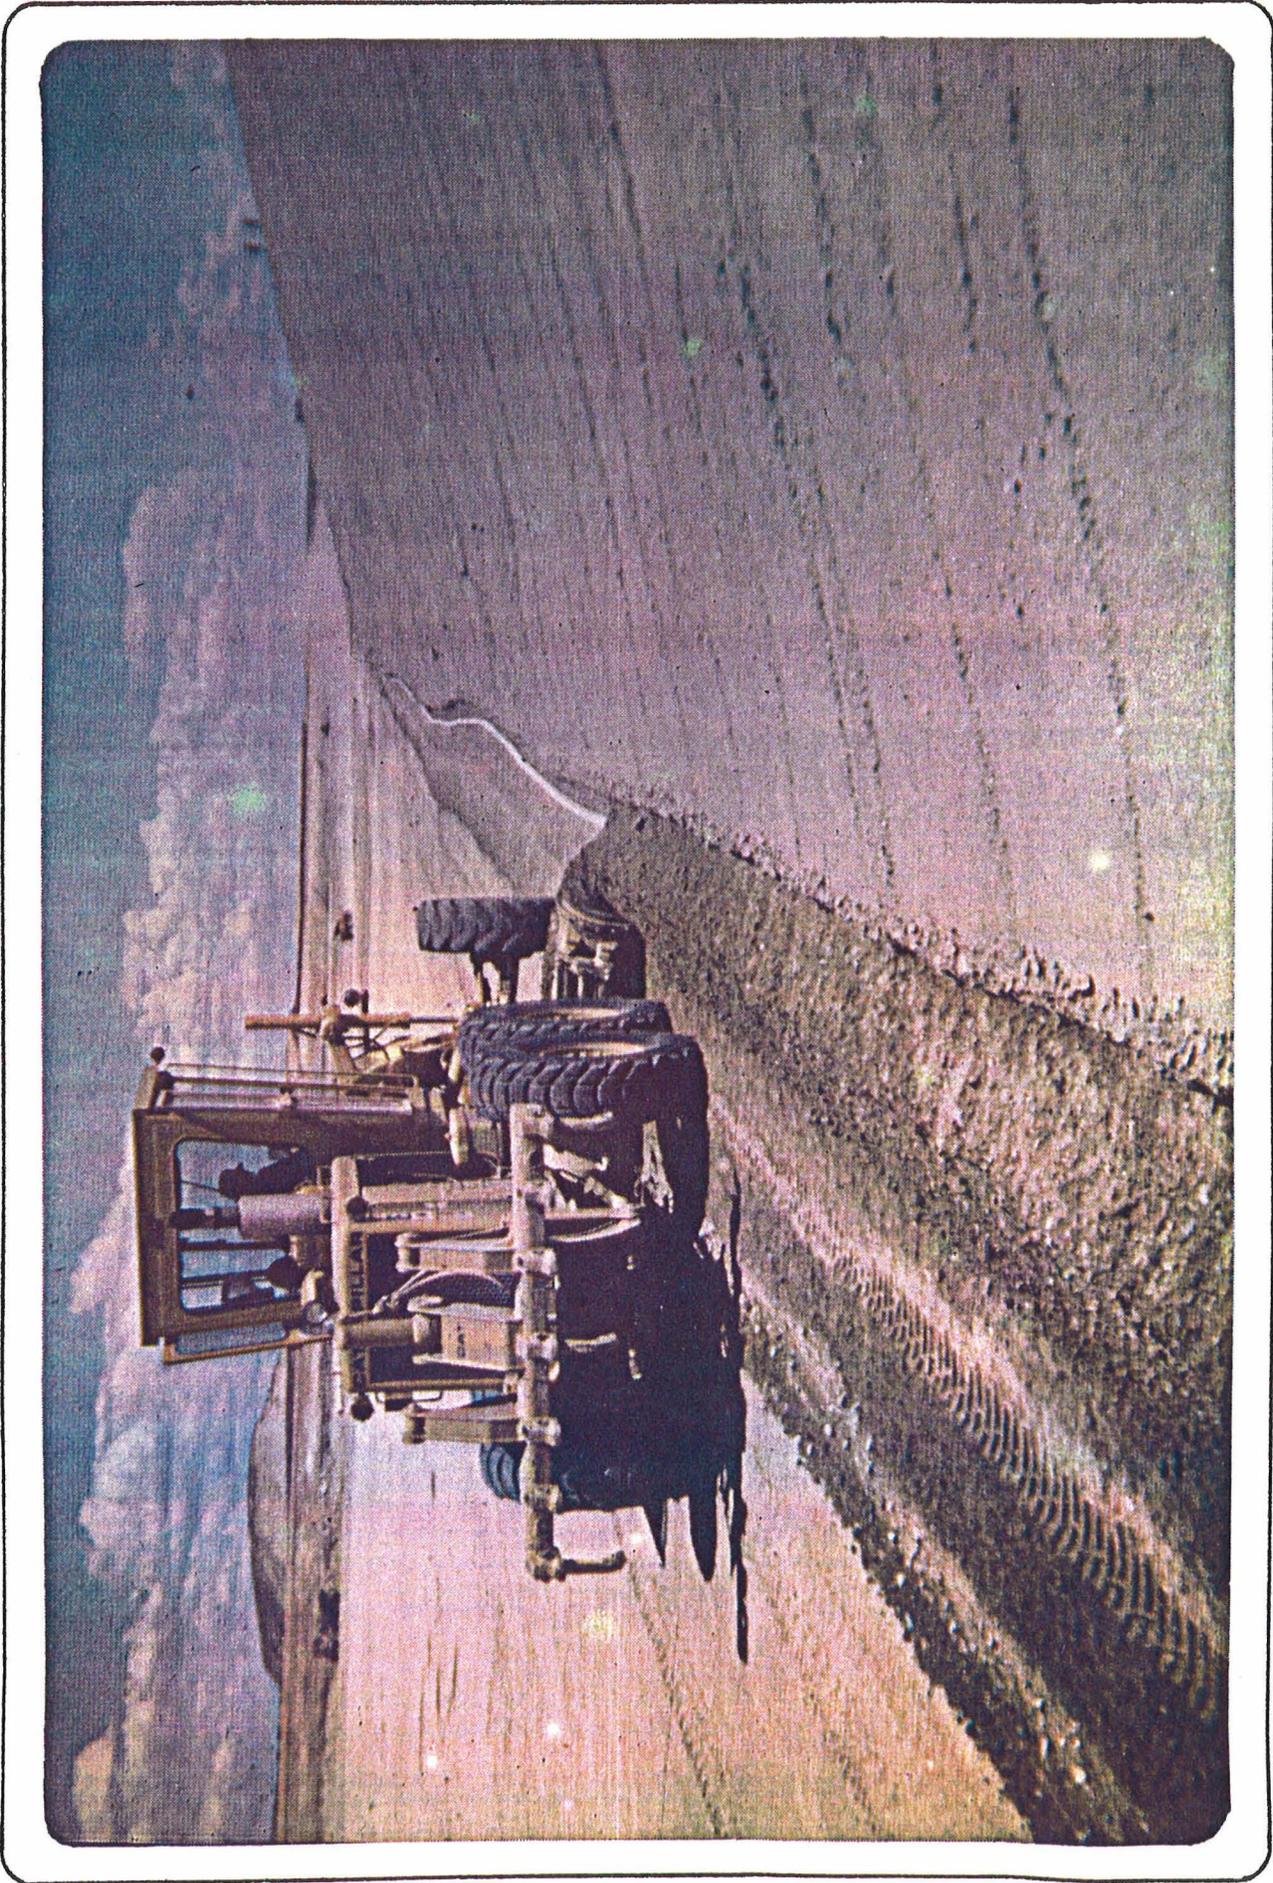
Cell 3 - Underdrain Installation

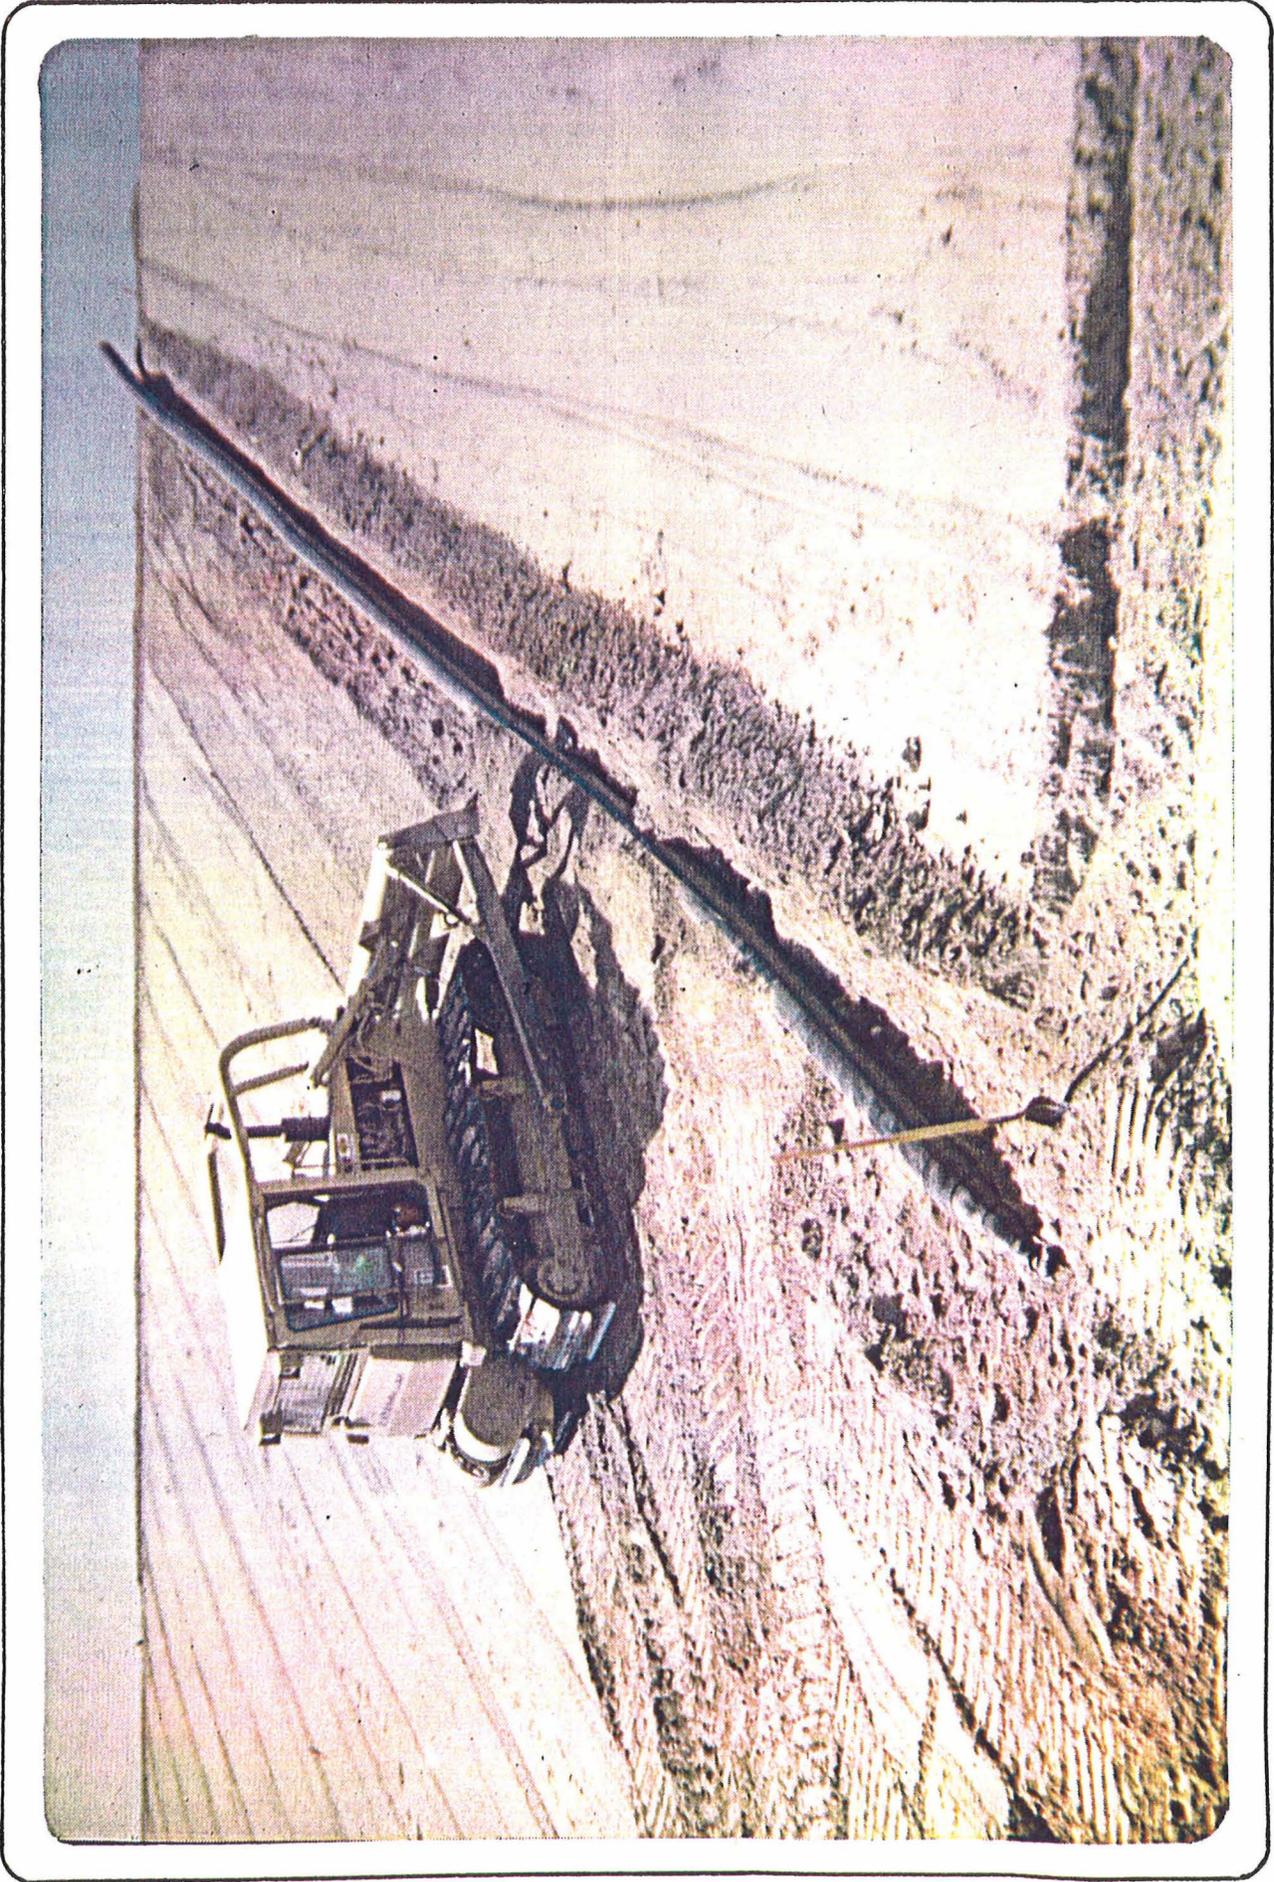
Cell 3 - Installation of Underdrain Access Riser

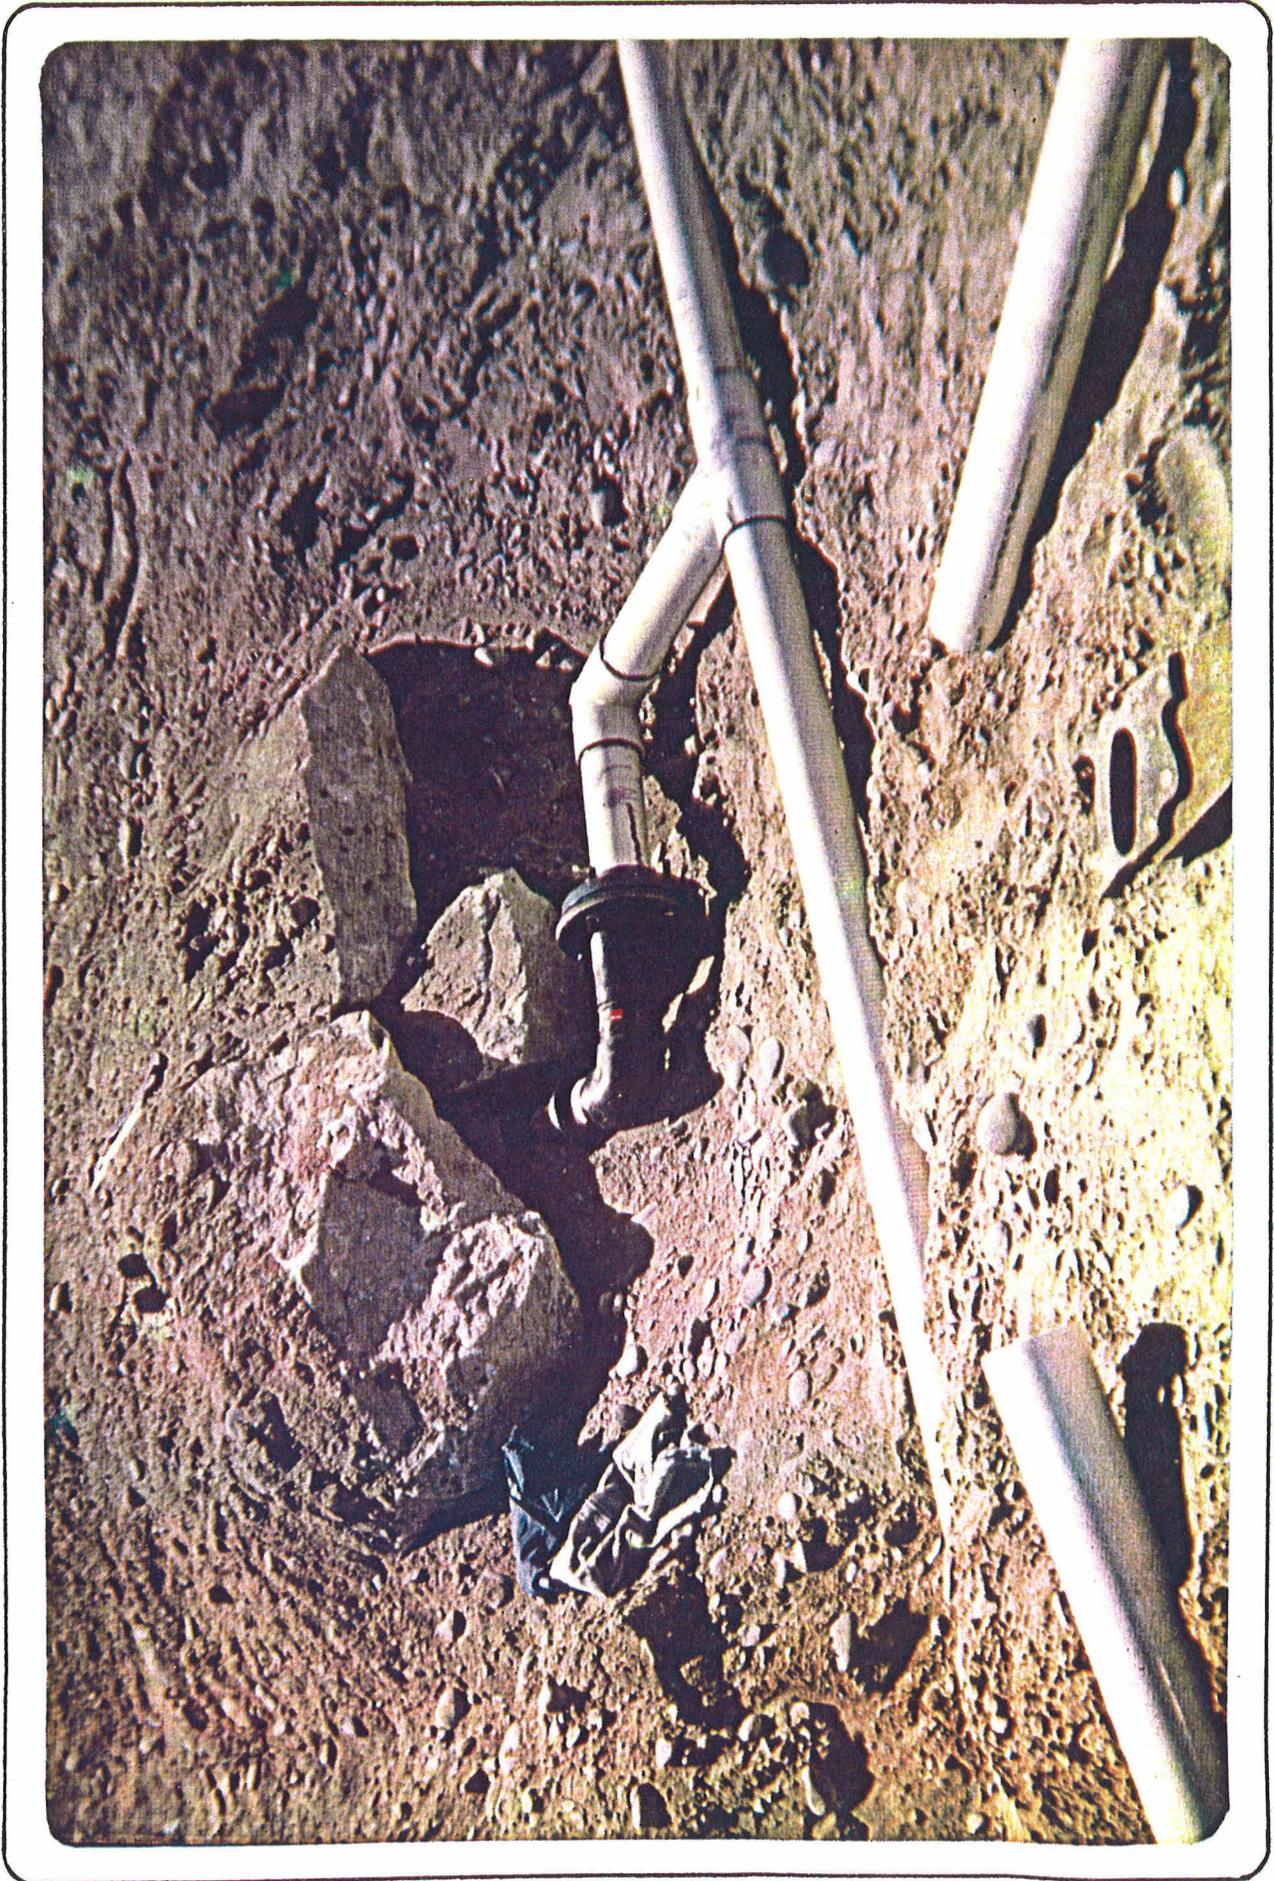
Cell 3 - Underdrain System, Final Piping Tie-in and Rock Stabilization
