CONSTRUCTION REPORT  
SECOND PHASE  
TAILINGS MANAGEMENT SYSTEM

White Mesa Uranium Project  
Energy Fuels Nuclear, Inc.  
March, 1983

SUA-1358, Docket 40-8681

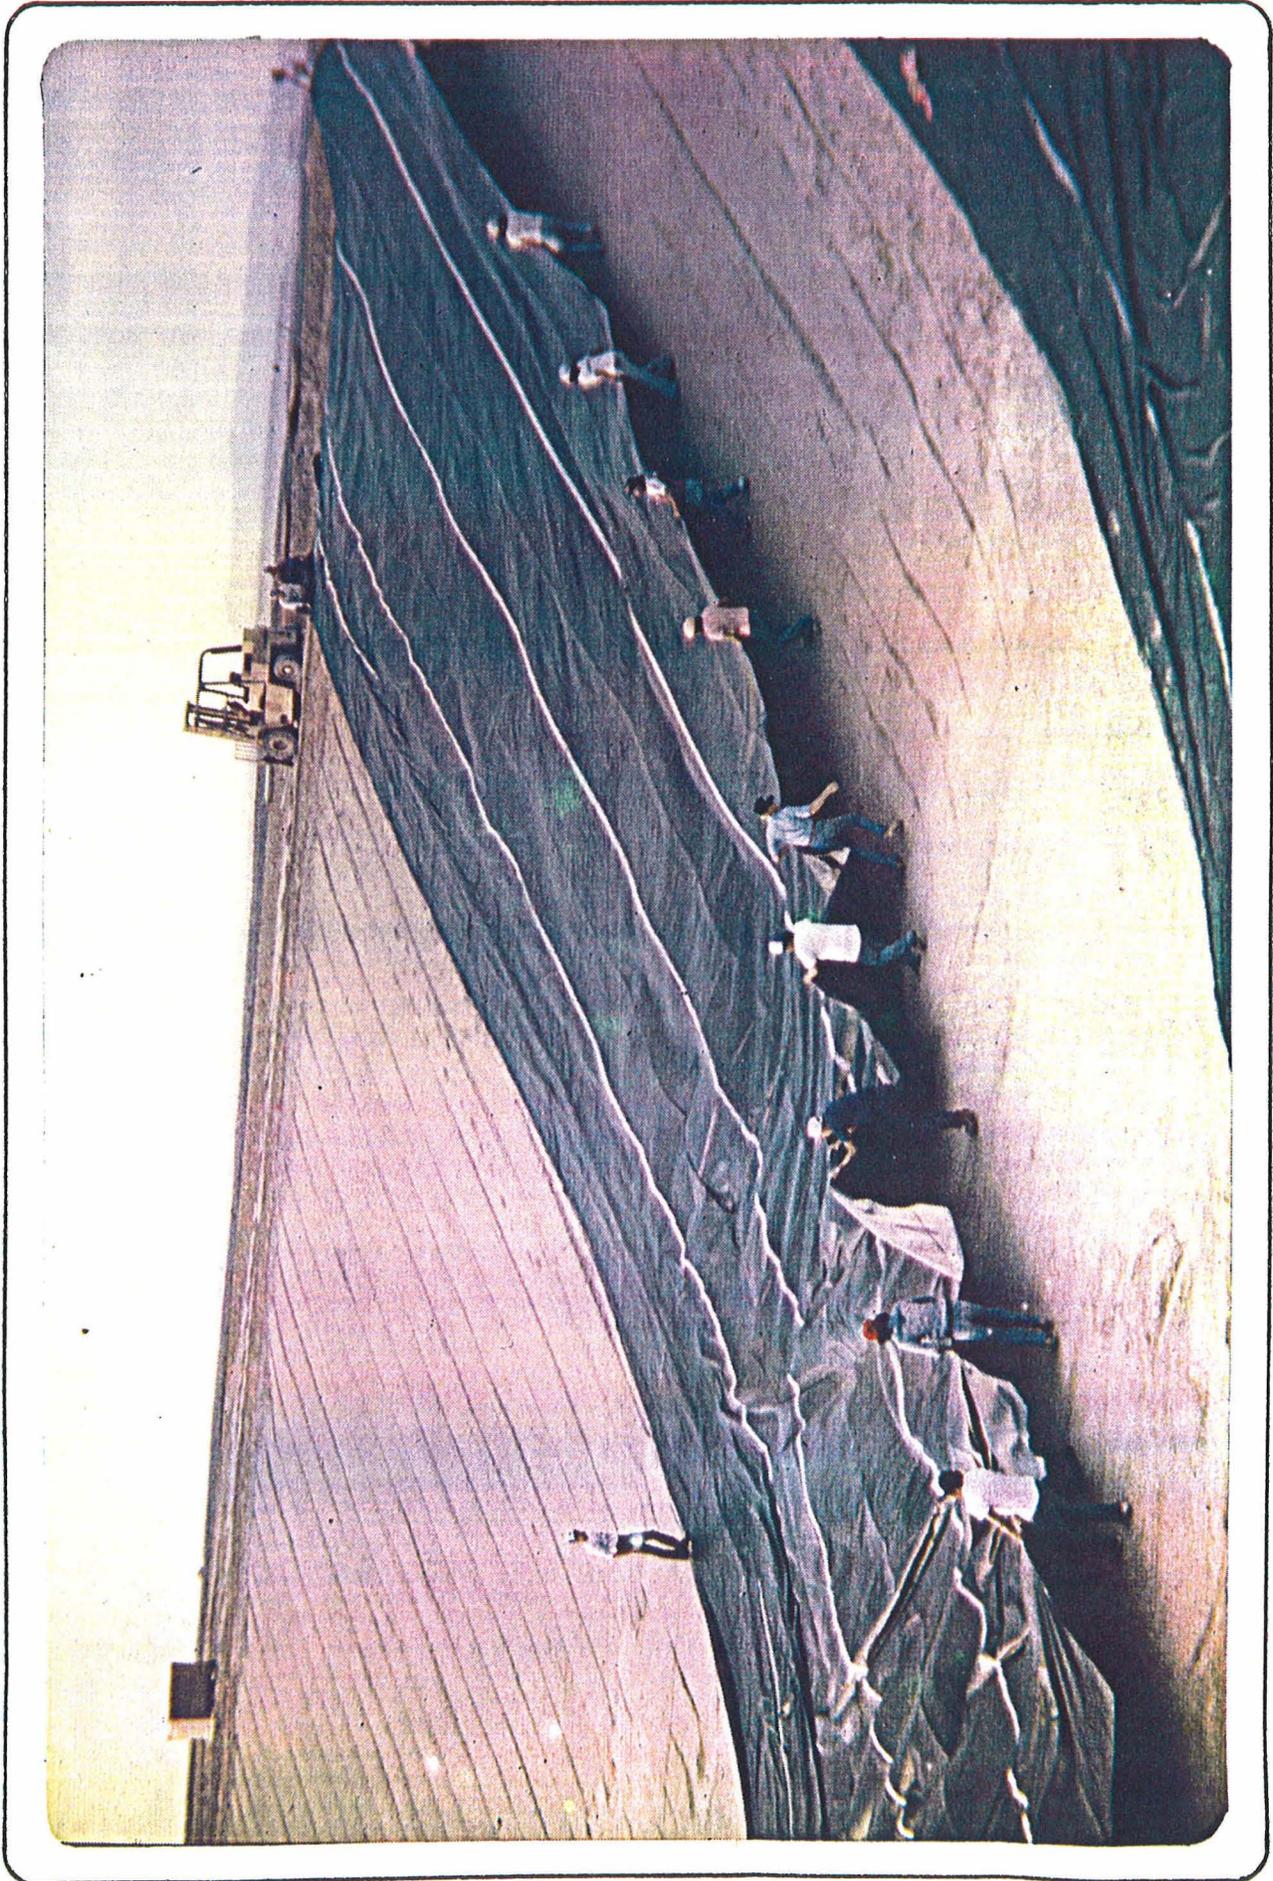
Cell 3 - PVC Liner Installation on Dike Face

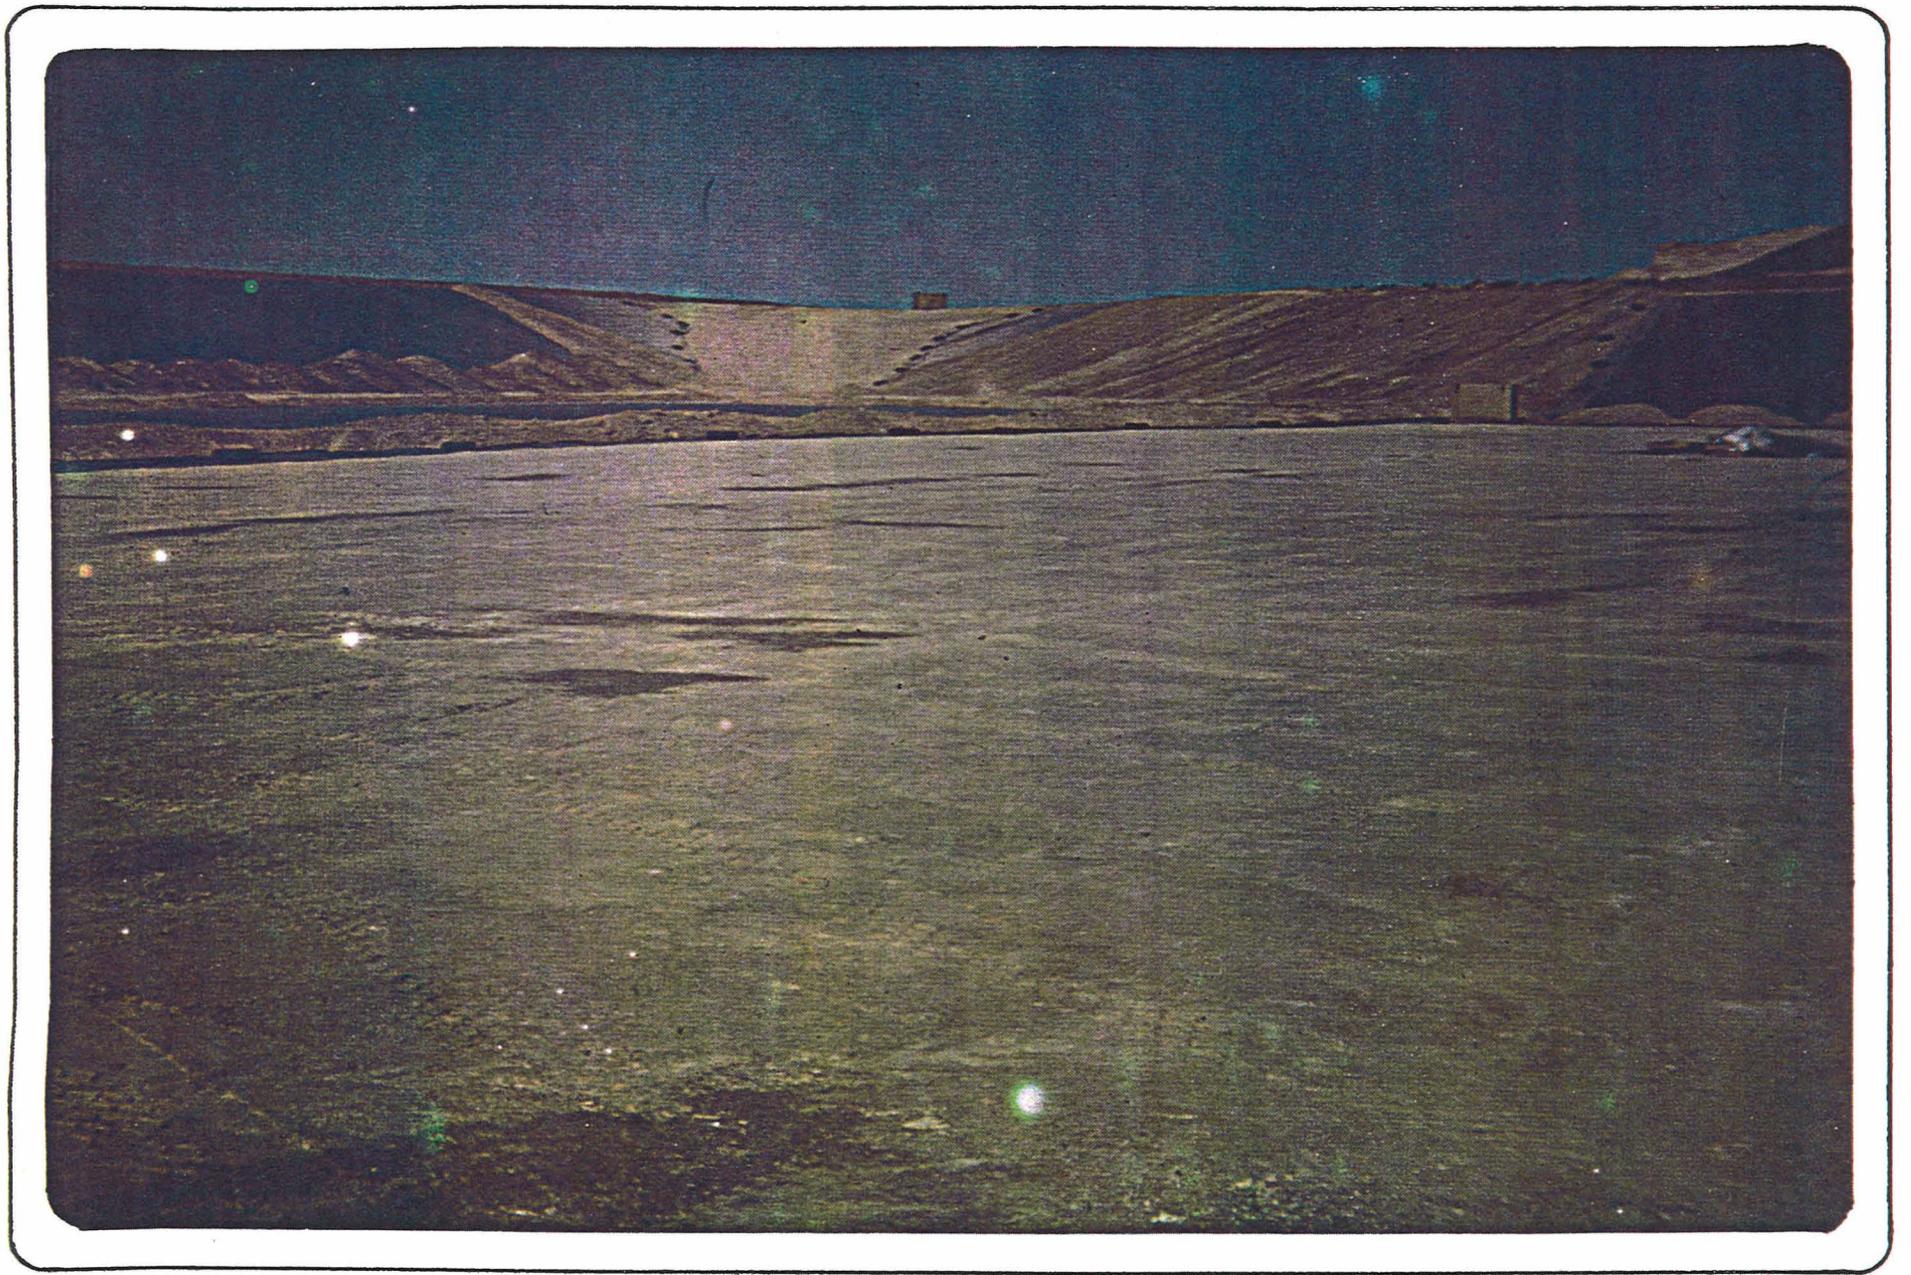
Cell 3 - Liner Installation and Start of Covering Operations

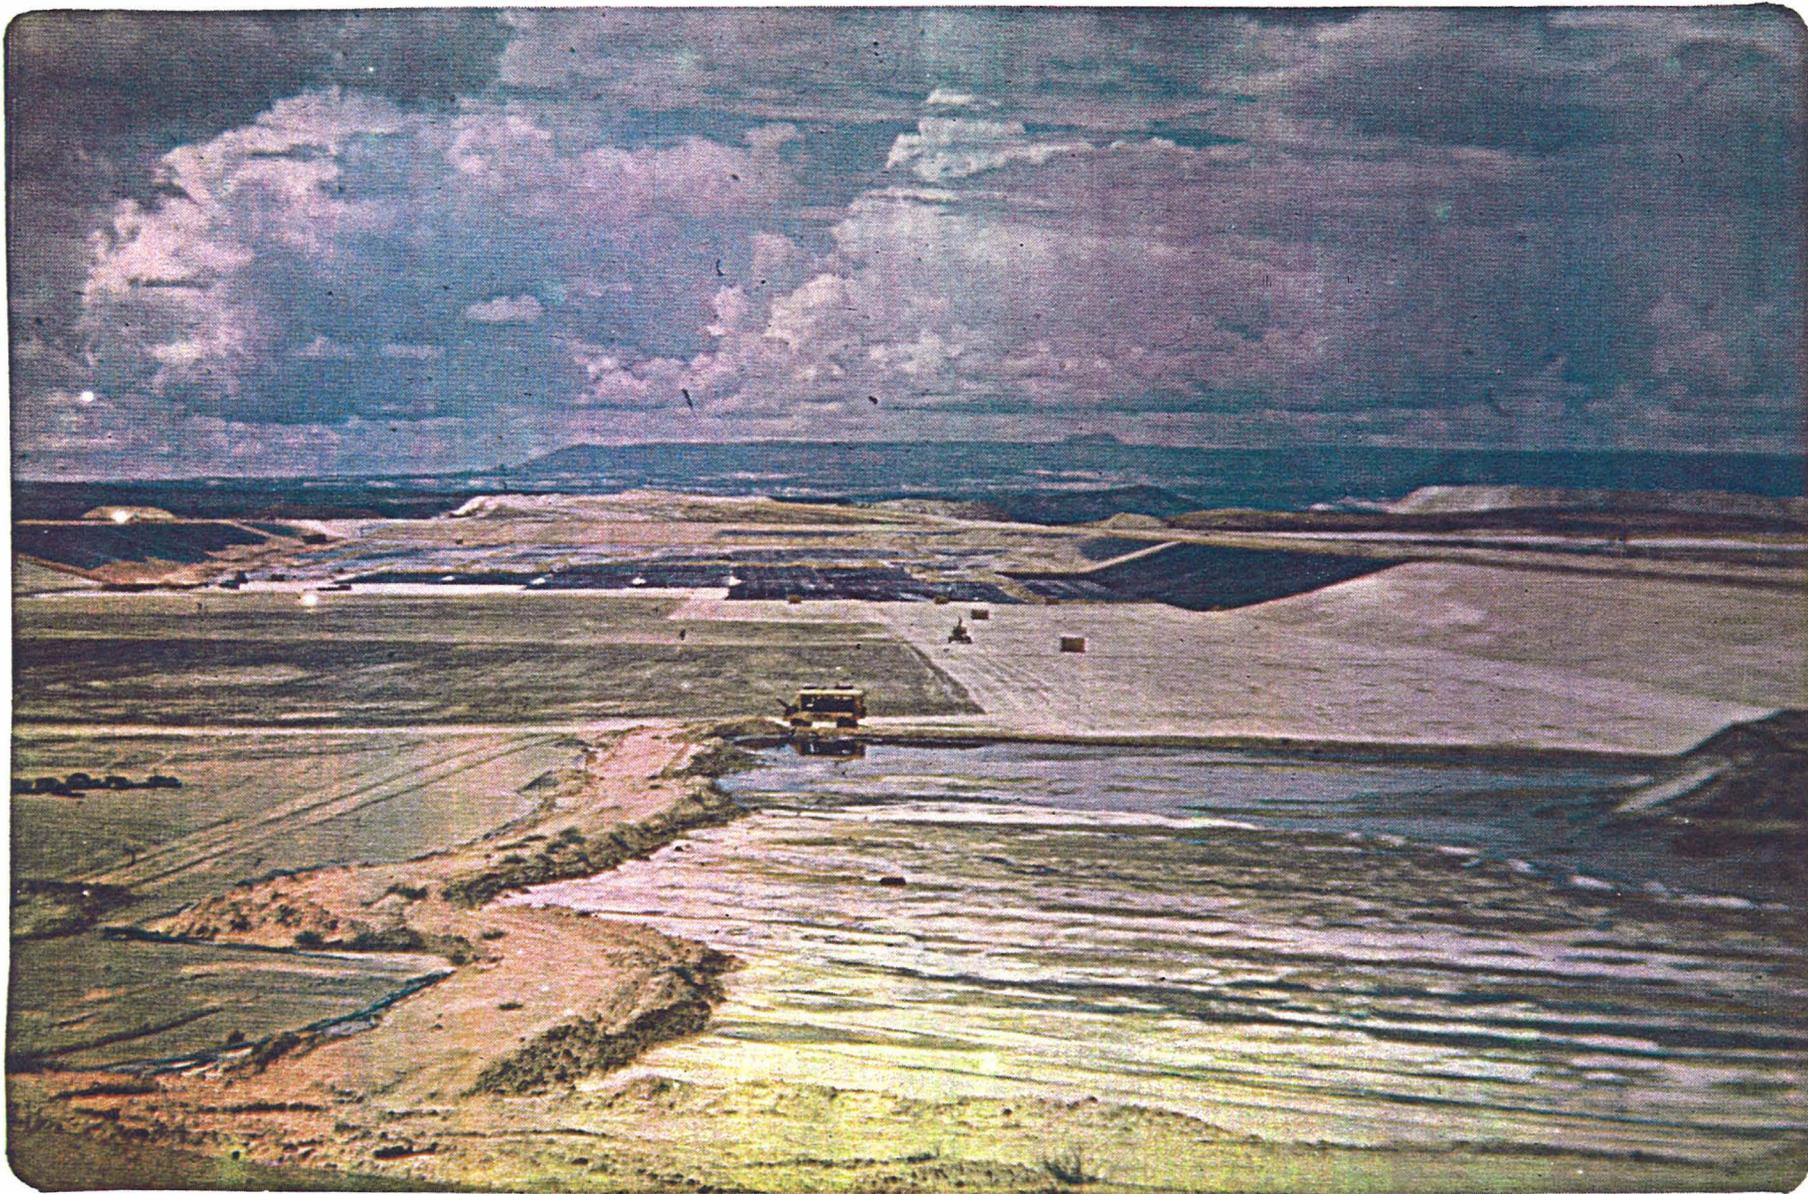
Cell 3 - Liner Installation, approximately 50% complete.  
(Note storage area for dewatered tailings sands - lower  
right)

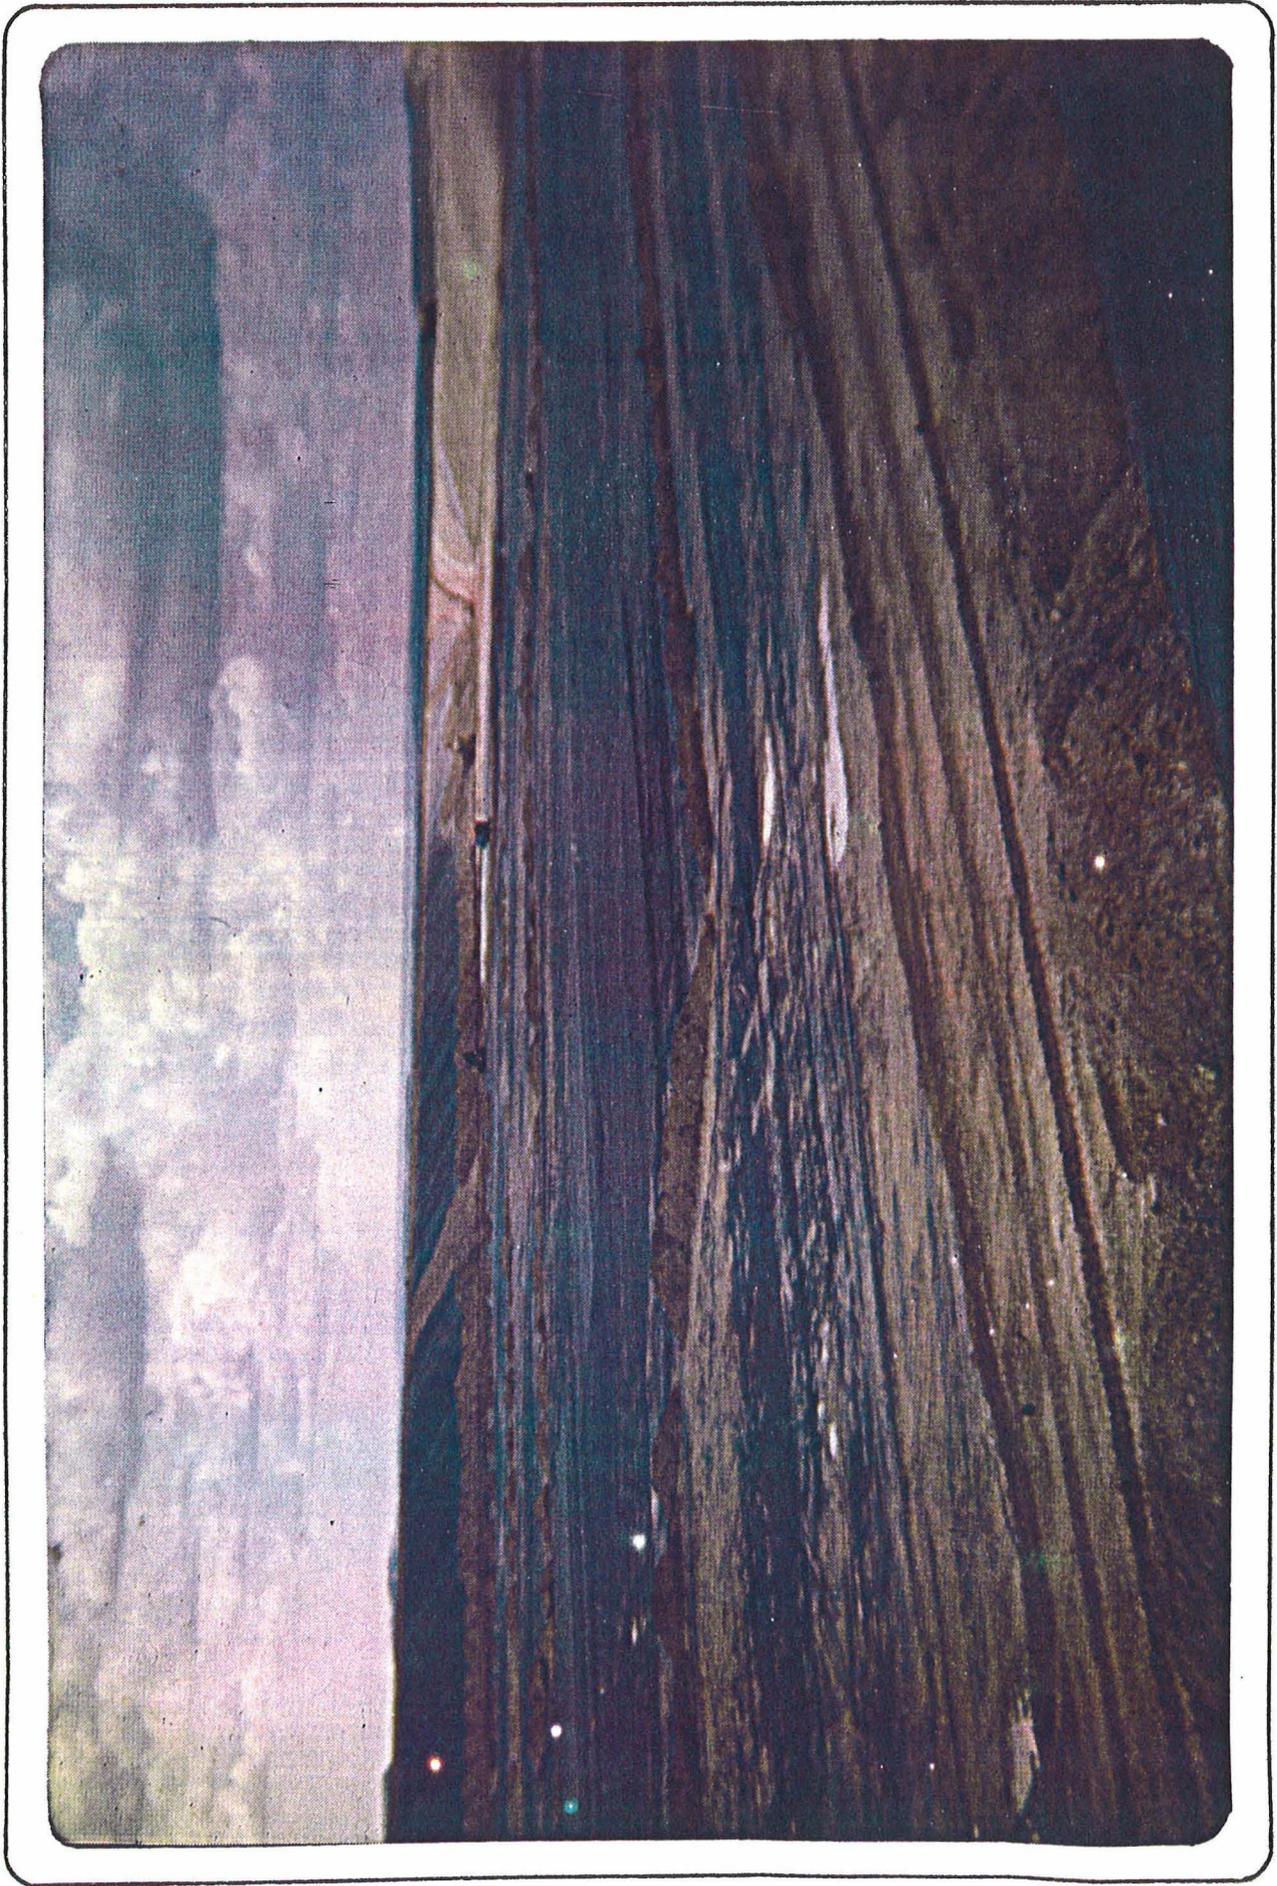
Cell 3 - Liner Installation and Cover Operations

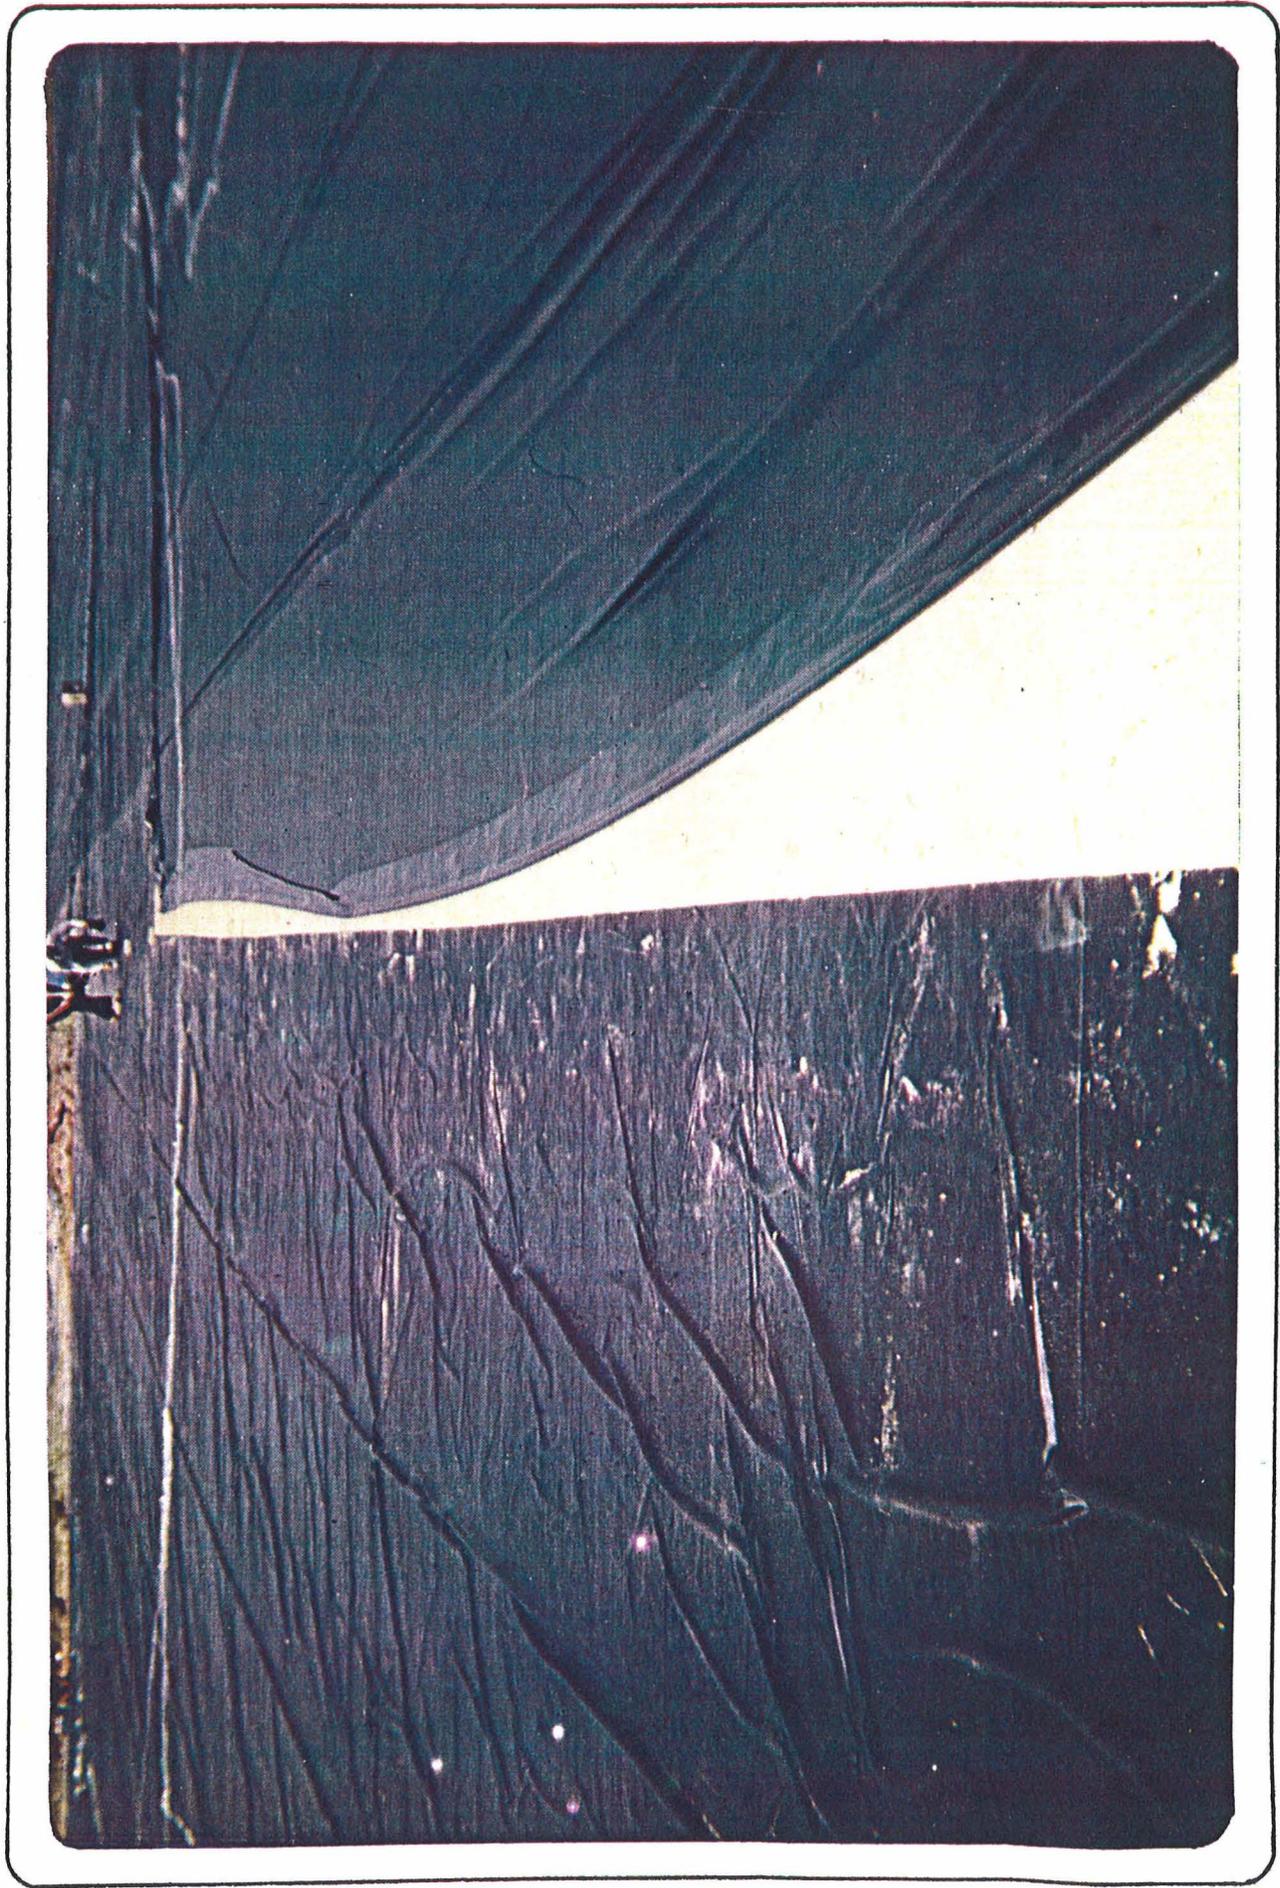
Cell 3 - Liner Installation, Typical Seaming Operation.

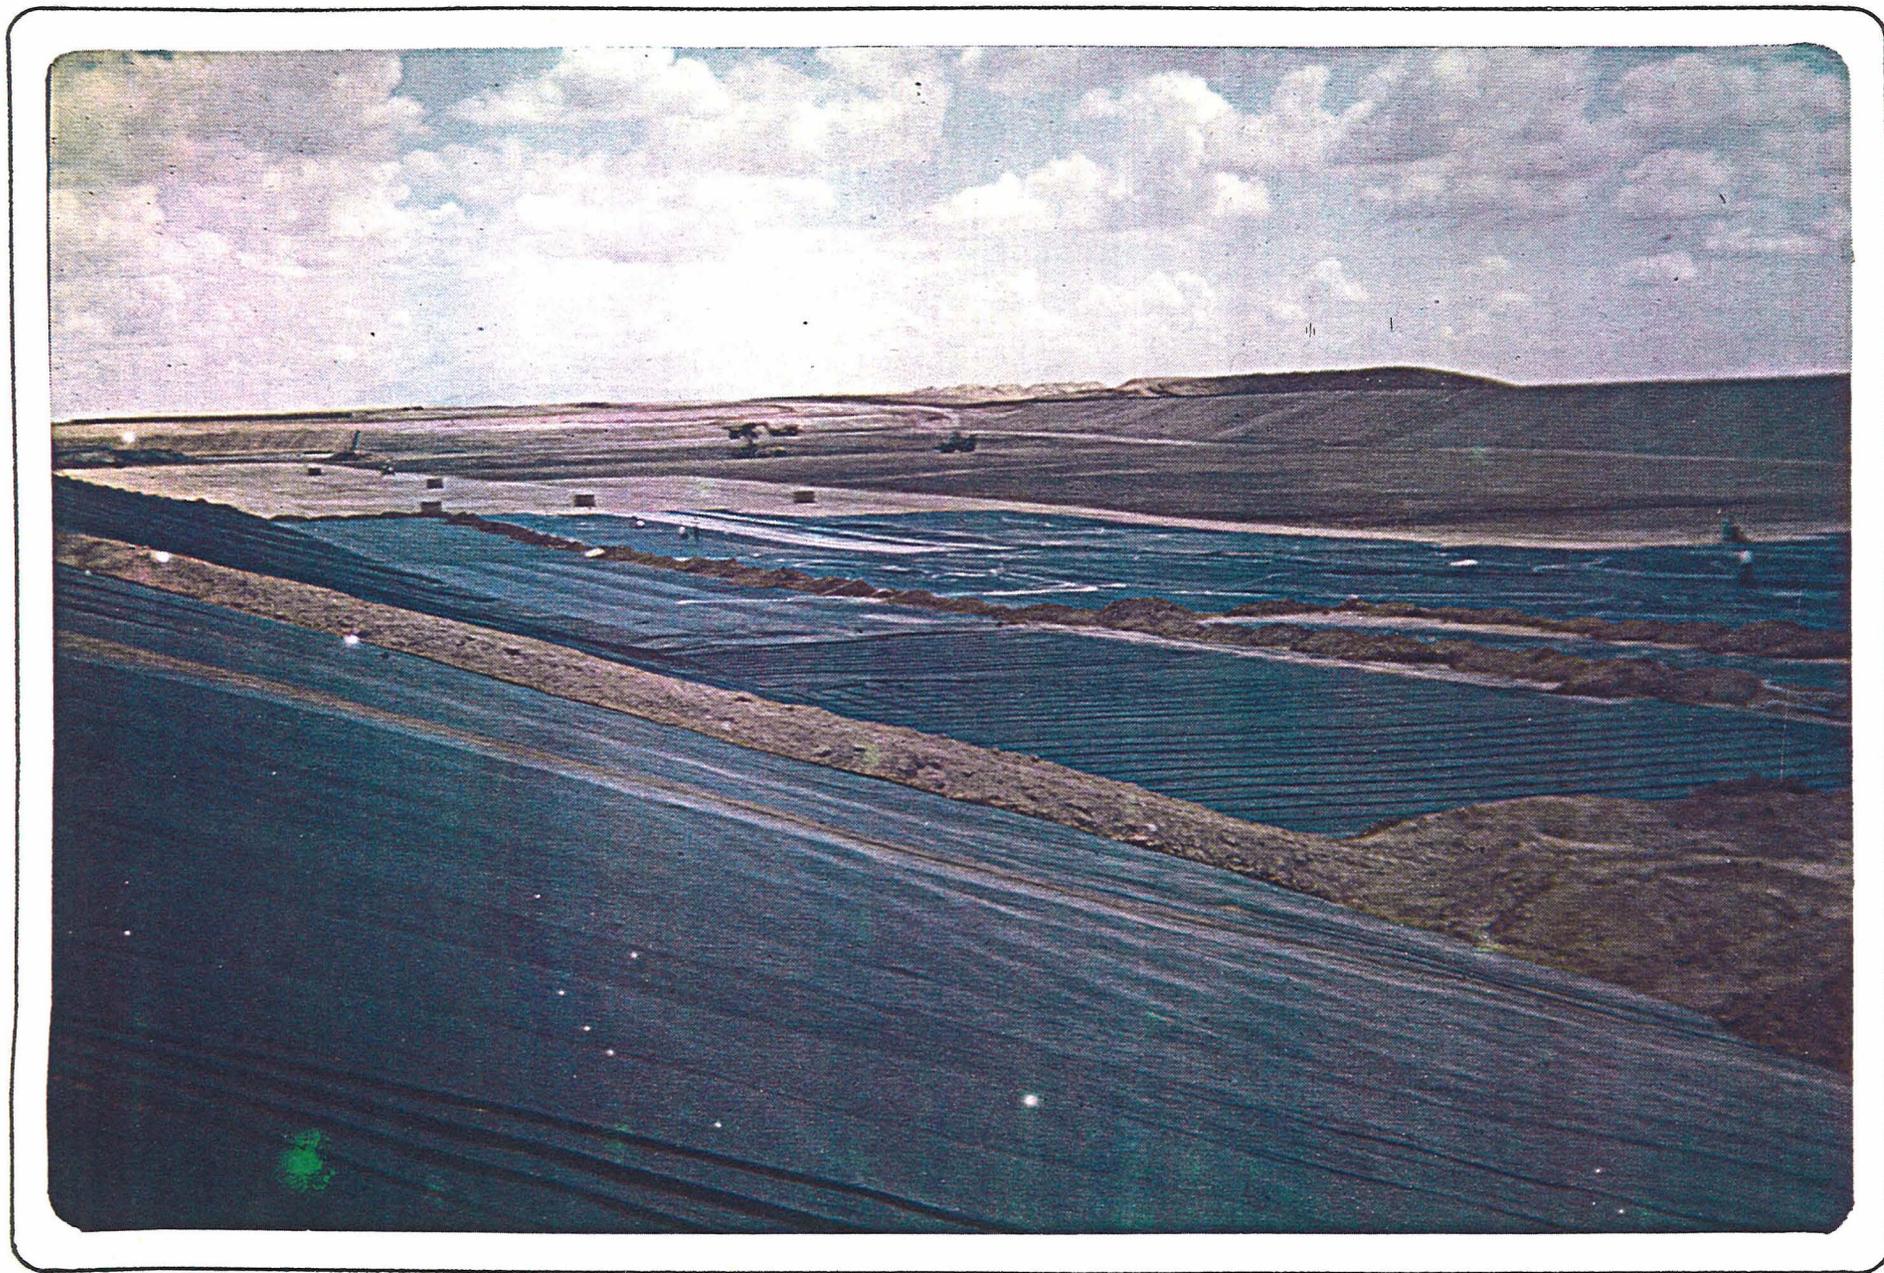
Cell 3 - Various Stages of Bottom Preparation, Liner  
Installation and Covering Operations

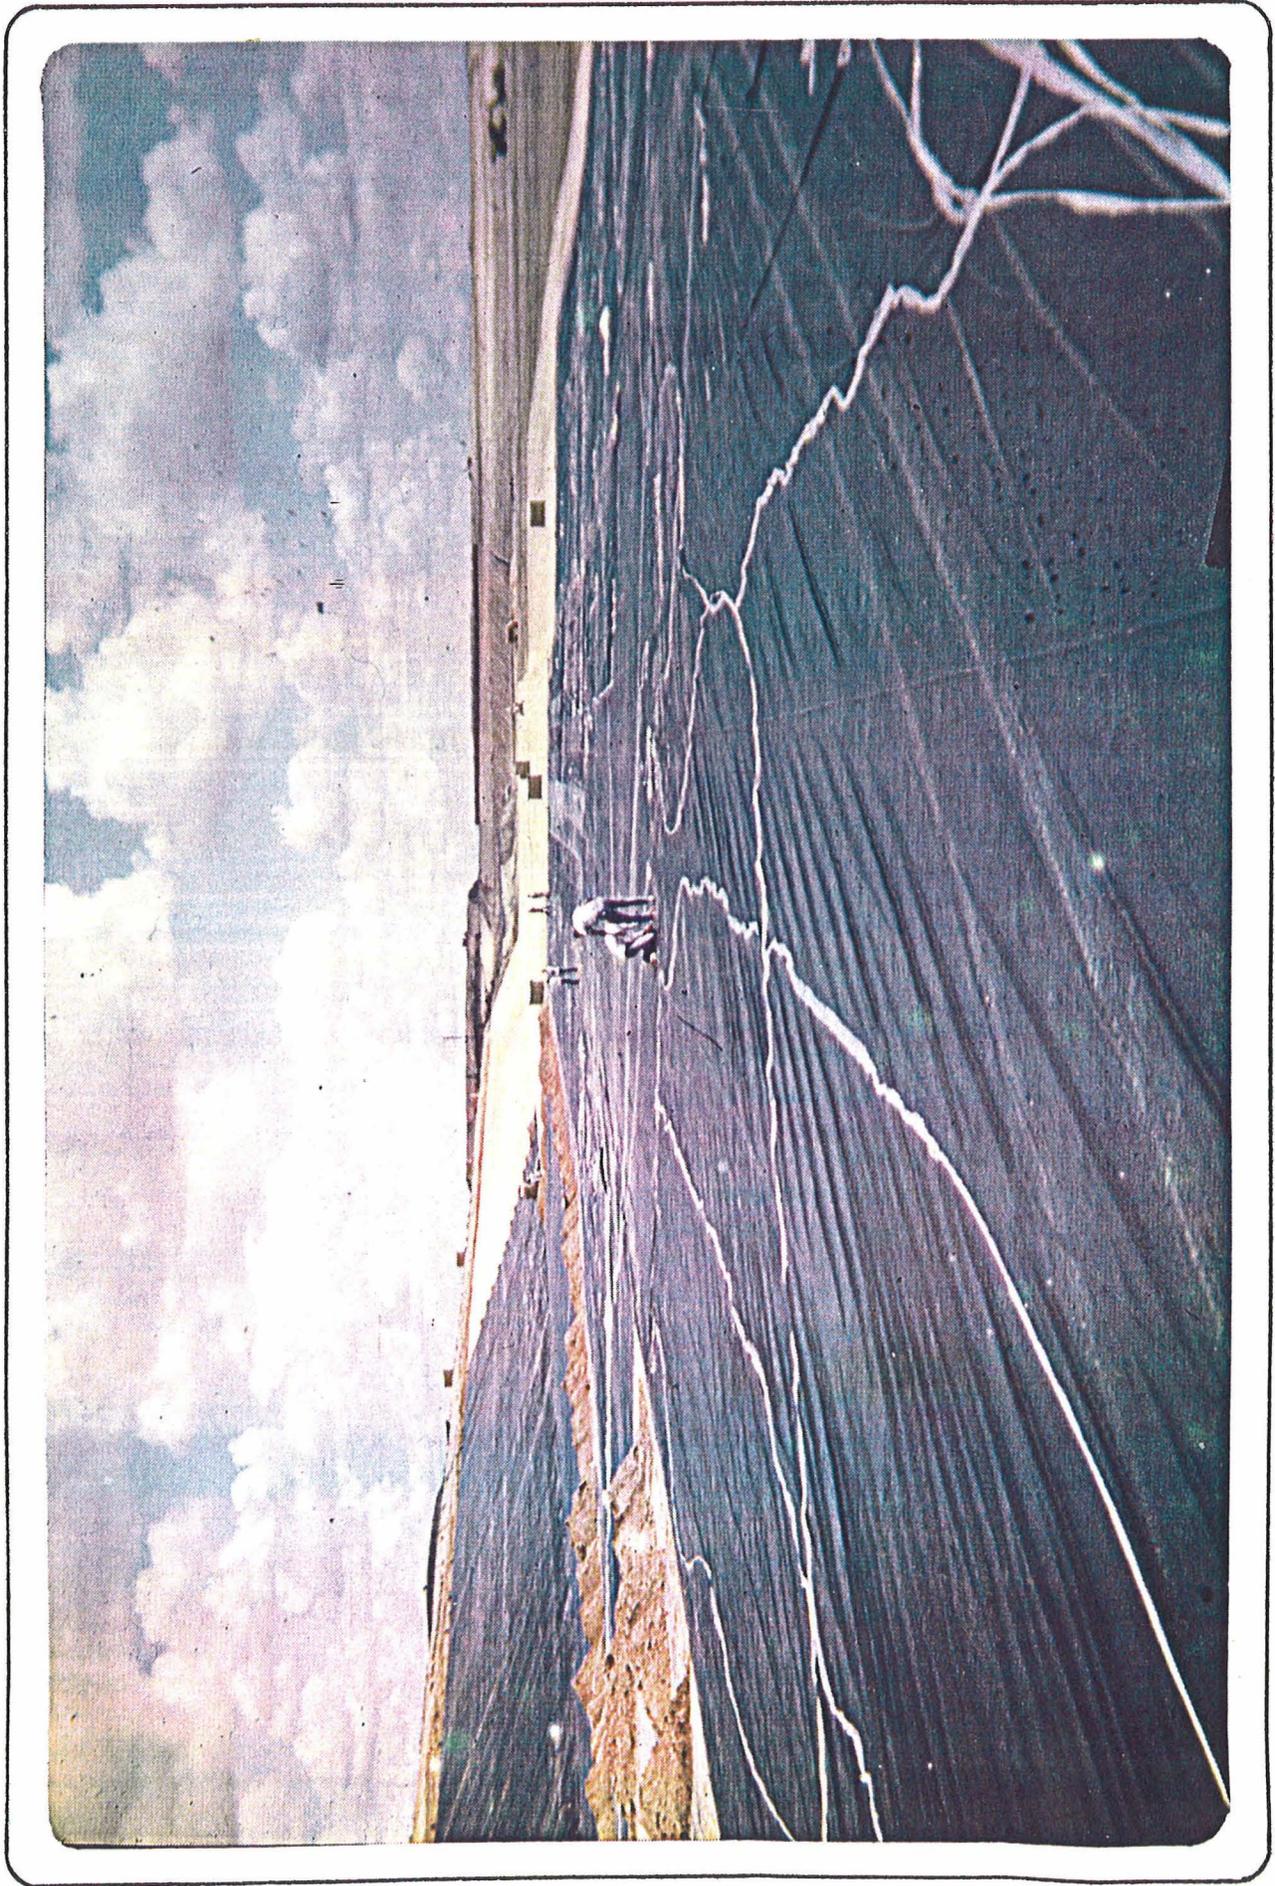
Cell 3 - Liner Installation and Seaming

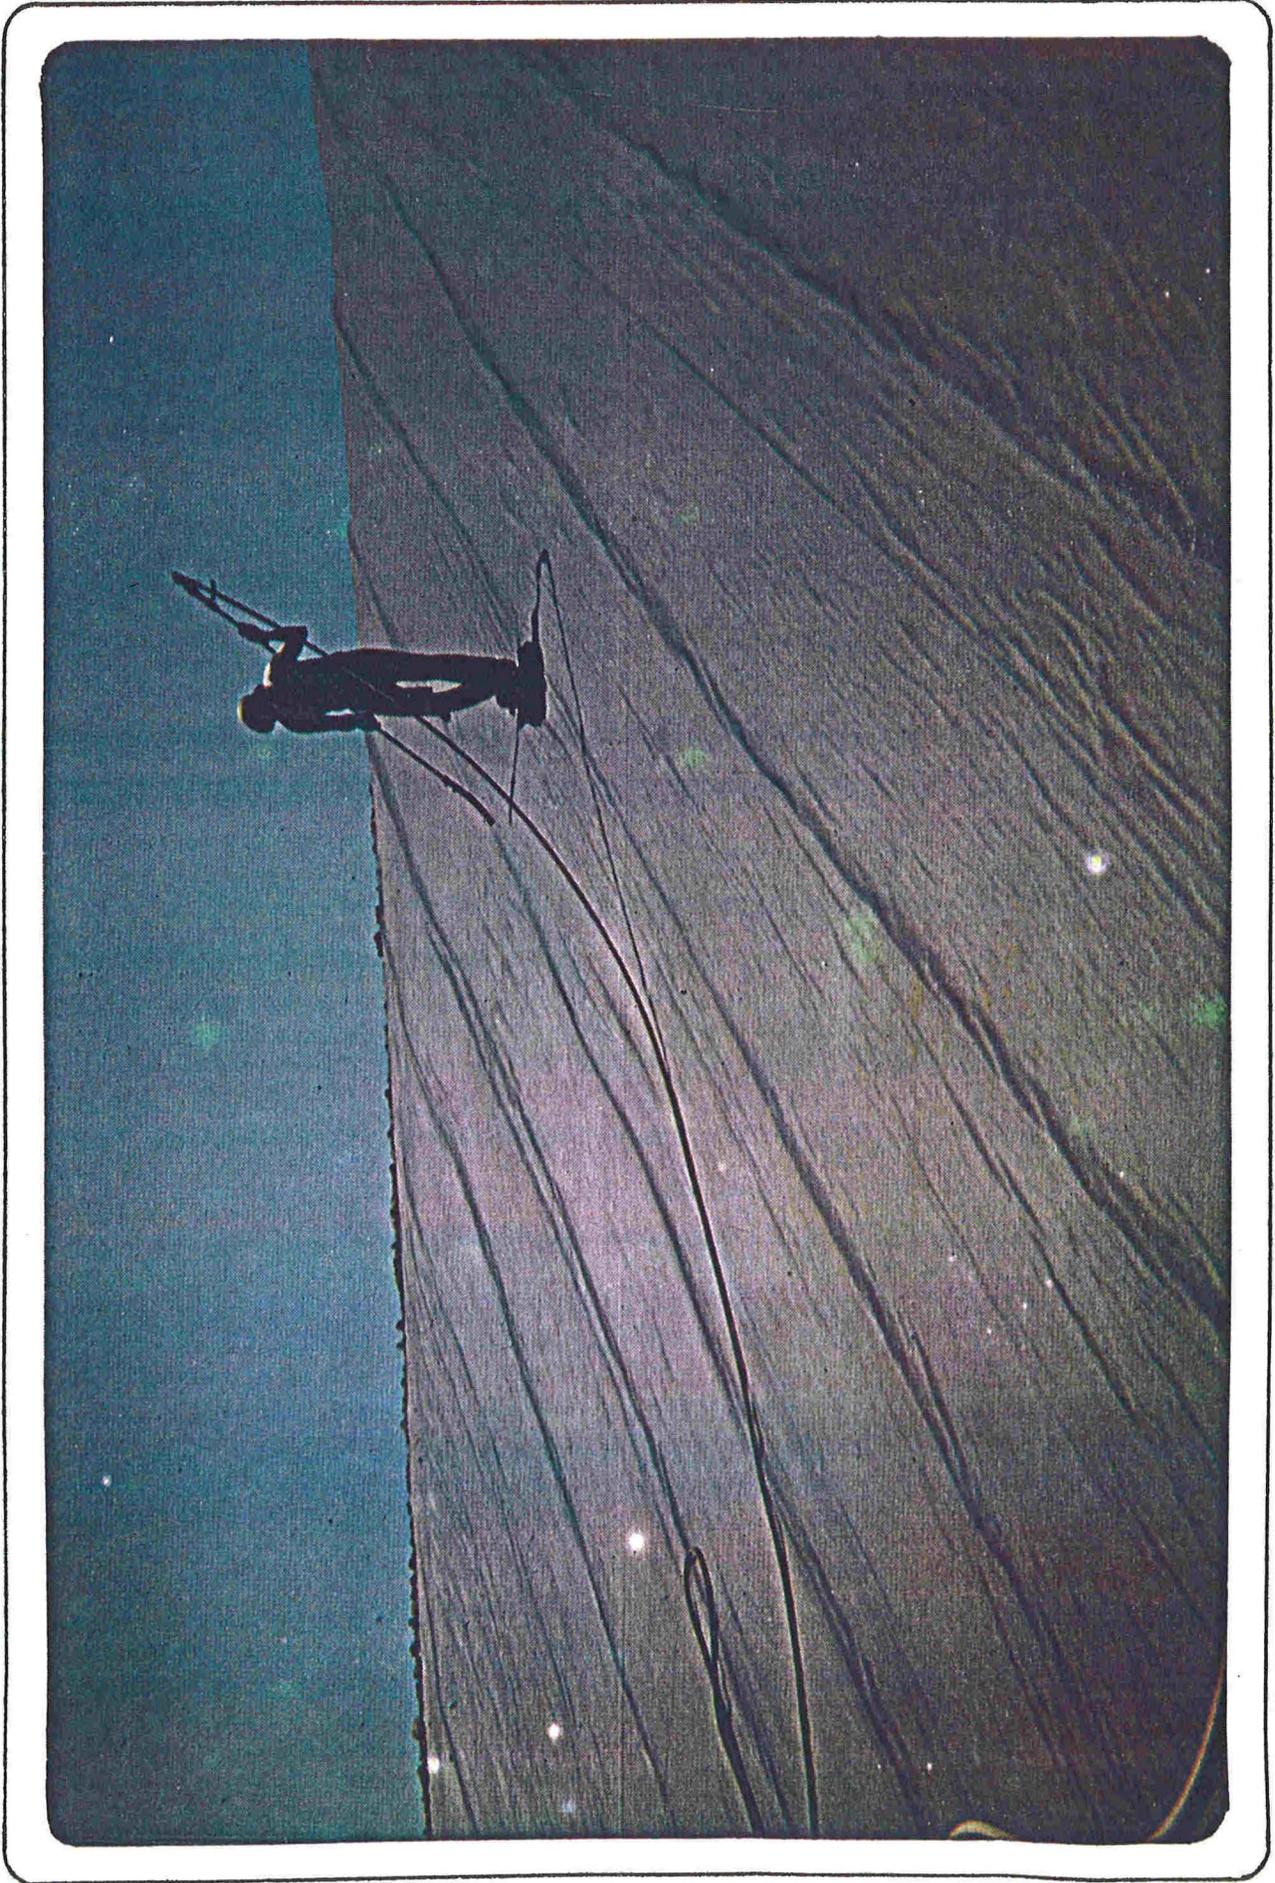
Cell 3 - Air Lancing of Liner Field Seams

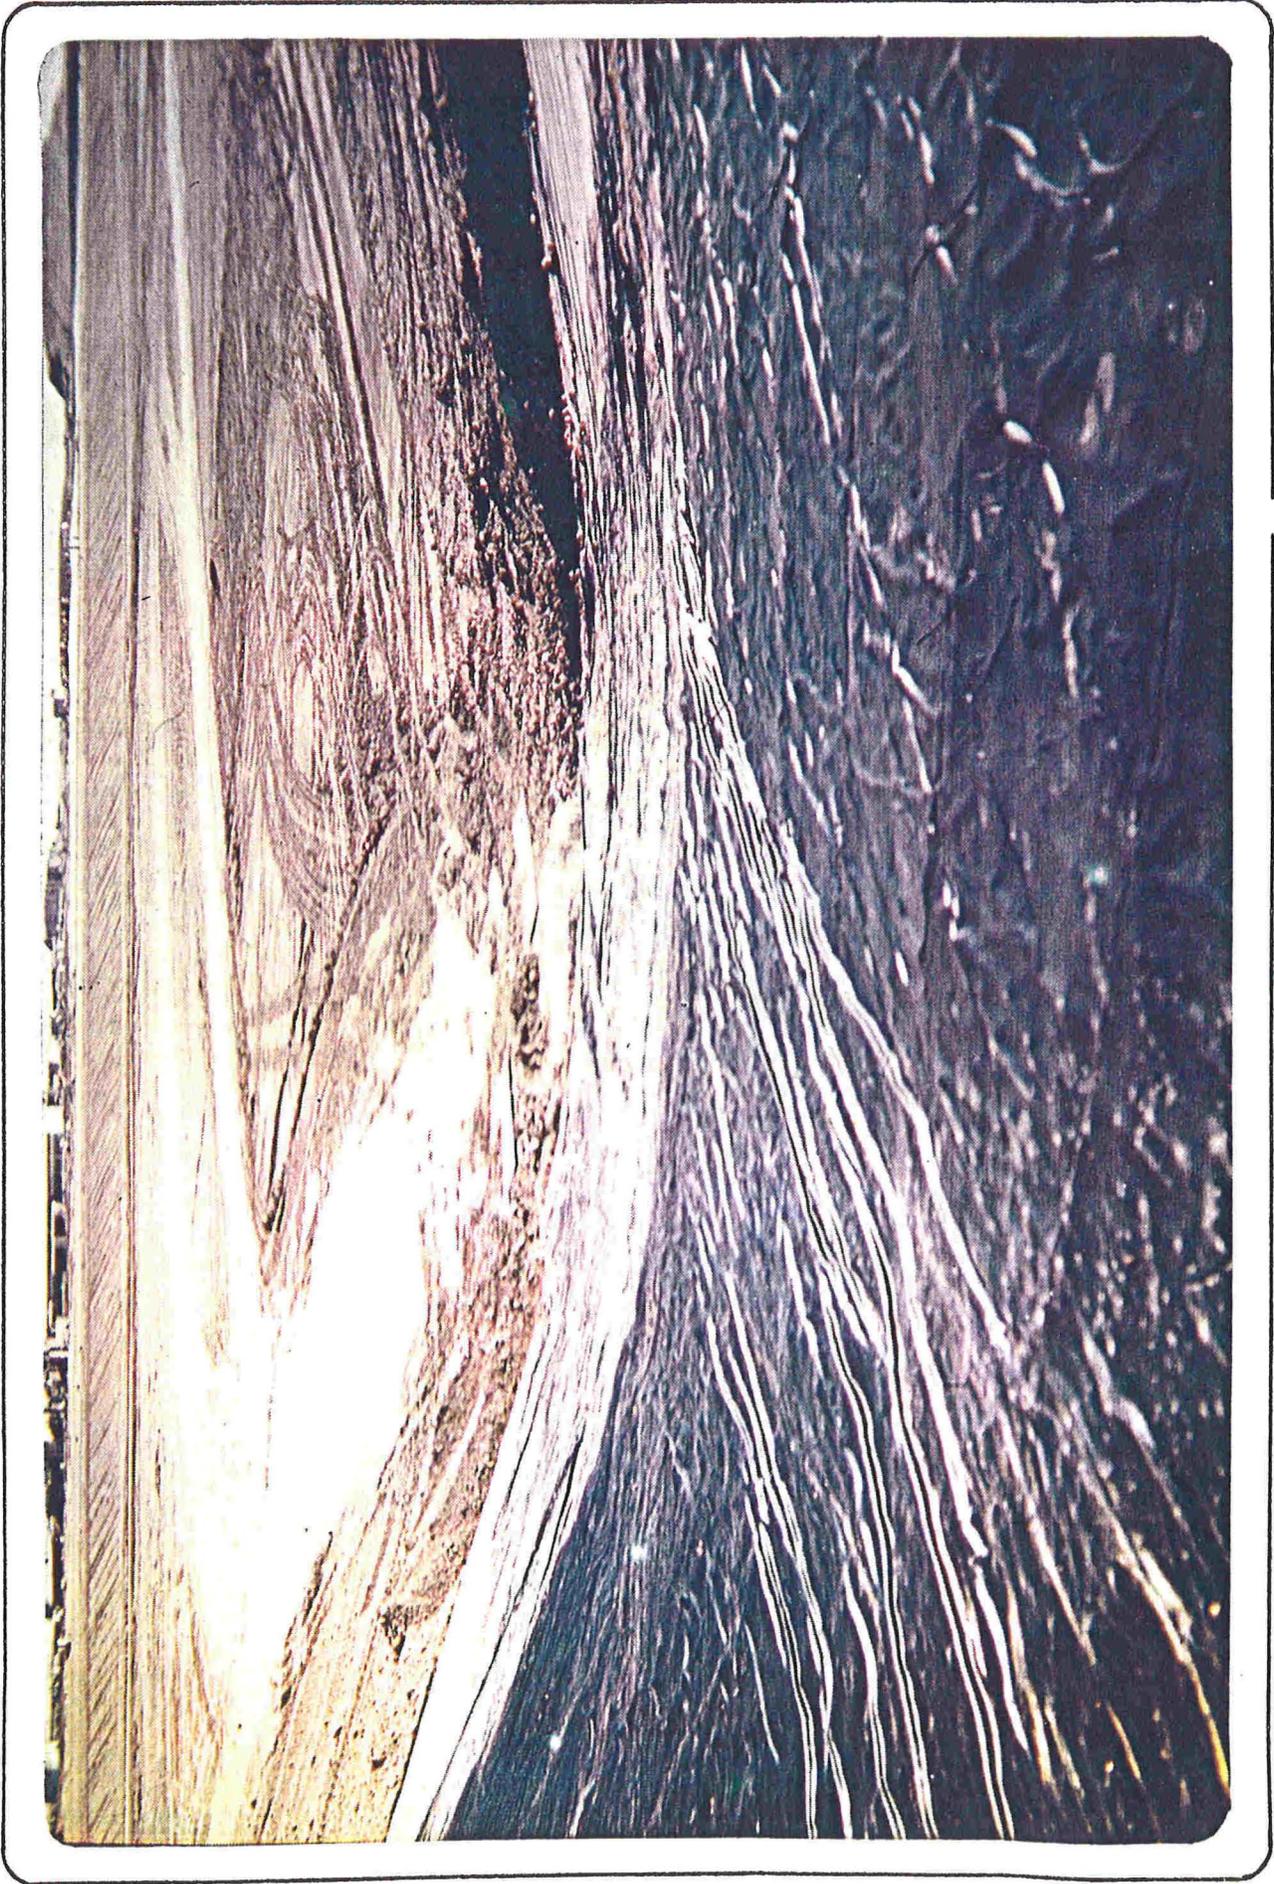
Cell 3 - Installation of PVC Liner Over Access Ramp
