Willard Spur Summer 2011: Sampling Program

Outline: Pre - Flood and Post Flood Conditions (at different study locations)

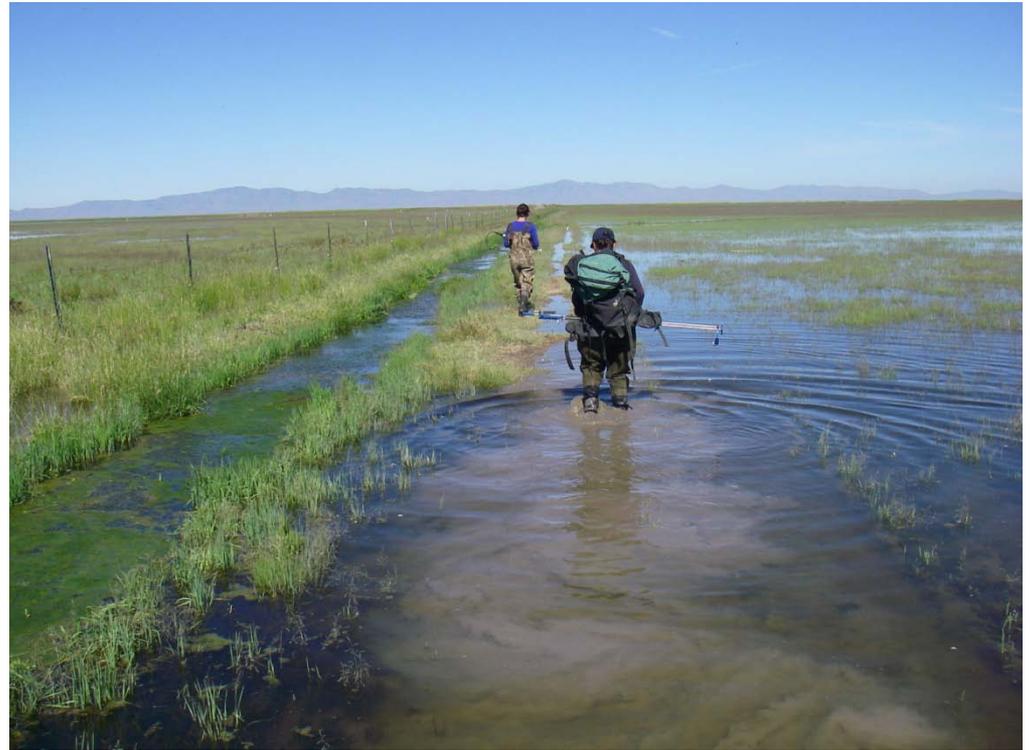
Pre-Flood Conditions
(ex. Willard Perry Outfall)

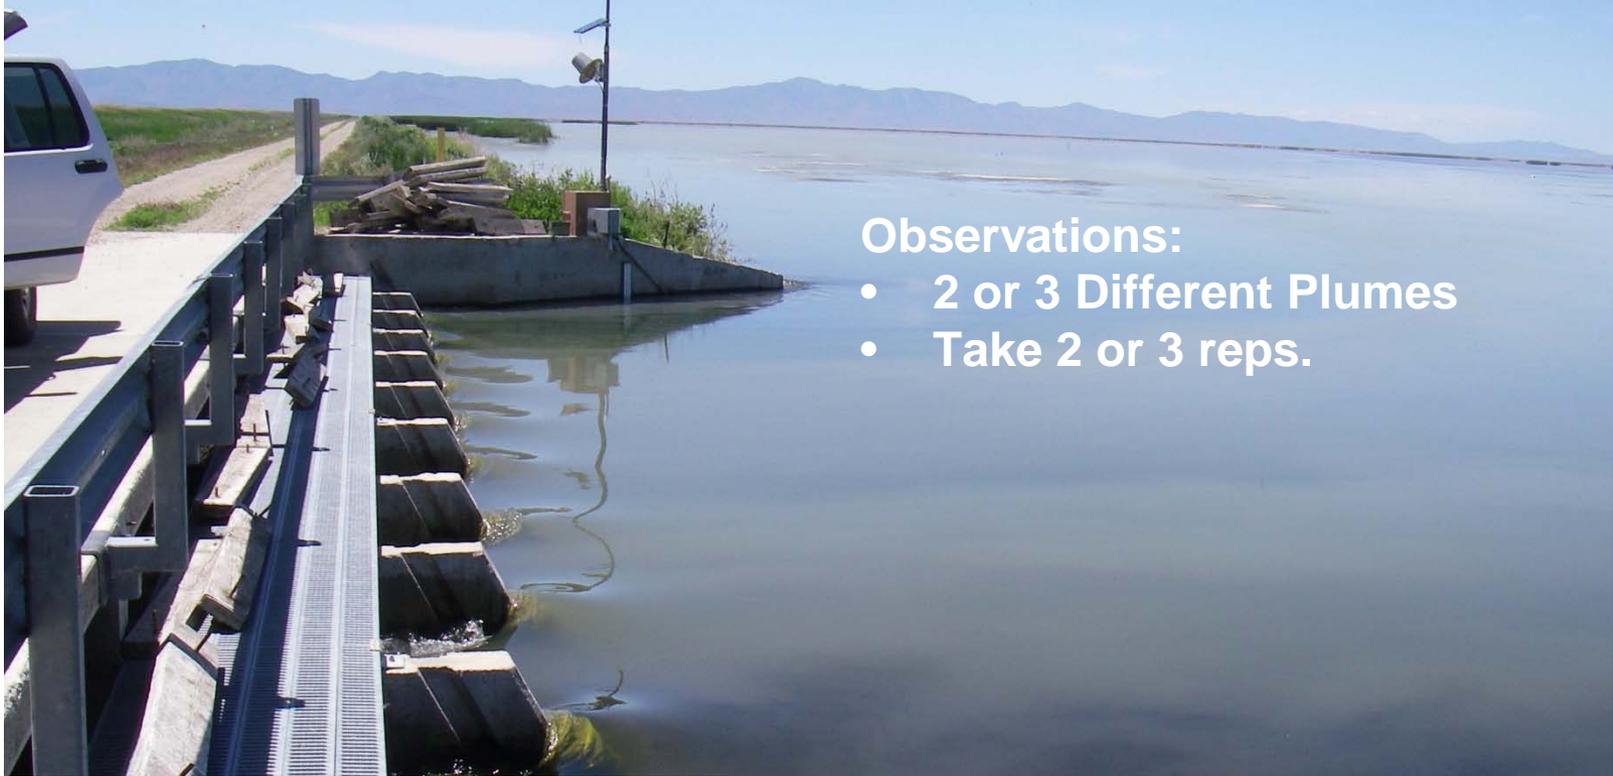
Pre-Flooding: Bear River Bird Refuge (BRR 11)

Observations:

- 2 or 3 Different Plumes
- Take 2 or 3 reps.

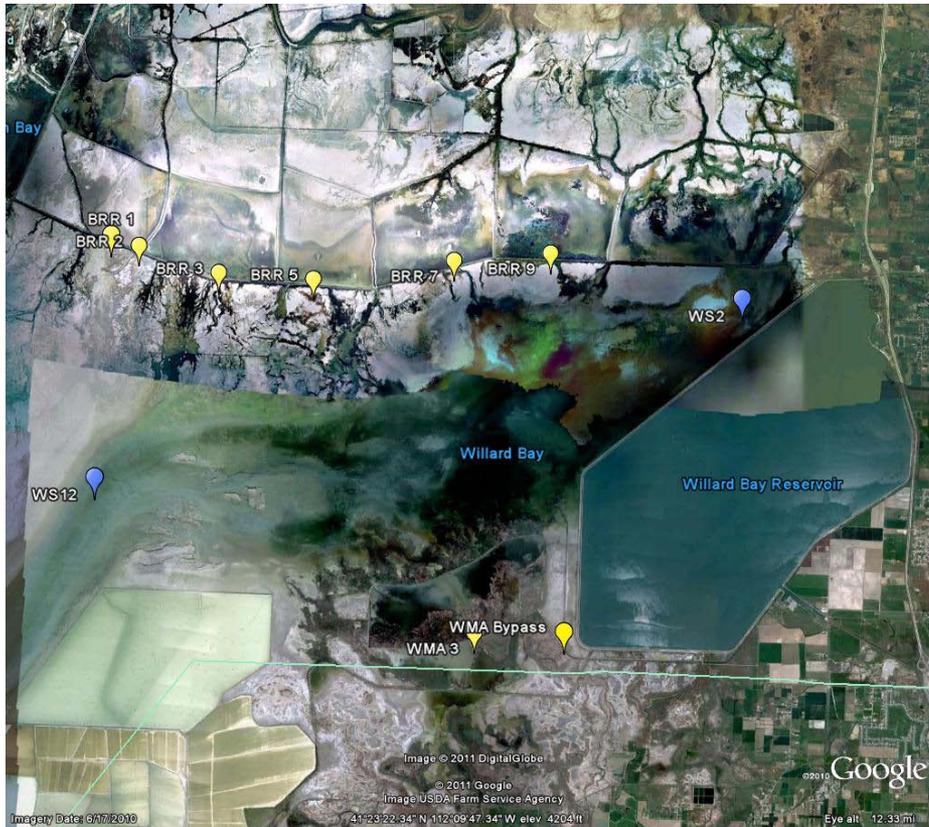
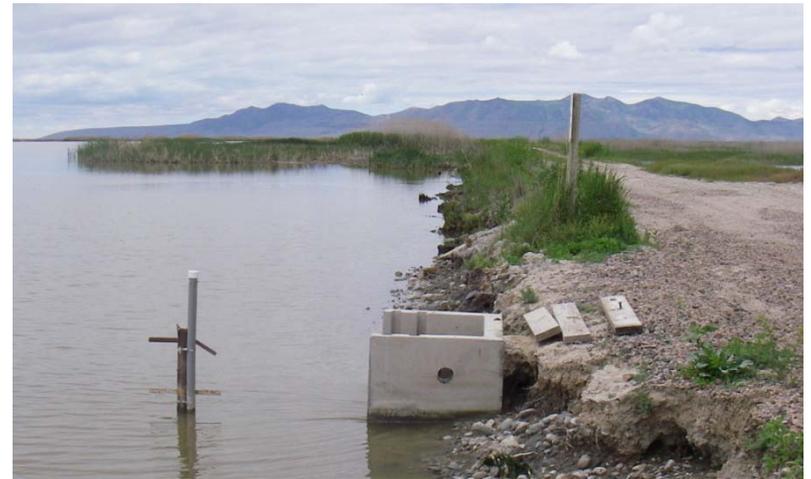
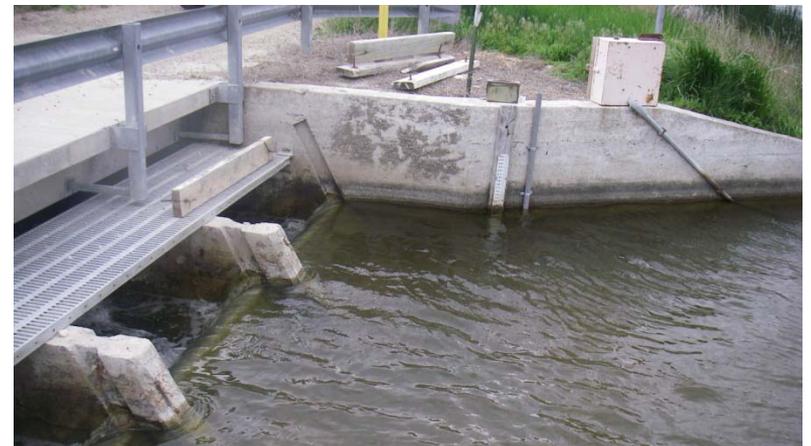
DWQ Pressure Transducers Installed

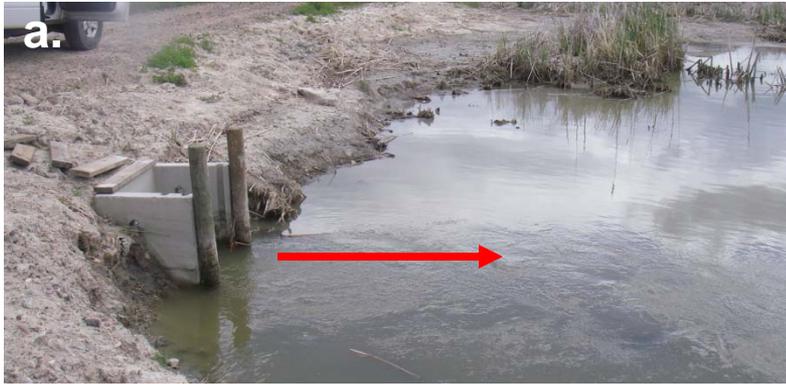
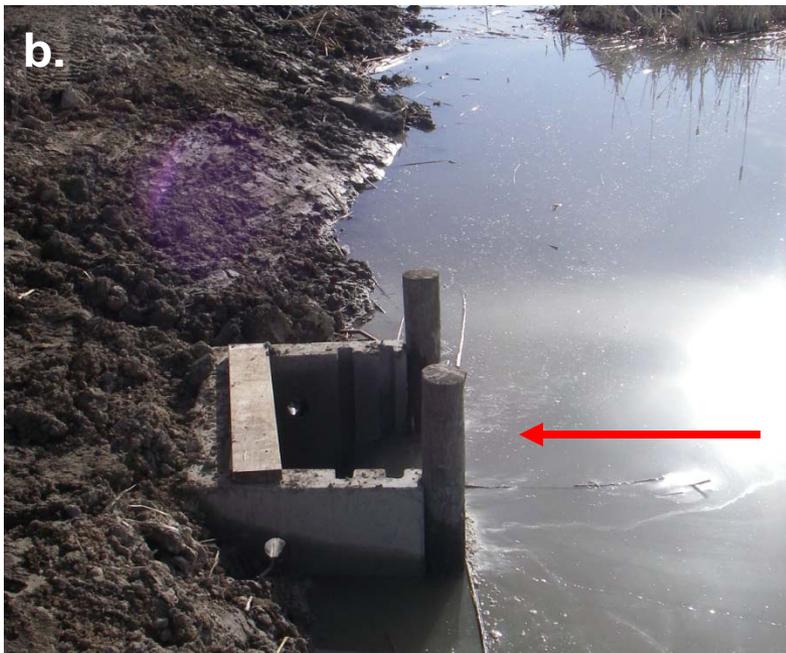
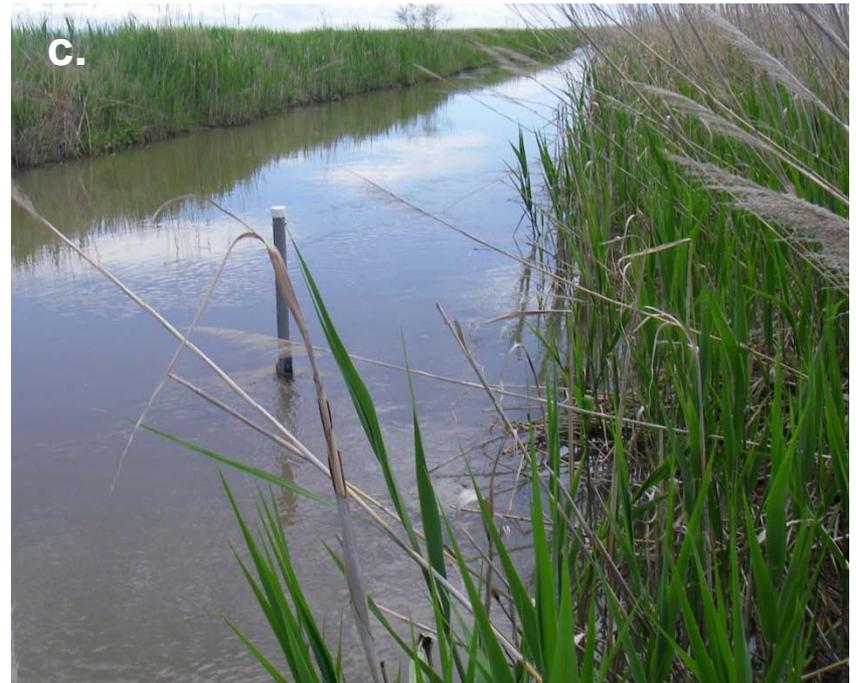
Post Flooding: Harold Crane WMA

- a. Boards removed, water flowing out of Willard Spur
- b. Boards in, water flowing into Willard Spur
- c. Water over banks at Harold Crane WMA Bypass Canal

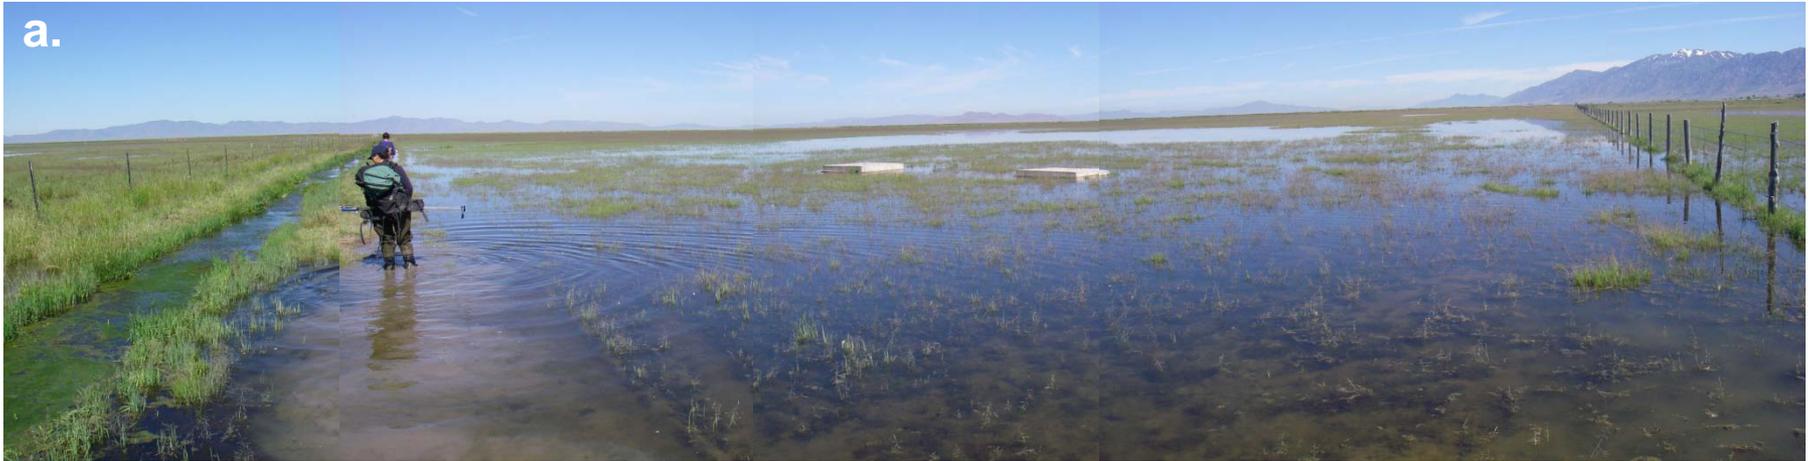
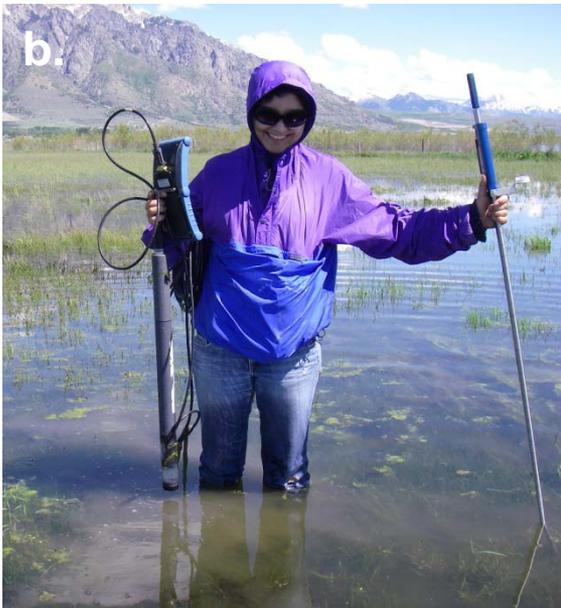
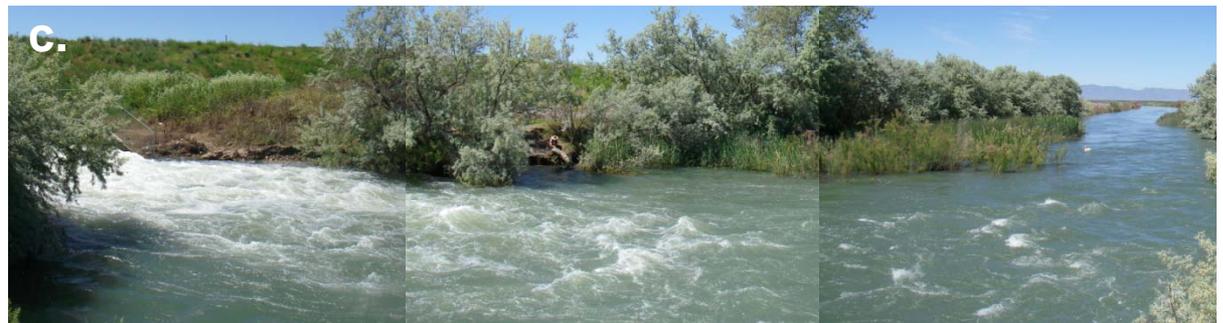
Post Flooding: East Side Drainage

a & b. Fields at Willard Perry Outfall & Irrigation Return Flow 1 flooded from Willard Spur
c. High Discharge from Willard Bay Res. N. Outlet

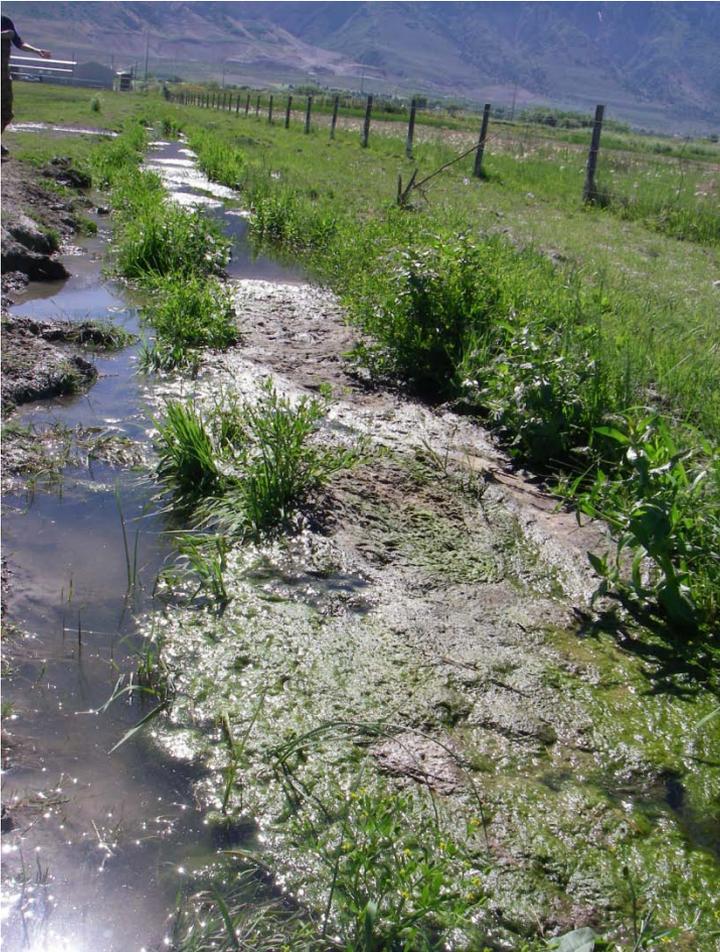
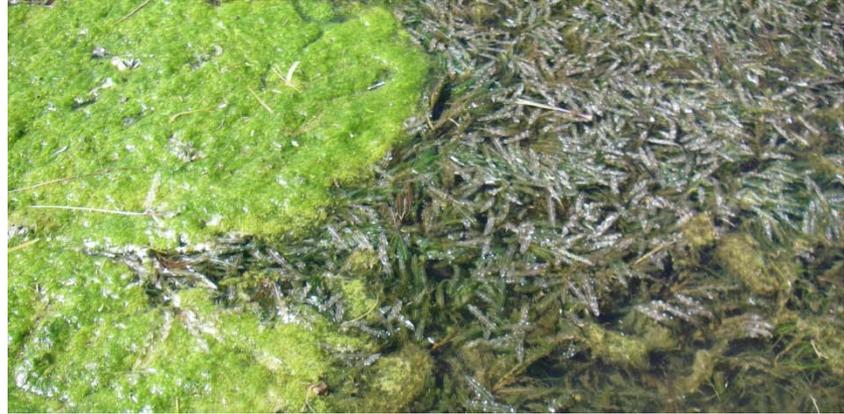
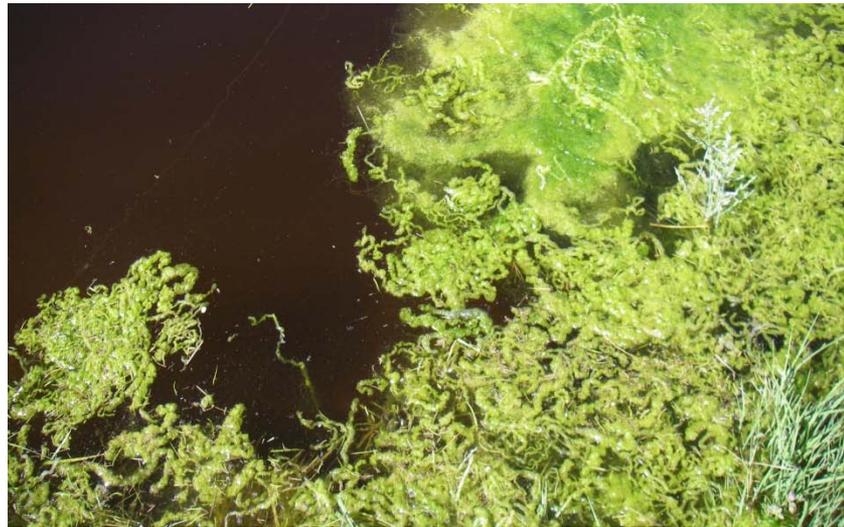
Post Flooding: East Side Drainage

(Vegetation Growth – 3 Types in Willard Perry Outfall)

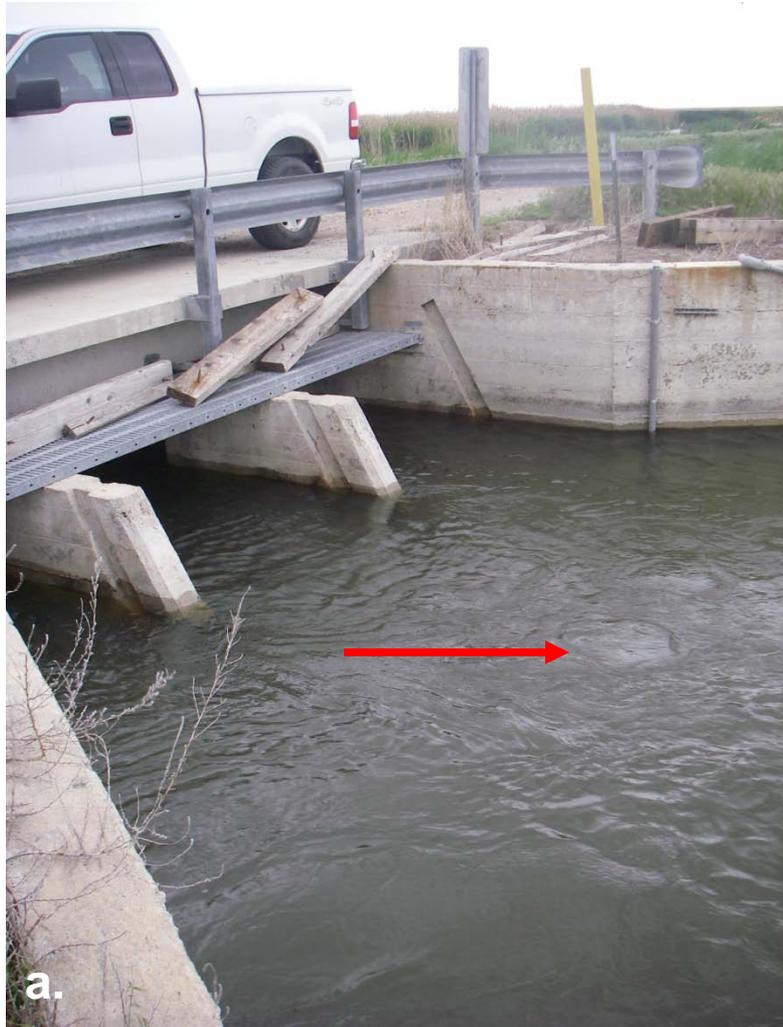
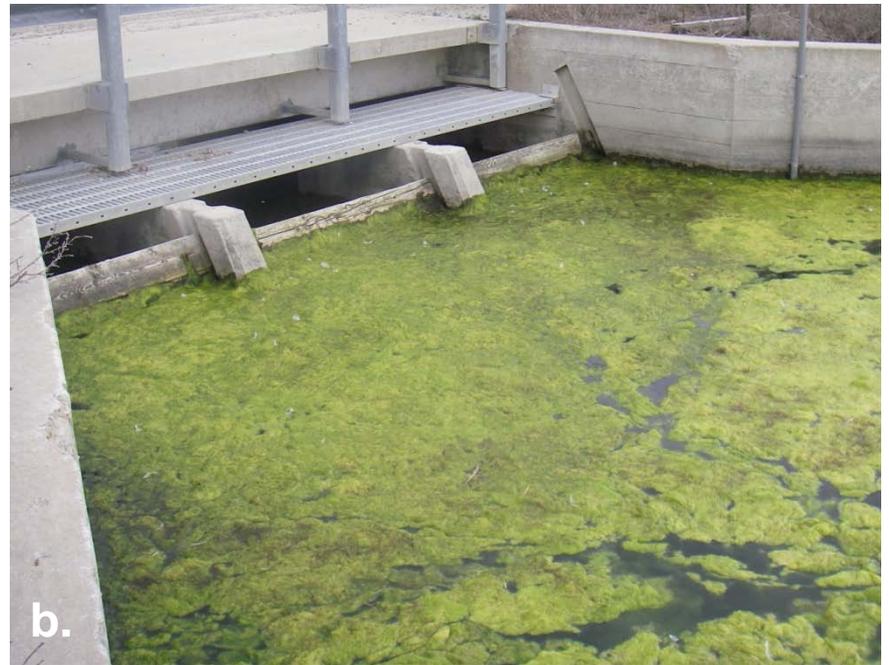
Post Flooding: Bear River Bird Refuge

- a. Boards removed, water flowing out of Willard Spur (ex. BRR 9)
- b. Boards in, Excessive Algal Growth (ex. BRR 5)

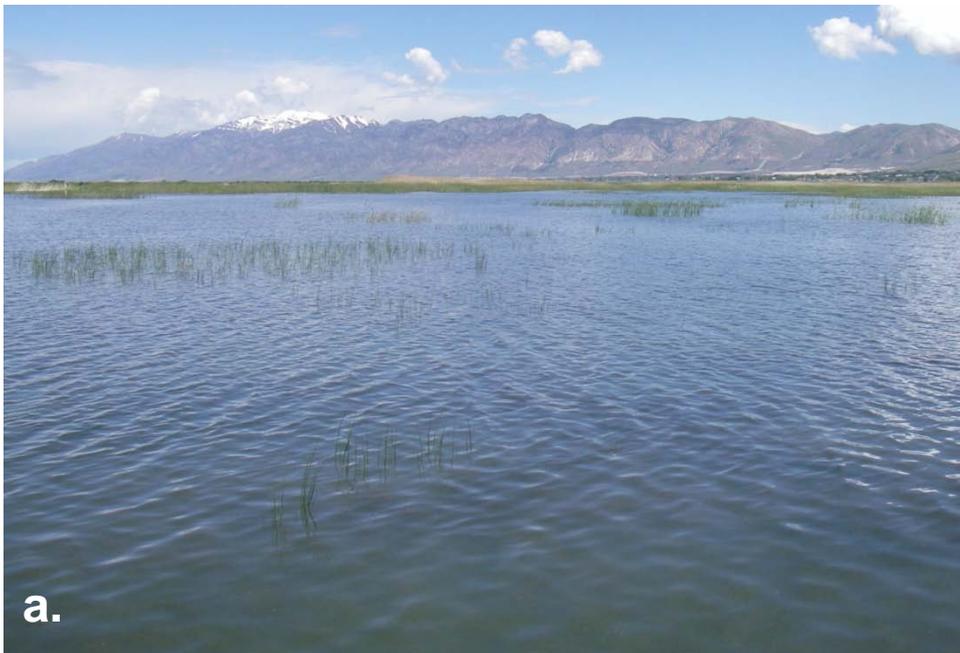
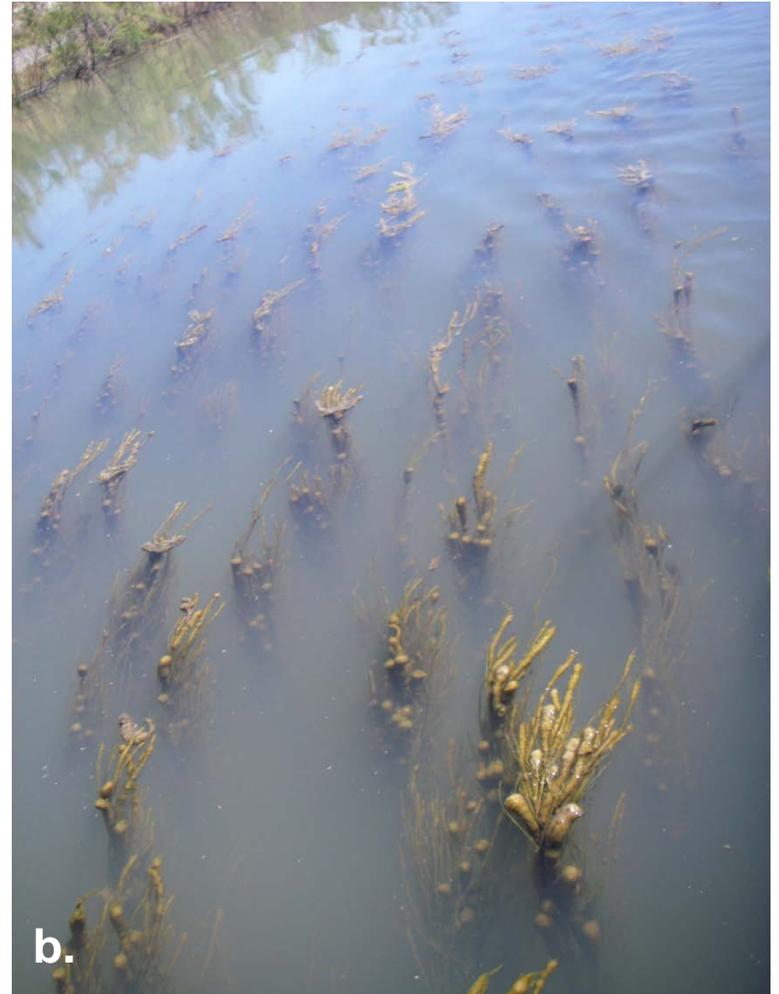
Open Water: Field Observations

- a. Before flooding with Weber River waters
- b. 4 days later excessive vegetation growth in open water.
