CELL 4A CONSTRUCTION QUALITY ASSURANCE REPORT

WHITE MESA MILL
BLANDING, UTAH

Geosyntec consultants

July 2008

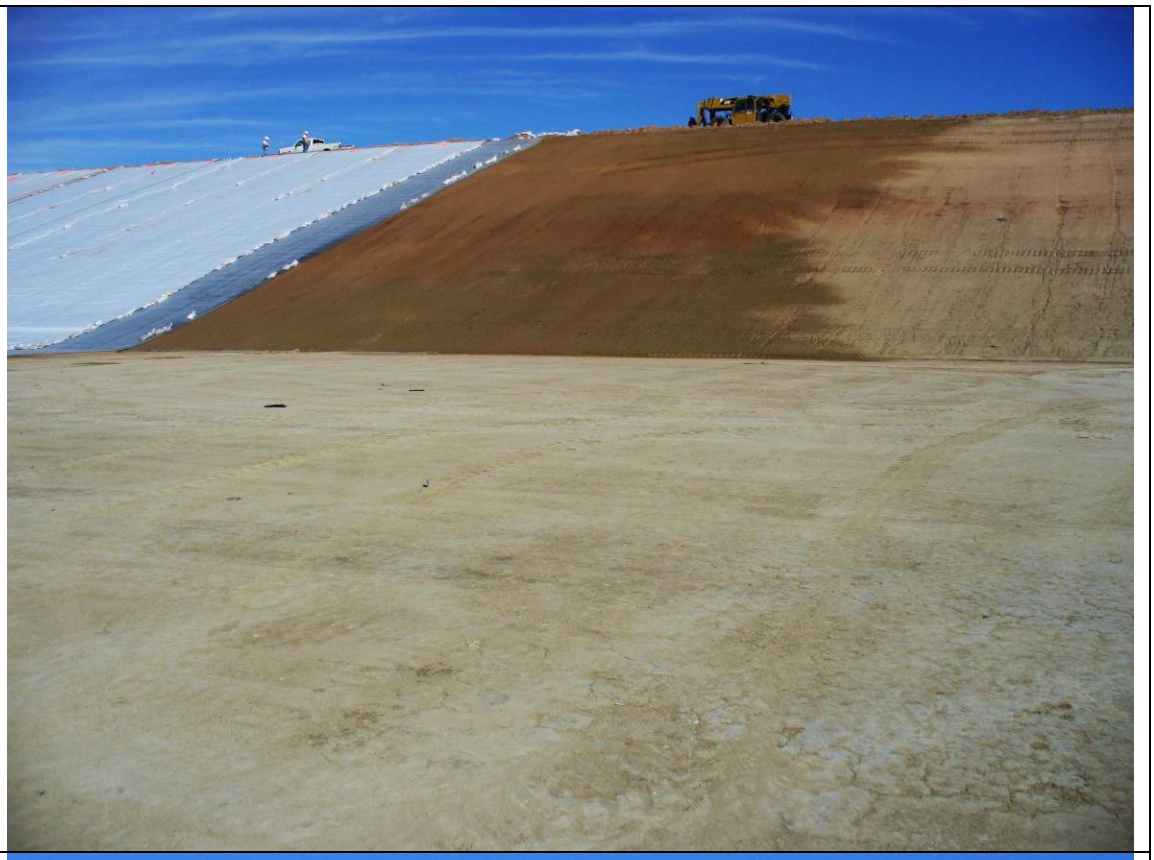
Date: 10/19/07 Direction: N Hydrated subgrade.

Date: 10/22/07 Direction: N Geosynthetic Clay Liner (GCL) deployment.

Date: 10/22/07 Direction: N Seaming of secondary geomembrane.	
Date: 10/26/07 Direction: SE Leak Detection System (LDS) trench excavation.

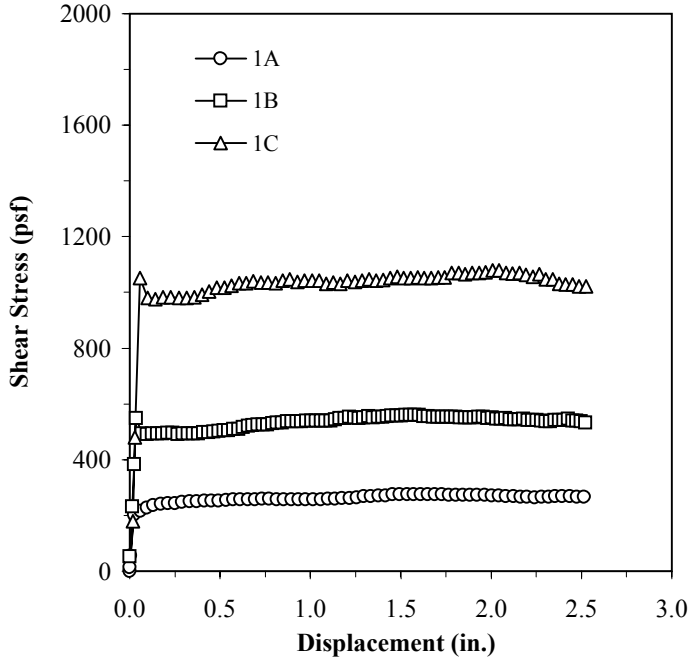
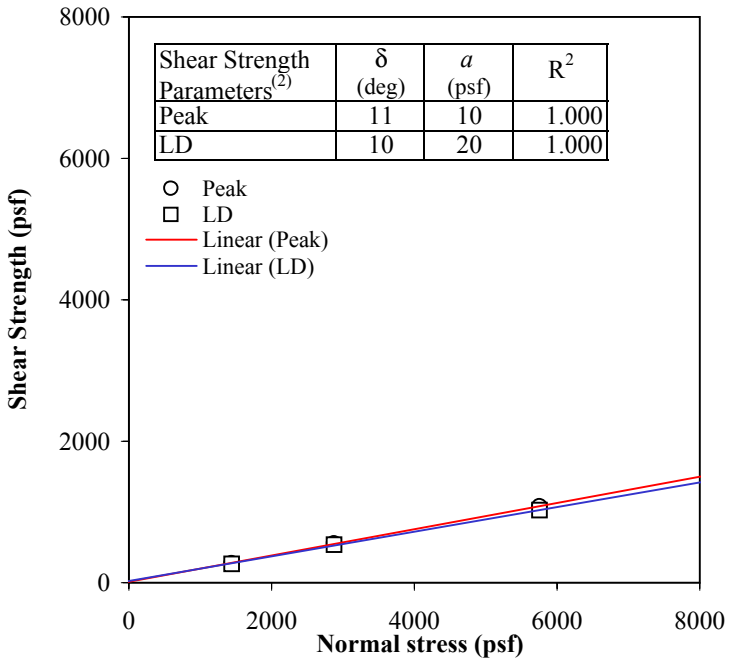
Test Series Number 1: SKAPS TN 330 geonet in machine direction against white side of GSE 60-mil black/white smooth HDPE geomembrane (Roll # 105130507) in machine direction under wetted conditions

(1) Sliding (i.e., shear failure) occurred at intended test interface in each test.

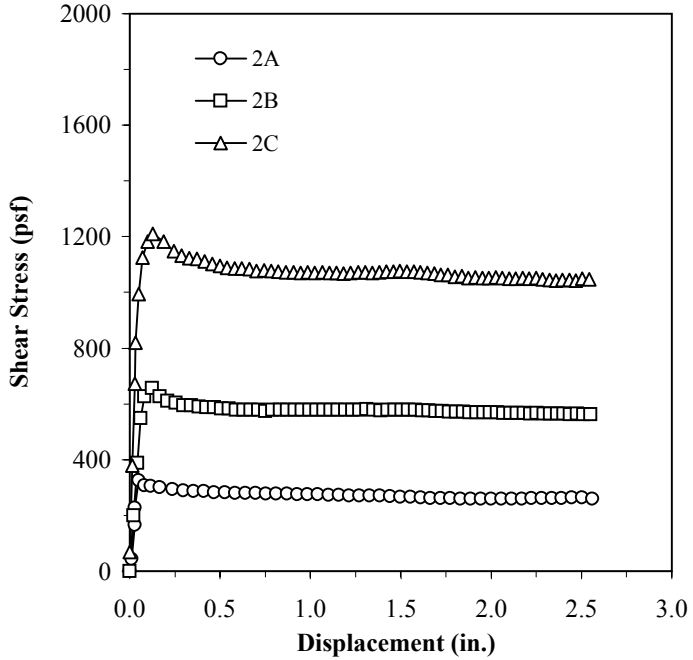
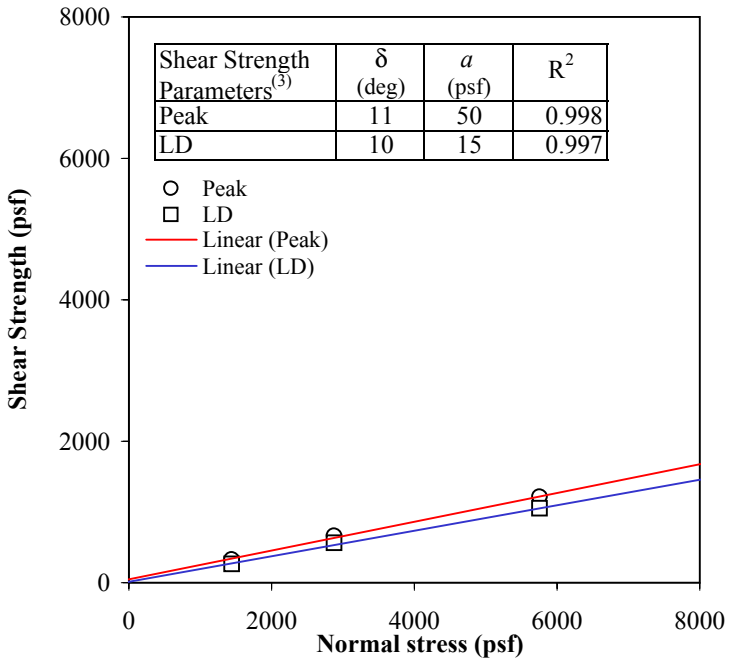
Test Series Number 2: Woven side of Bentomat ST GCL (Lot # 200640LO/Roll #6397) in machine direction against black side of GSE 60-mil black/white smooth HDPE geomembrane (Roll # 105130507) in machine direction under soaked and consolidated conditions

(2) Sliding (i.e., shear failure) occurred at intended test interface in each test.
