## **ATTACHMENT 3-5 DTTF FACILITY DESCRIPTION**

### **1.0 INTRODUCTION**

This attachment to the Dugway Resource Conservation and Recovery Act (RCRA) permit describes the Dugway Thermal Treatment Facility (DTTF) as required by 40 Code of Federal Regulations (CFR) §264.10; and the Utah Administrative Code (UAC) R315-8-2. This attachment is organized in the following sections:

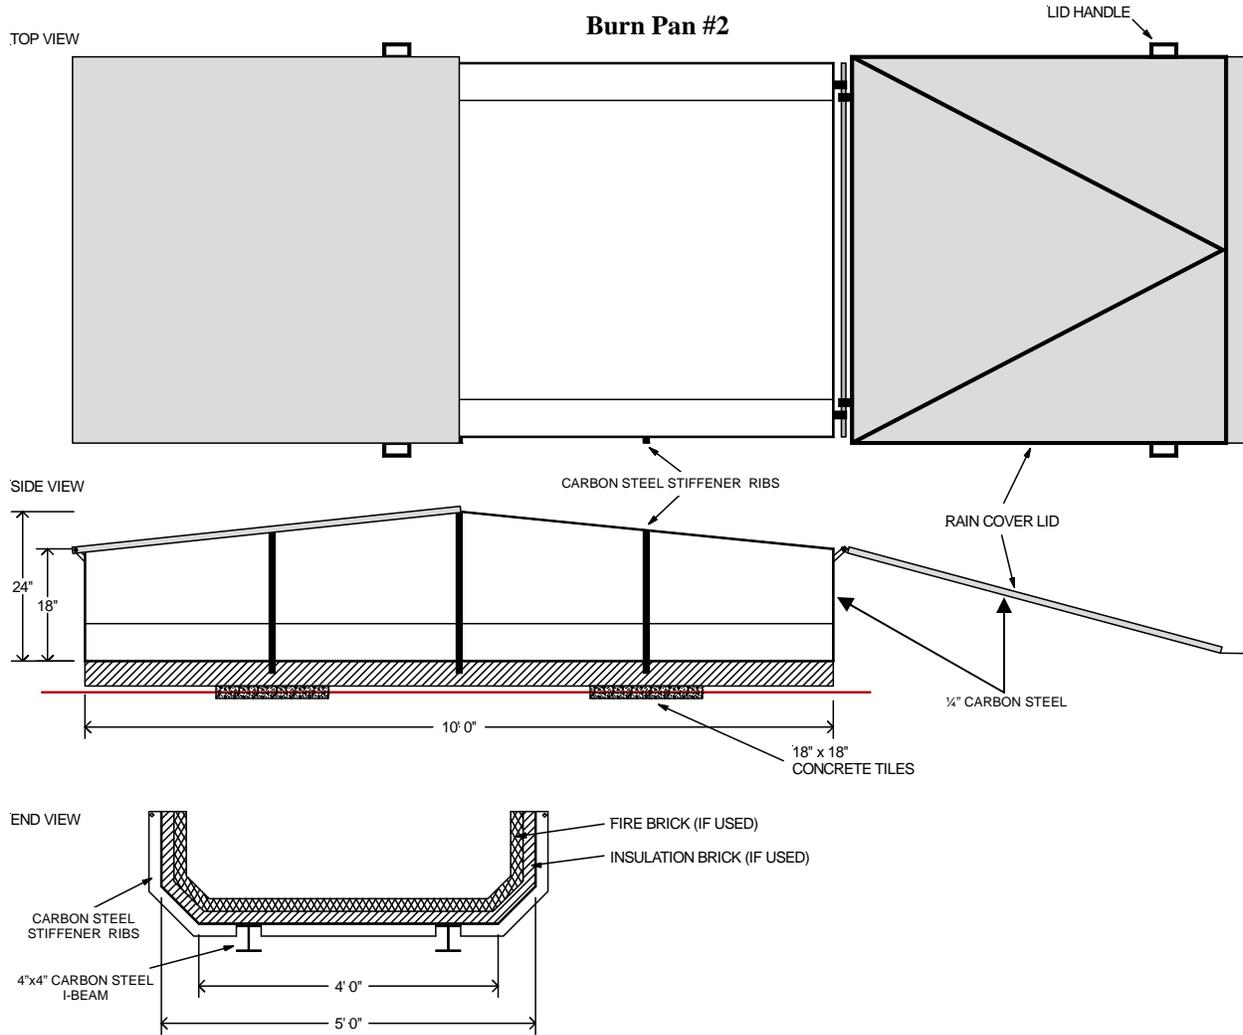
**Figure 3. Burn Pan Drawings**

Burn Pans #1 and #3 have aluminum rain cover lids.

DPG currently conducts OB operations within three burn pans located in the northern part of the DTTF. Burn Pan #2 (Figure 3), installed in 1987, is 5 feet wide by 10 feet long by 1.5 feet deep and is constructed of 1/4-inch thick carbon steel boiler plate with fully welded seams. The sides of the pan slope in toward the bottom to create a slight dish shape. The burn pan is equipped with a hinged steel cover designed to prevent accumulation of precipitation. The pan is supported on steel I-beams which rest on 18-inch square concrete pads. The pan is not equipped with an engineered liner or secondary containment system. The concrete pads and I-beams raise the pan approximately six inches above the native soil. The burn pan is approximately 2,700 feet northeast of Durand Road and 200 feet inside the perimeter of the DTTF. The elevation of the unit is approximately 4,420 feet above mean sea level (AMSL).
