# Temperature Total Maximum Daily Load (TMDL) for Upper Nine Mile Creek Watershed

# Nine Mile Creek Temperature TMDL

## Upper Nine Mile Creek TMDL

Waterbody ID	14060005-002
Location	Carbon and Duchesne Counties, Utah
Pollutant of Concern	Temperature
Impaired Beneficial Use	Class 3A: Protected for cold water species of game fish and other cold water aquatic life
Current Loading Loading Capacity (TMDL) Load Reduction	835,045.6 kWh/day 231,637.6 kWh/day 603,408 kWh/day (72.3%)
Wasteload Allocation Load Allocation Margin of Safety	0 kWh/day 231,637.6 kWh/day Implicit
Defined Targets/Endpoints	<ol style="list-style-type: none"> <li>1. Water quality target of 20° C</li> <li>2. Total maximum load of 231,637.6 kWh/d</li> <li>3. 36% increase in riparian shade</li> </ol>
Implementation Strategy	Stormwater, grazing, and riparian best management practices
<p>This document is identified as a TMDL for waters of Upper Nine Mile Creek watershed and is submitted under §303d of the Clean Water Act to U.S. EPA for review and approval.</p>

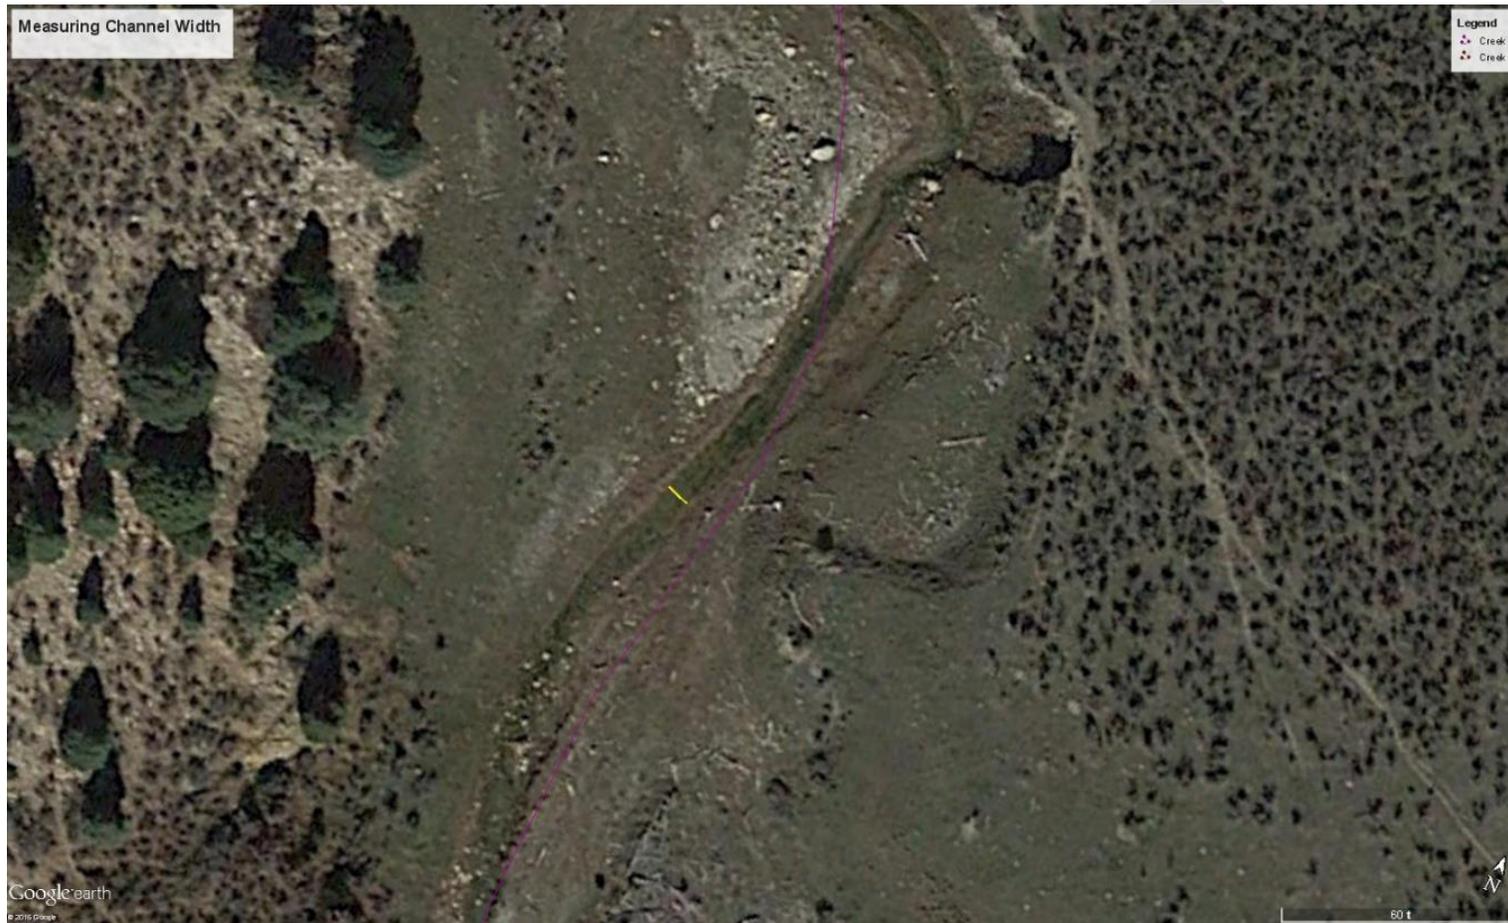
Figure 40. Example of Collecting Stream Widths (yellow hash mark) in Google Earth Pro. This example has an estimated 2.05m width.
