Reclamation Plan White Mesa Mill Blanding, Utah

Source Material License No. SUA-1358

Revision 3.0

July 2000

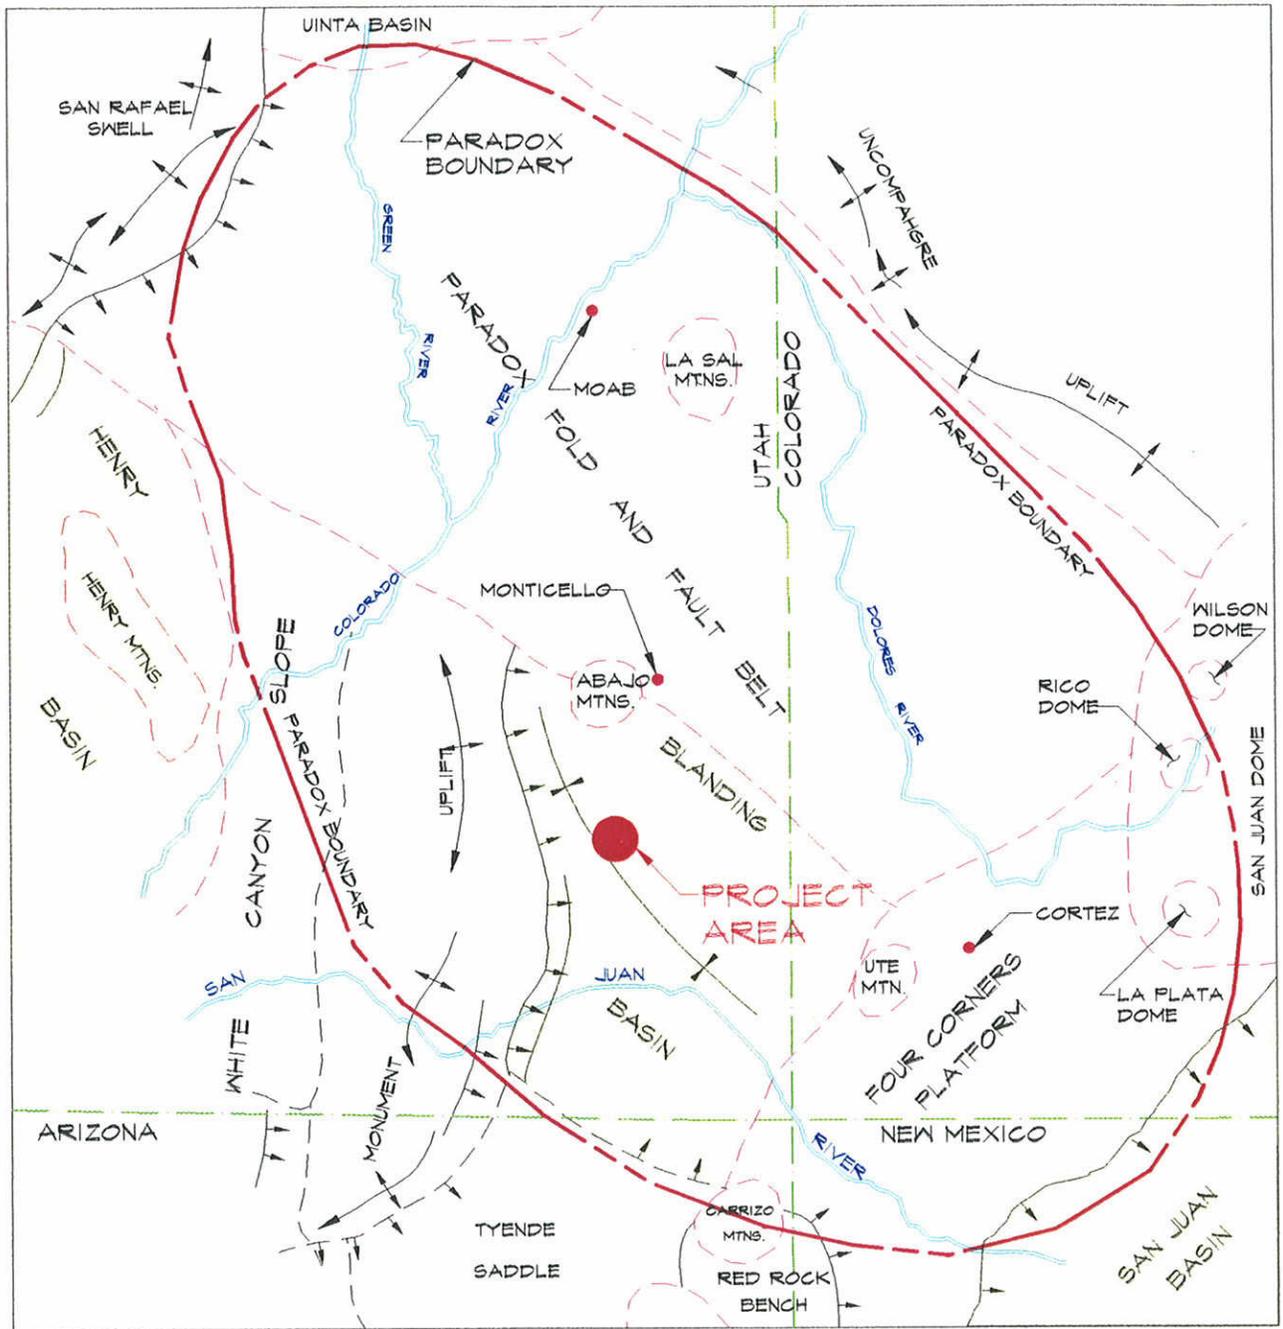
FIGURE 1.5.1
 Colorado Plateau Geologic Map

- BOUNDARY OF TECTONIC DIVISION
- MONOCLINE SHOWING TRACE OF AXIS AND DIRECTION OF DIP
- ANTICLINE SHOWING TRACE OF AXIS AND DIRECTION OF FLUNGE
- SYNCLINE SHOWING TRACE OF AXIS AND DIRECTION OF FLUNGE

Recharge to aquifers in the region occurs by infiltration of precipitation into the aquifers along the flanks of the Abajo, Henry and La Sal Mountains and along the flanks of folds, such as Comb Ridge Monocline and the San Rafael Swell, where the permeable formations are exposed at the surface (Figure 1.5-1, Hydrogeologic Evaluation Figure 1.1).

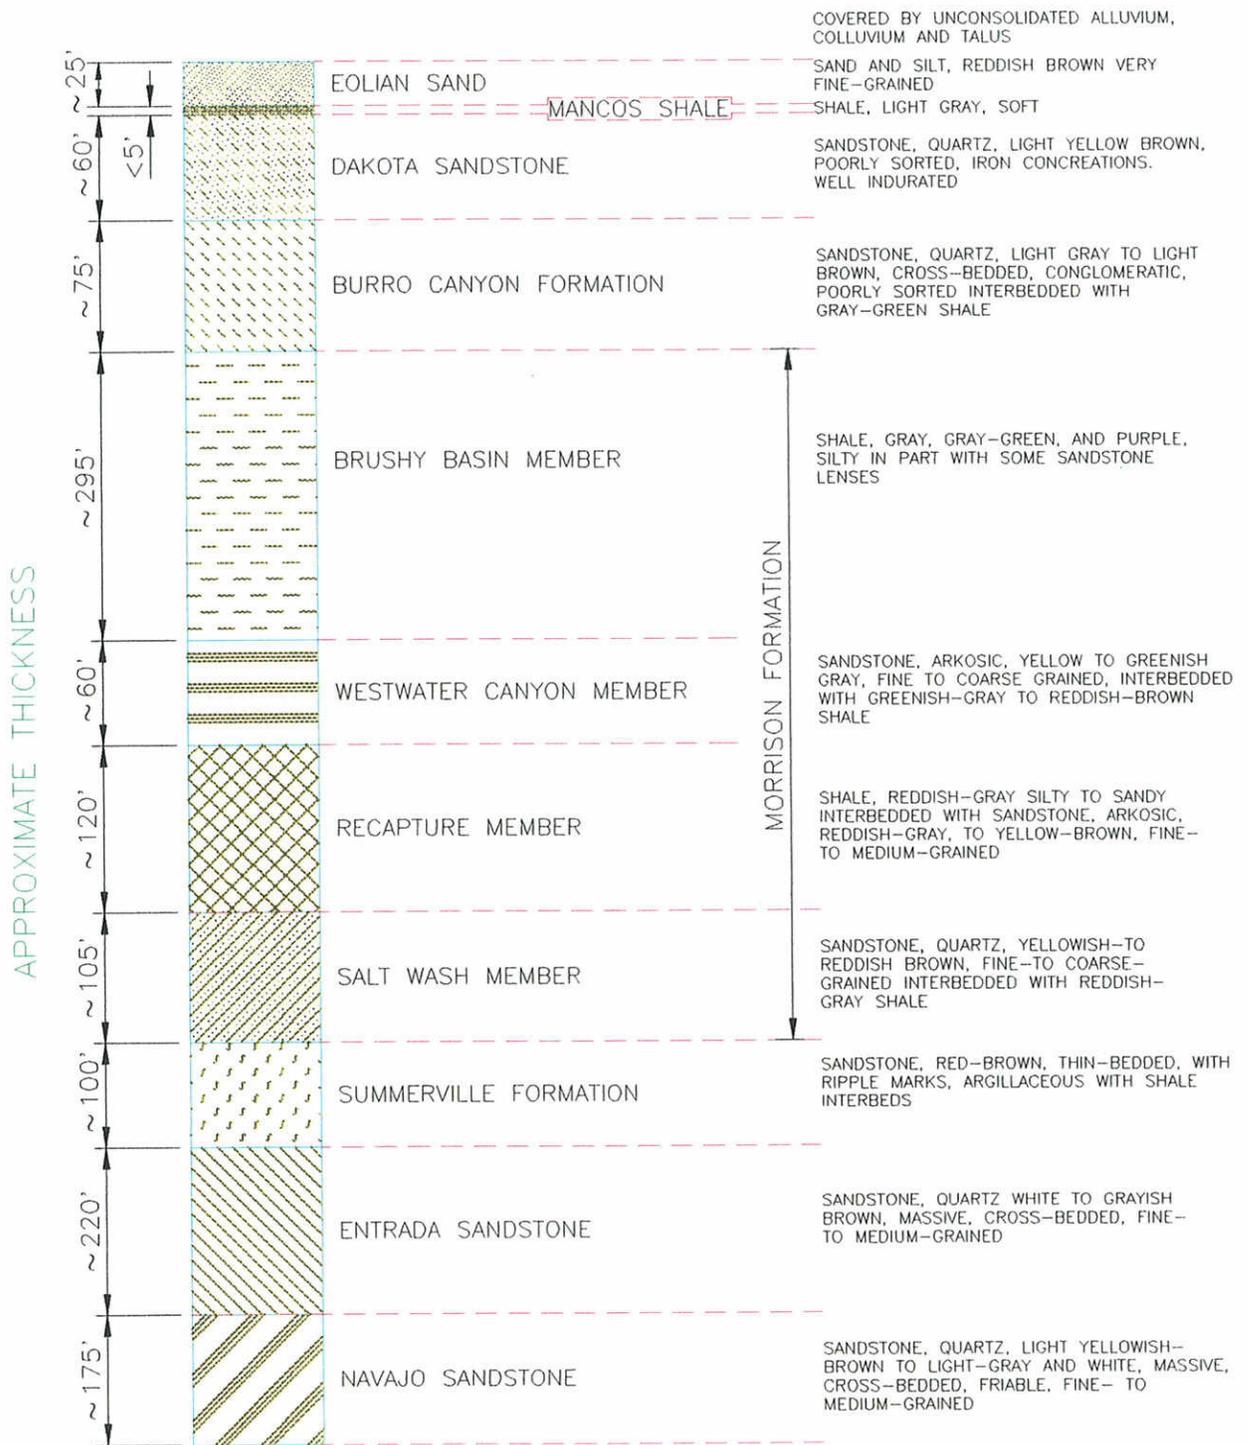
FIGURE 1.5-2
Generalized Stratigraphy of White Mesa

The strata underlying White Mesa have a regional dip of 1/2 to 1 degrees to the south; however, local dips of 5 degrees have been measured. Haynes, et al (1972) includes a map showing the structure at the base of the Dakota formation. Approximately 25 miles to the north, the Abajo Mountains, formed by igneous intrusions, have caused local faulting, upwarping, and displacement of the sedimentary section. However, no faults have been mapped in the immediate vicinity of White Mesa.

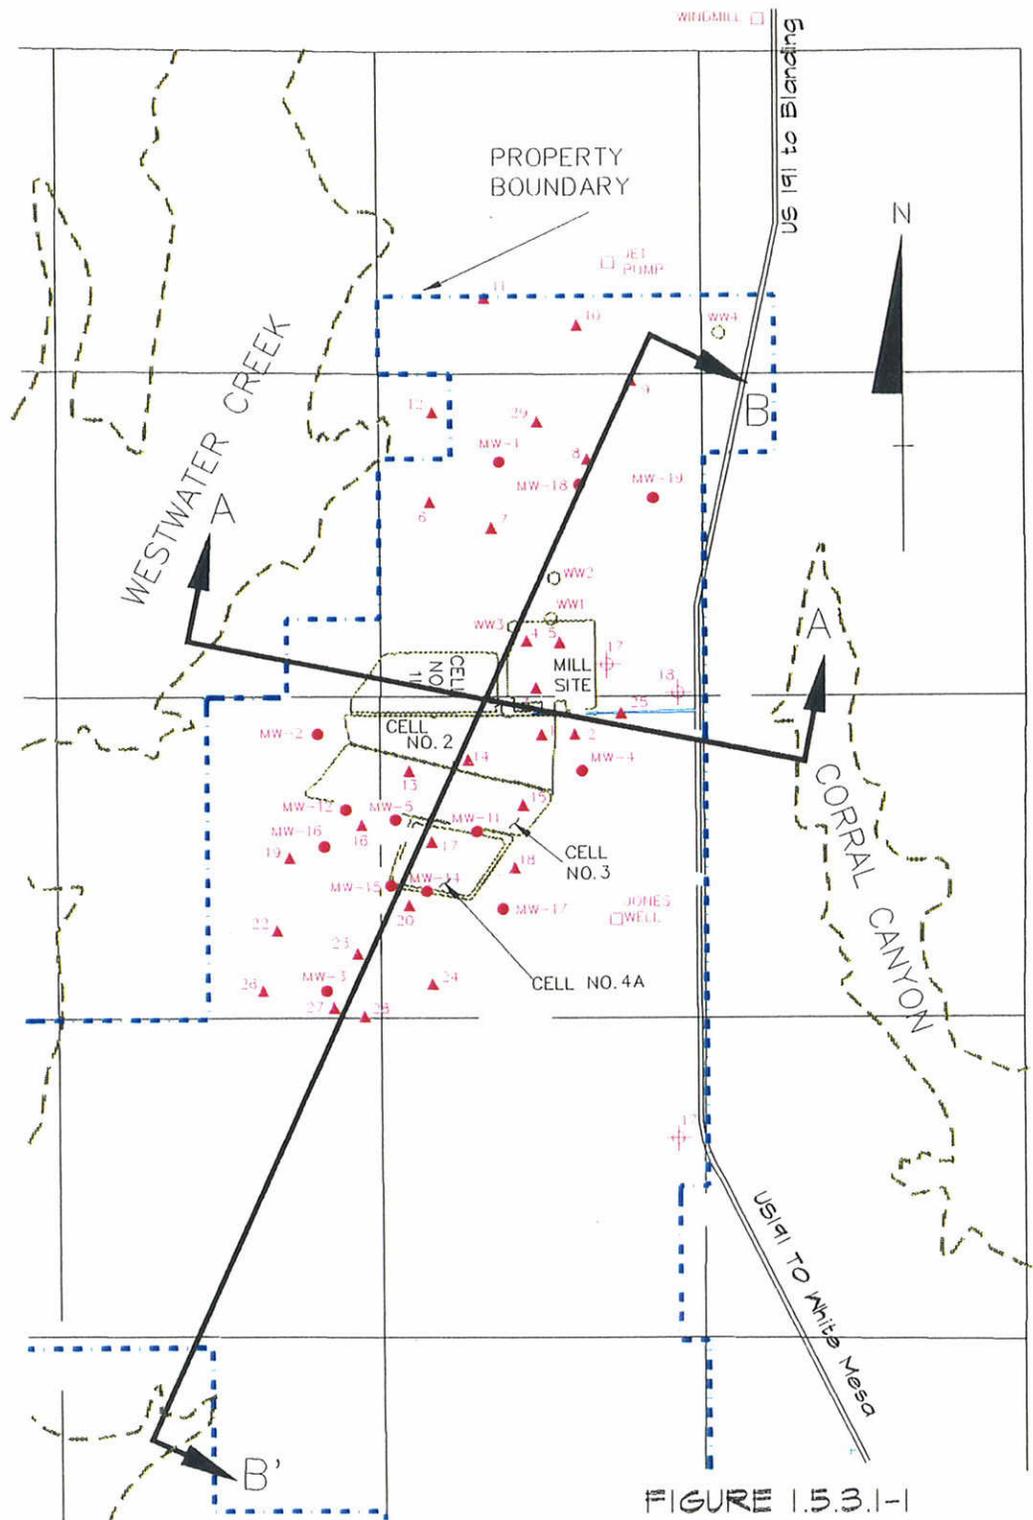
FIGURE 1.5.3.1-1

White Mesa Mill
 Site Plan Map showing
 Monitor Wells and Borings

The thickness of the Brushy Basin Member in this region reportedly varies from 200-450 feet (Dames & Moore, 1978). This stratum was penetrated by six water supply wells [see Figure 1.5.3.1-1 (Hydrogeologic Evaluation Figure 2.1)] and Appendix A of the Hydrogeologic Evaluation) and its thickness was estimated at 275 feet. Borings which terminate in the Brushy Basin Member encounter moderately plastic dark green to dark reddish-brown mudstones. Plastic bentonitic mudstone is not prone to develop fracturing. Hence, competency of this strata, as an aquitard, is very likely.

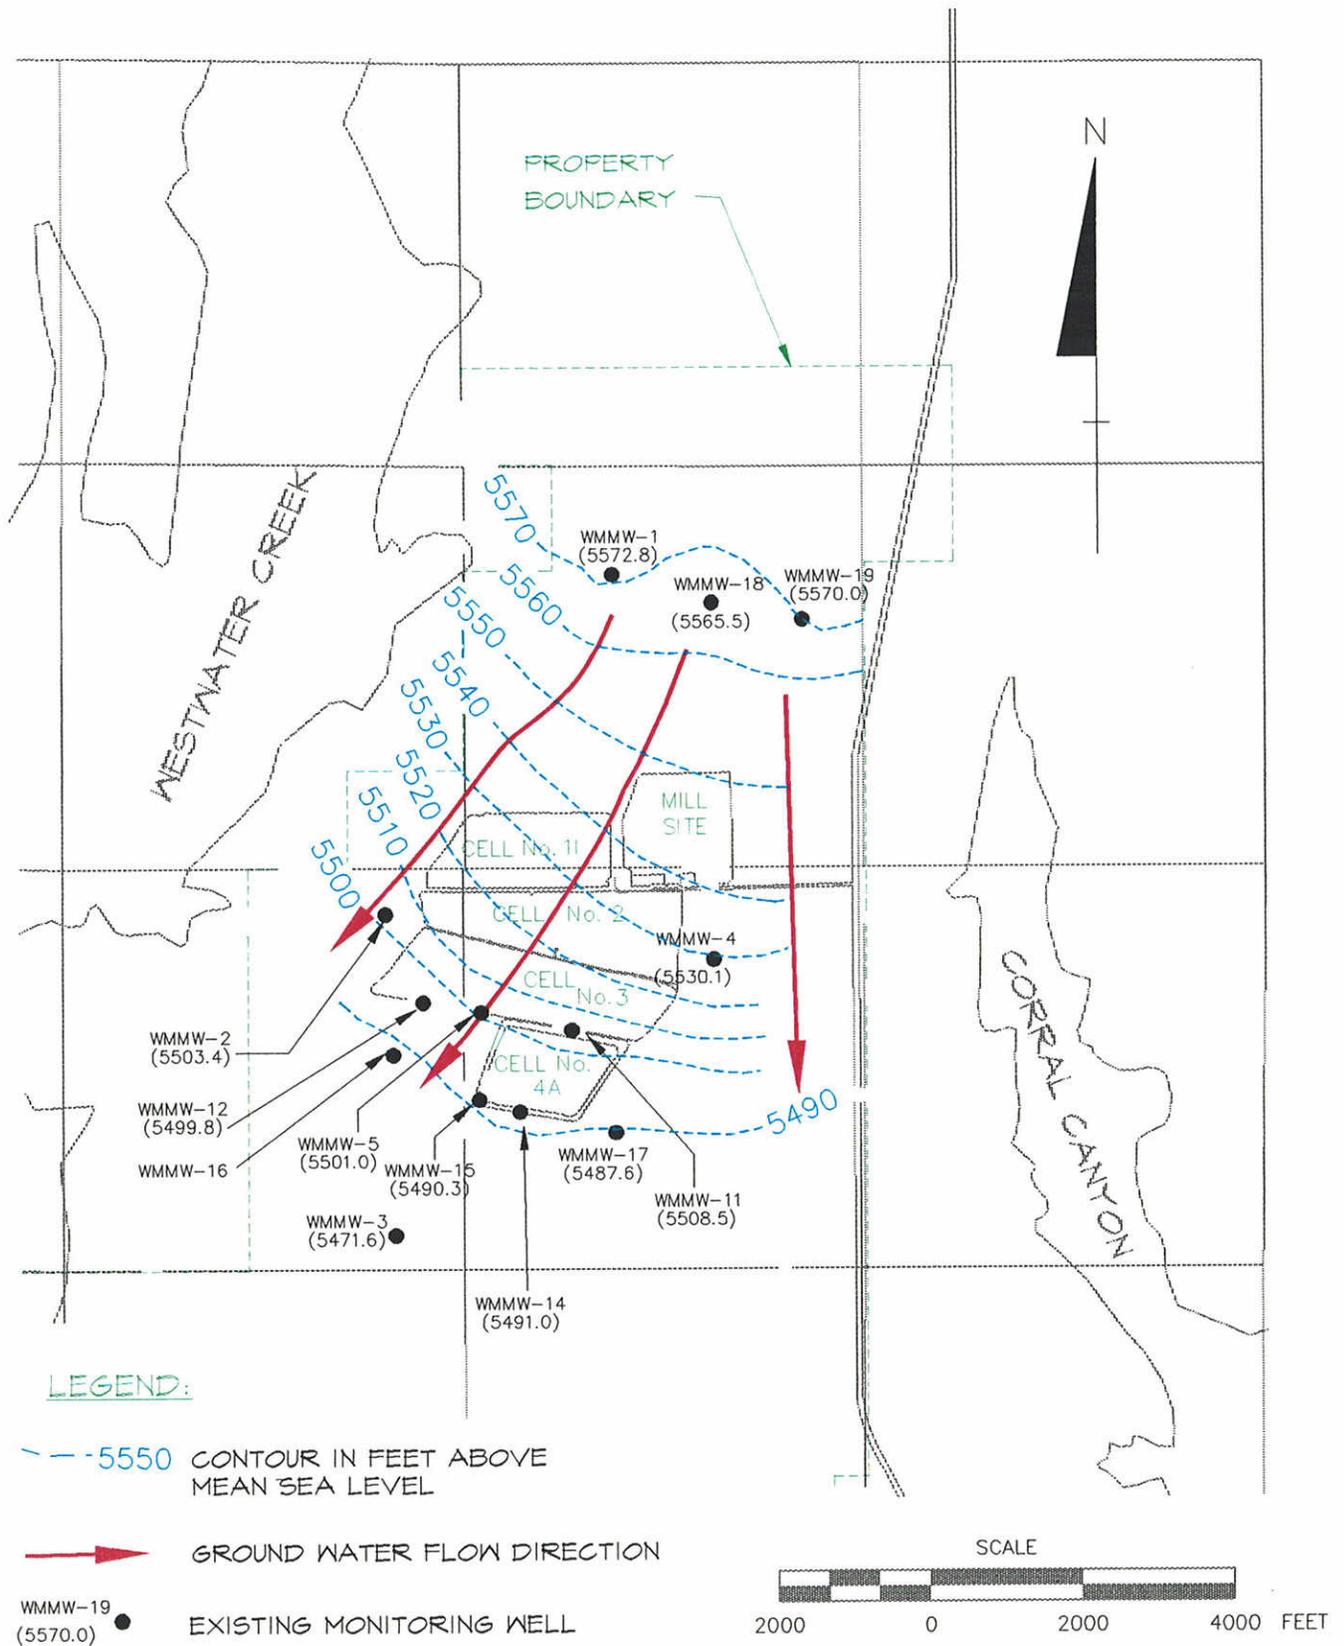
FIGURE I.5.5-1 : Perched Ground Water Levels

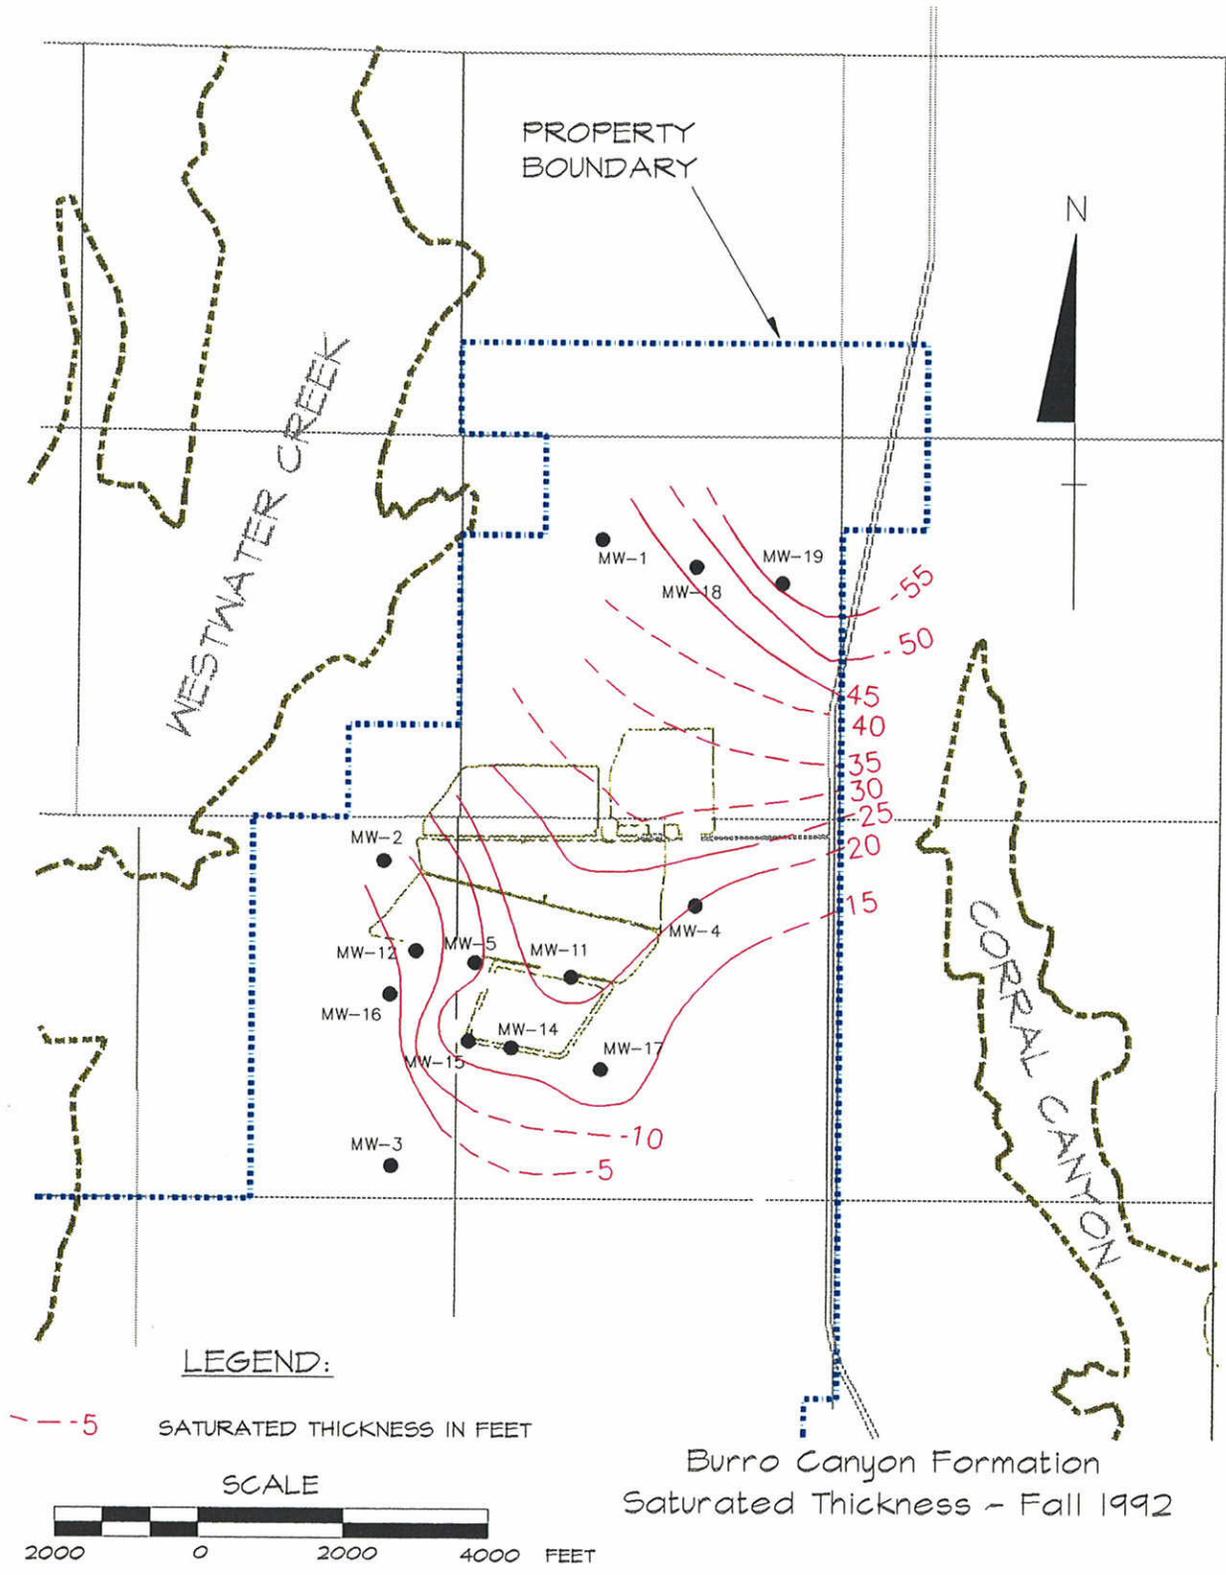
FIGURE I.5.5-2: Saturated Thickness of Perched Water

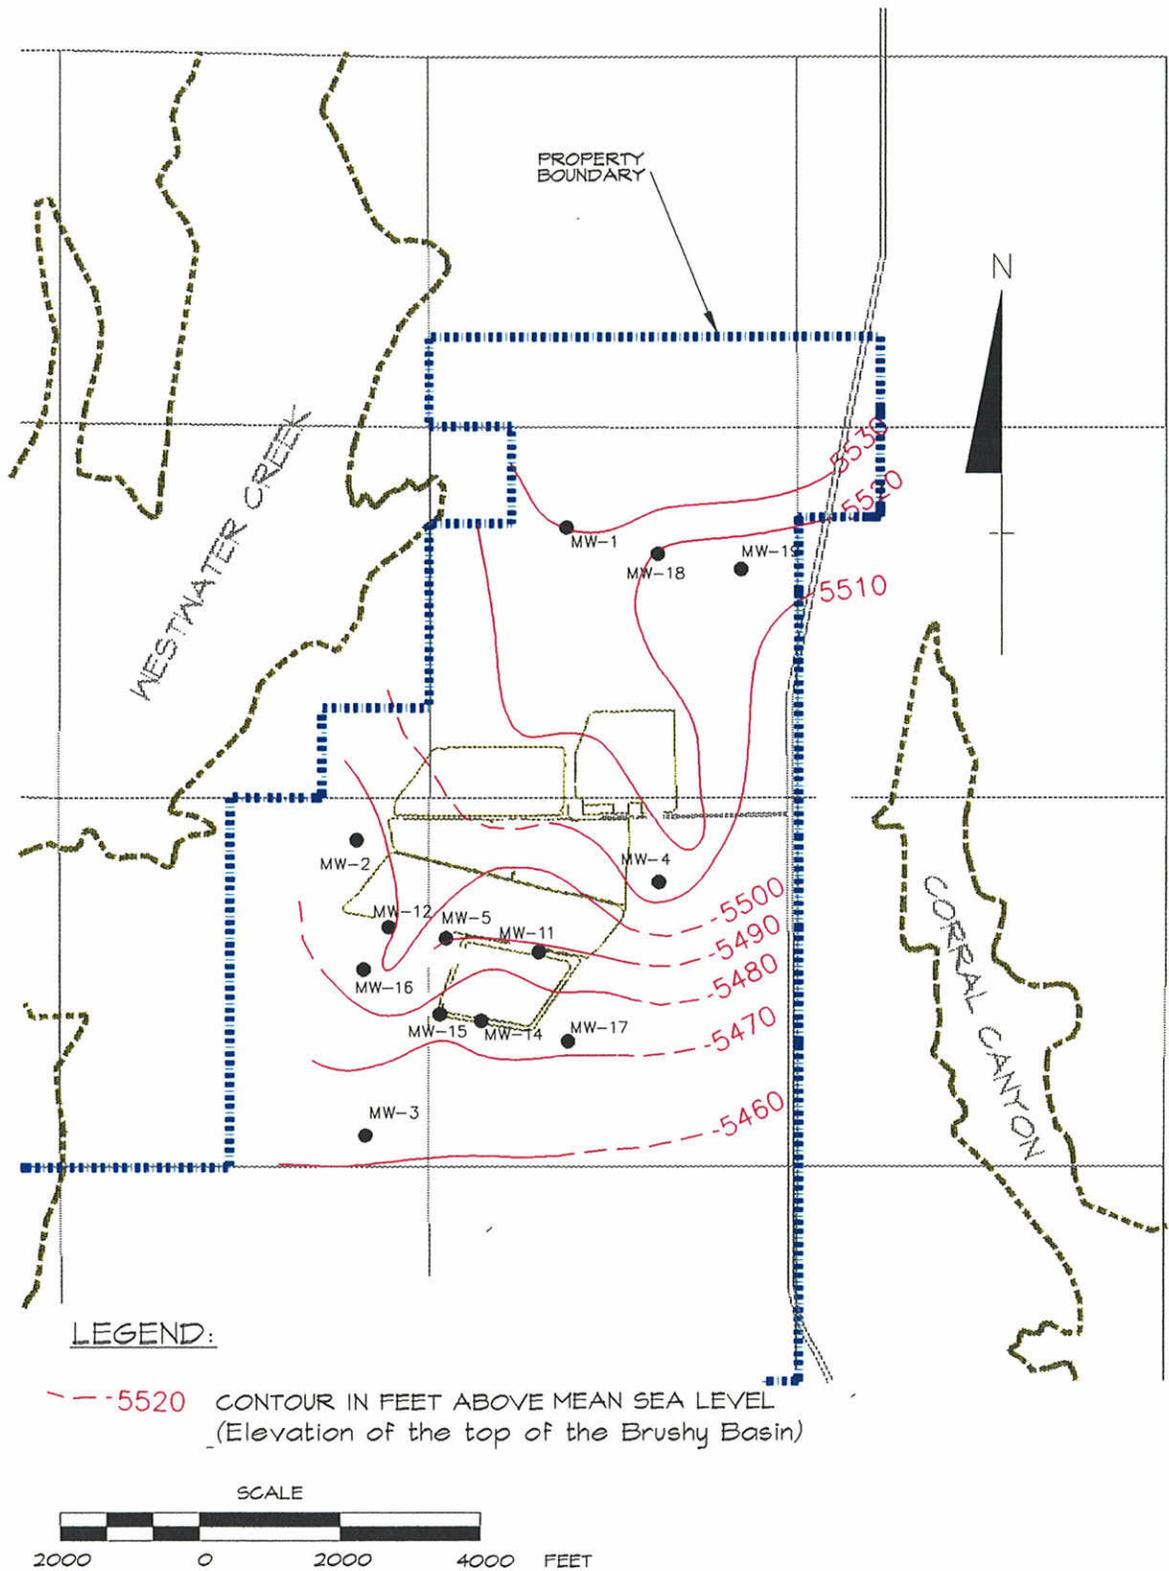
FIGURE I.5.5-3: Topography of the Brushy Basin Formation

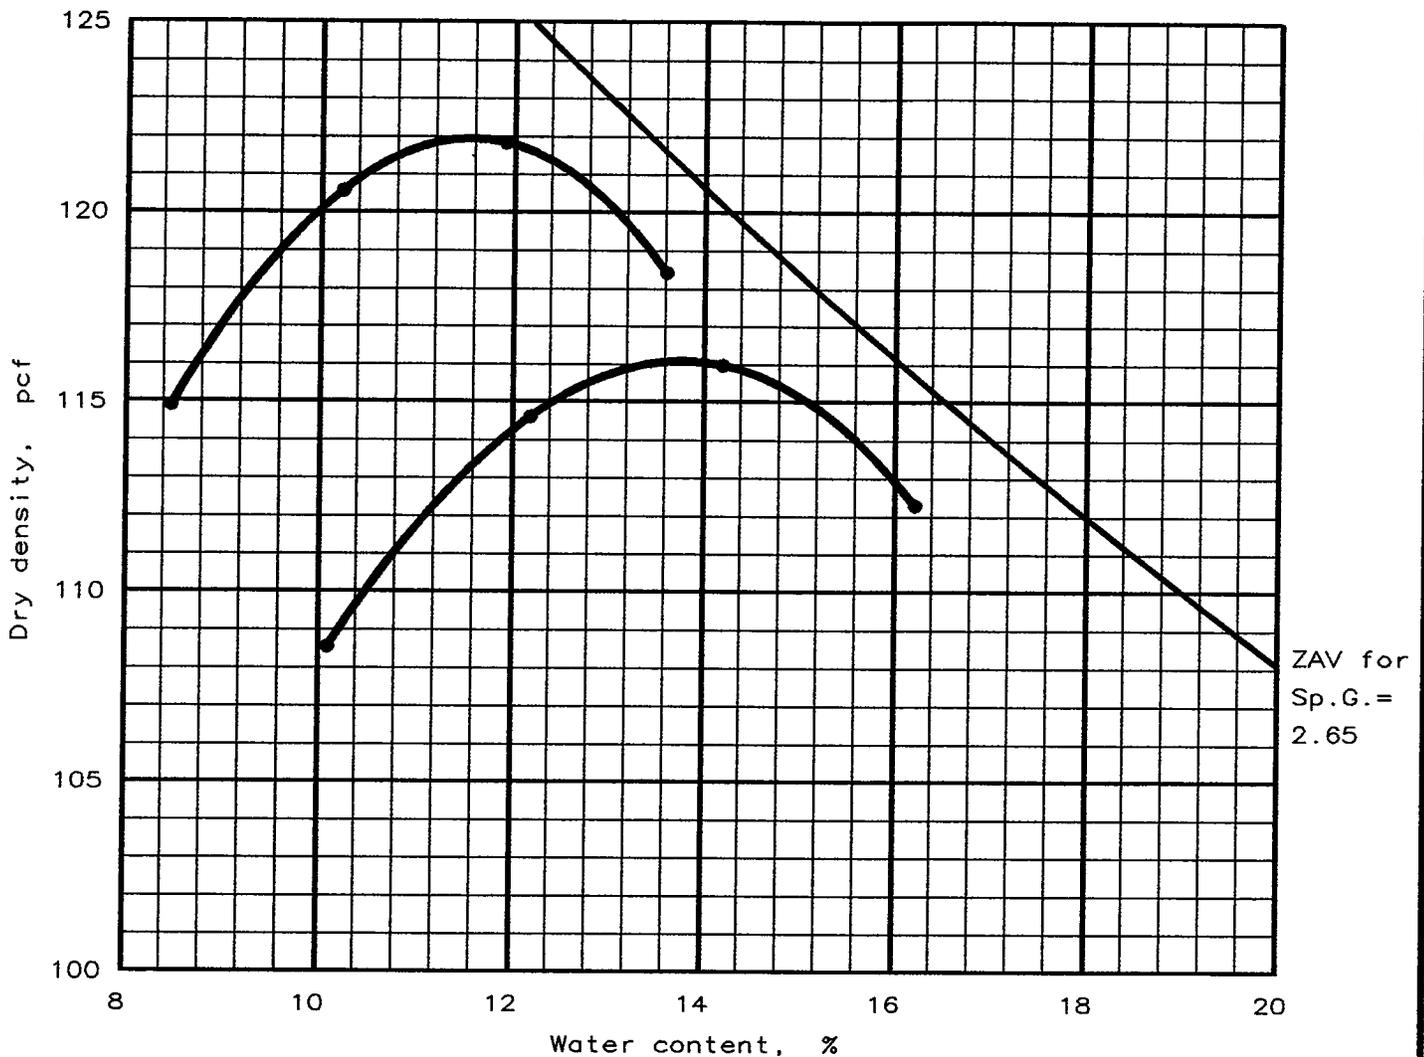
MOISTURE-DENSITY RELATIONSHIP TEST

Test specification: ASTM D 698-91 Procedure B, Standard
 Oversize correction applied to each point

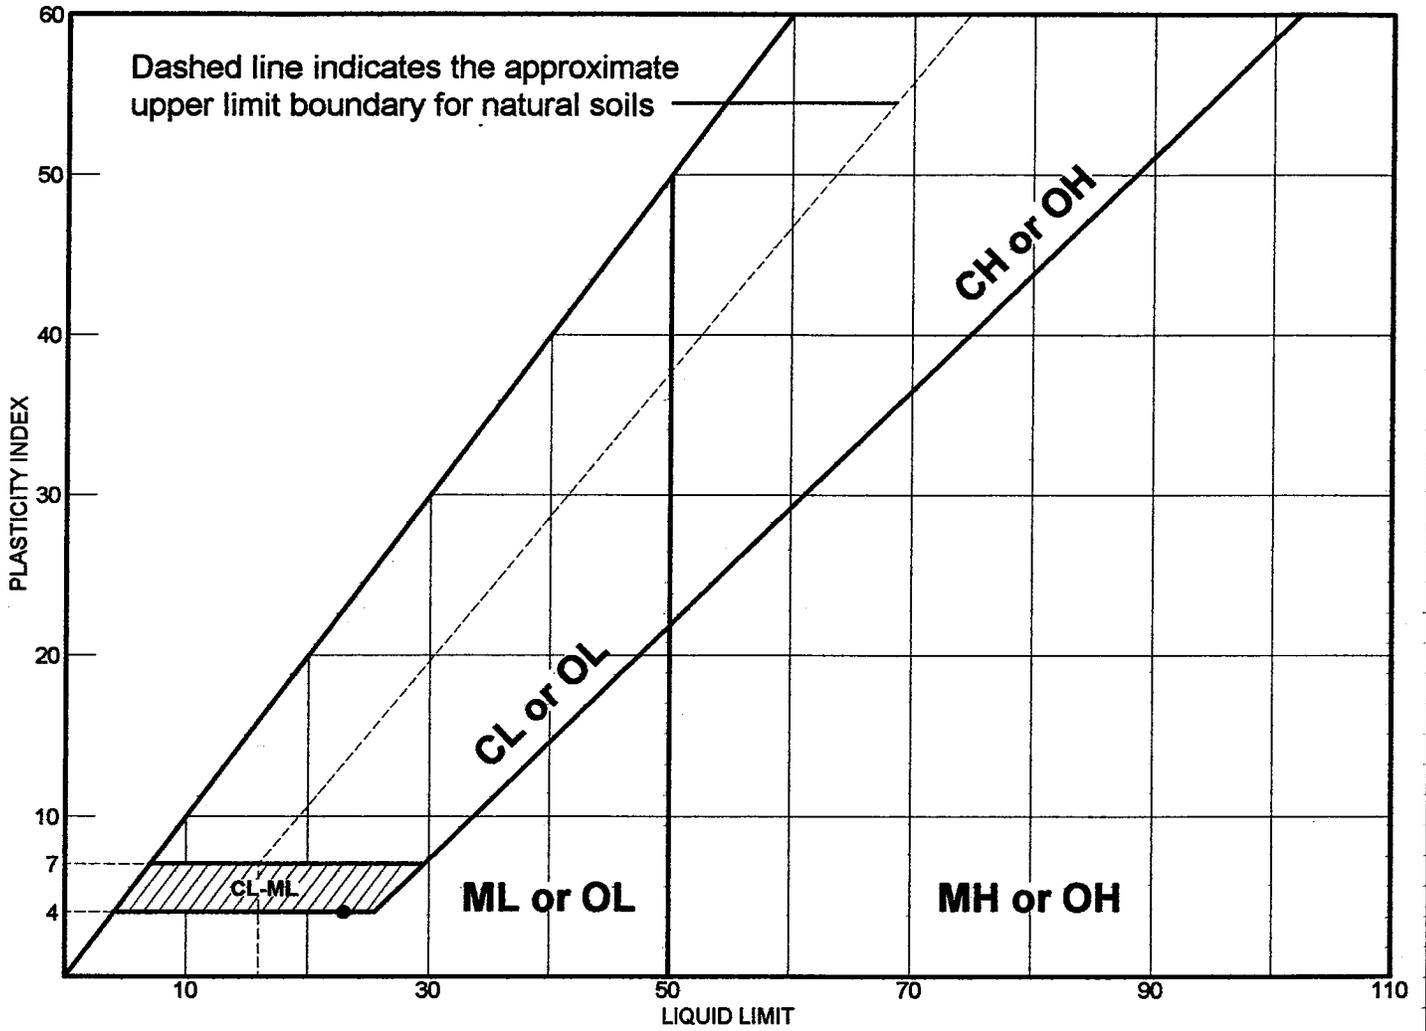
LIQUID AND PLASTIC LIMITS TEST REPORT

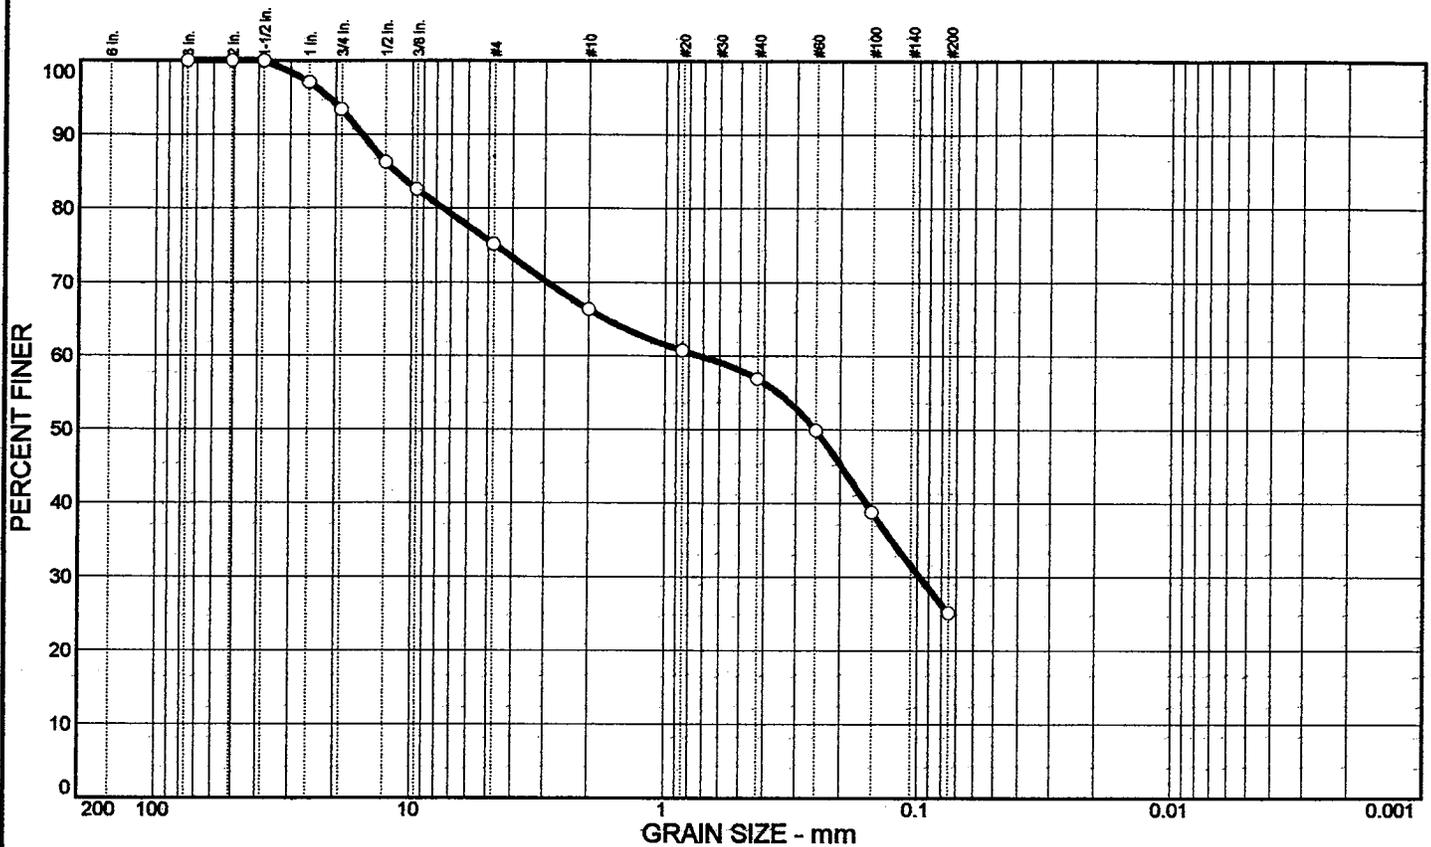
PARTICLE SIZE DISTRIBUTION TEST REPORT

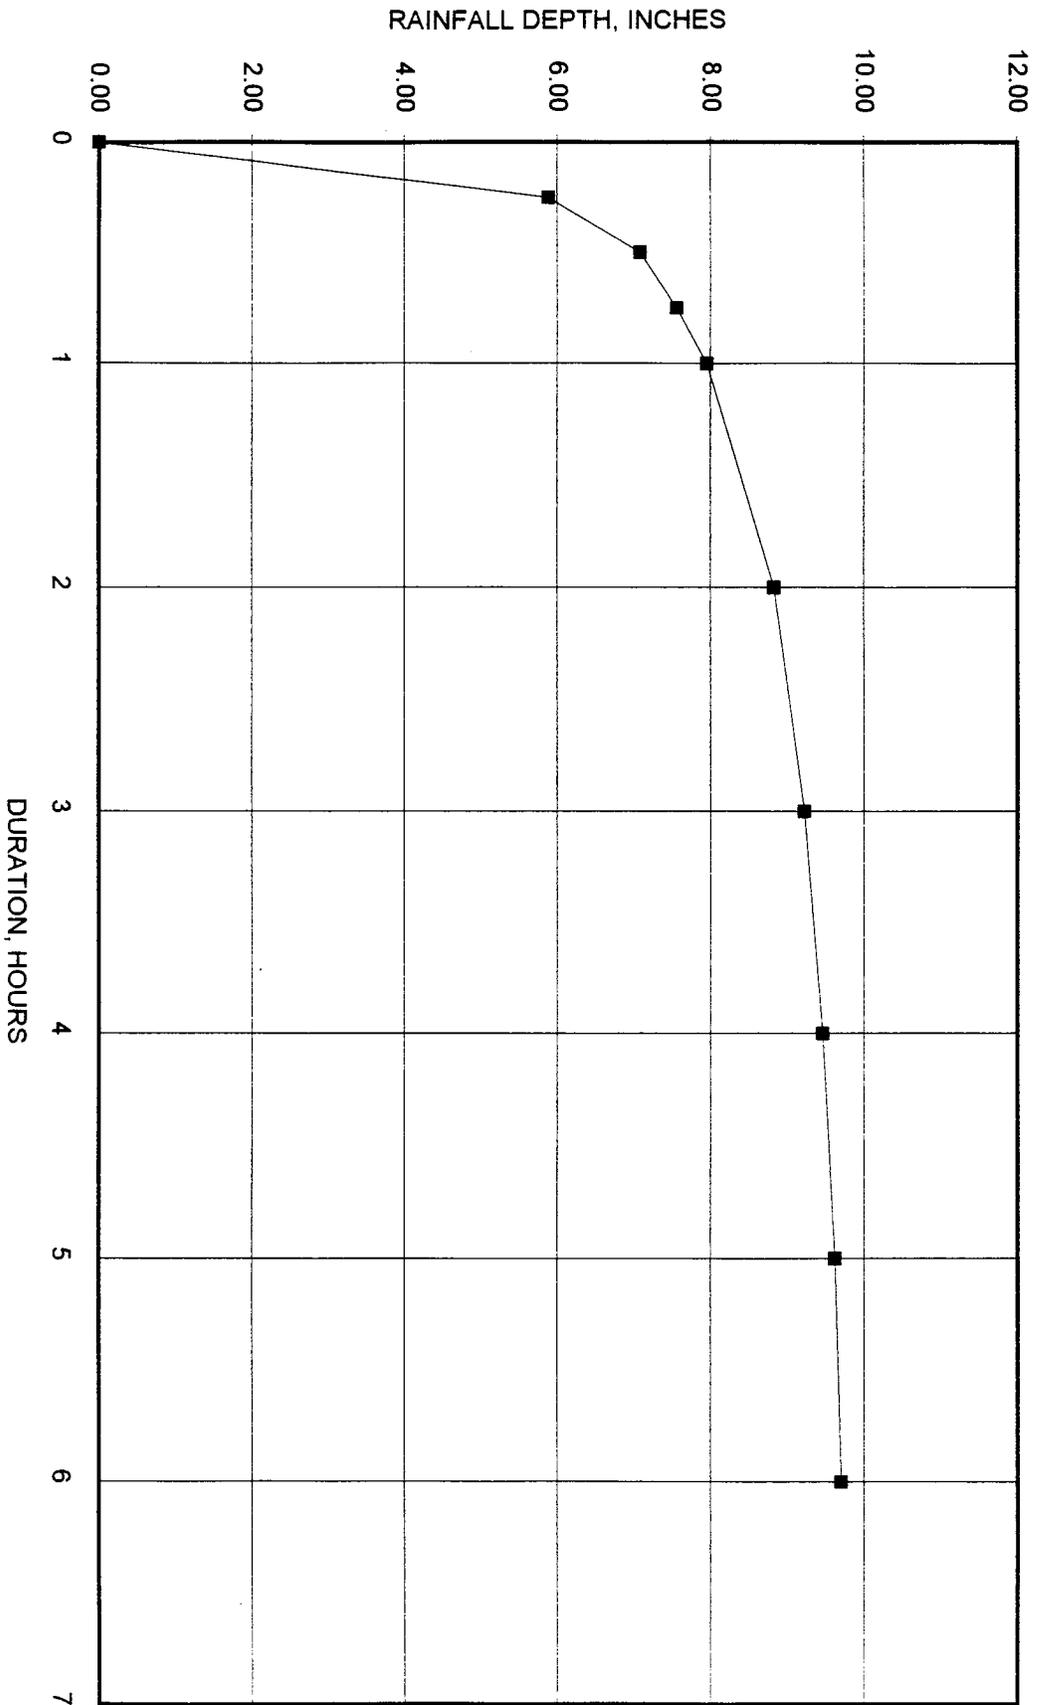
DEPTH VS DURATION FOR 6-HR PMP
WHITE MESA MILL, UTAH
ATTACHMENT 8 RESPONSE TO NRC COMMENTS 7/17/98

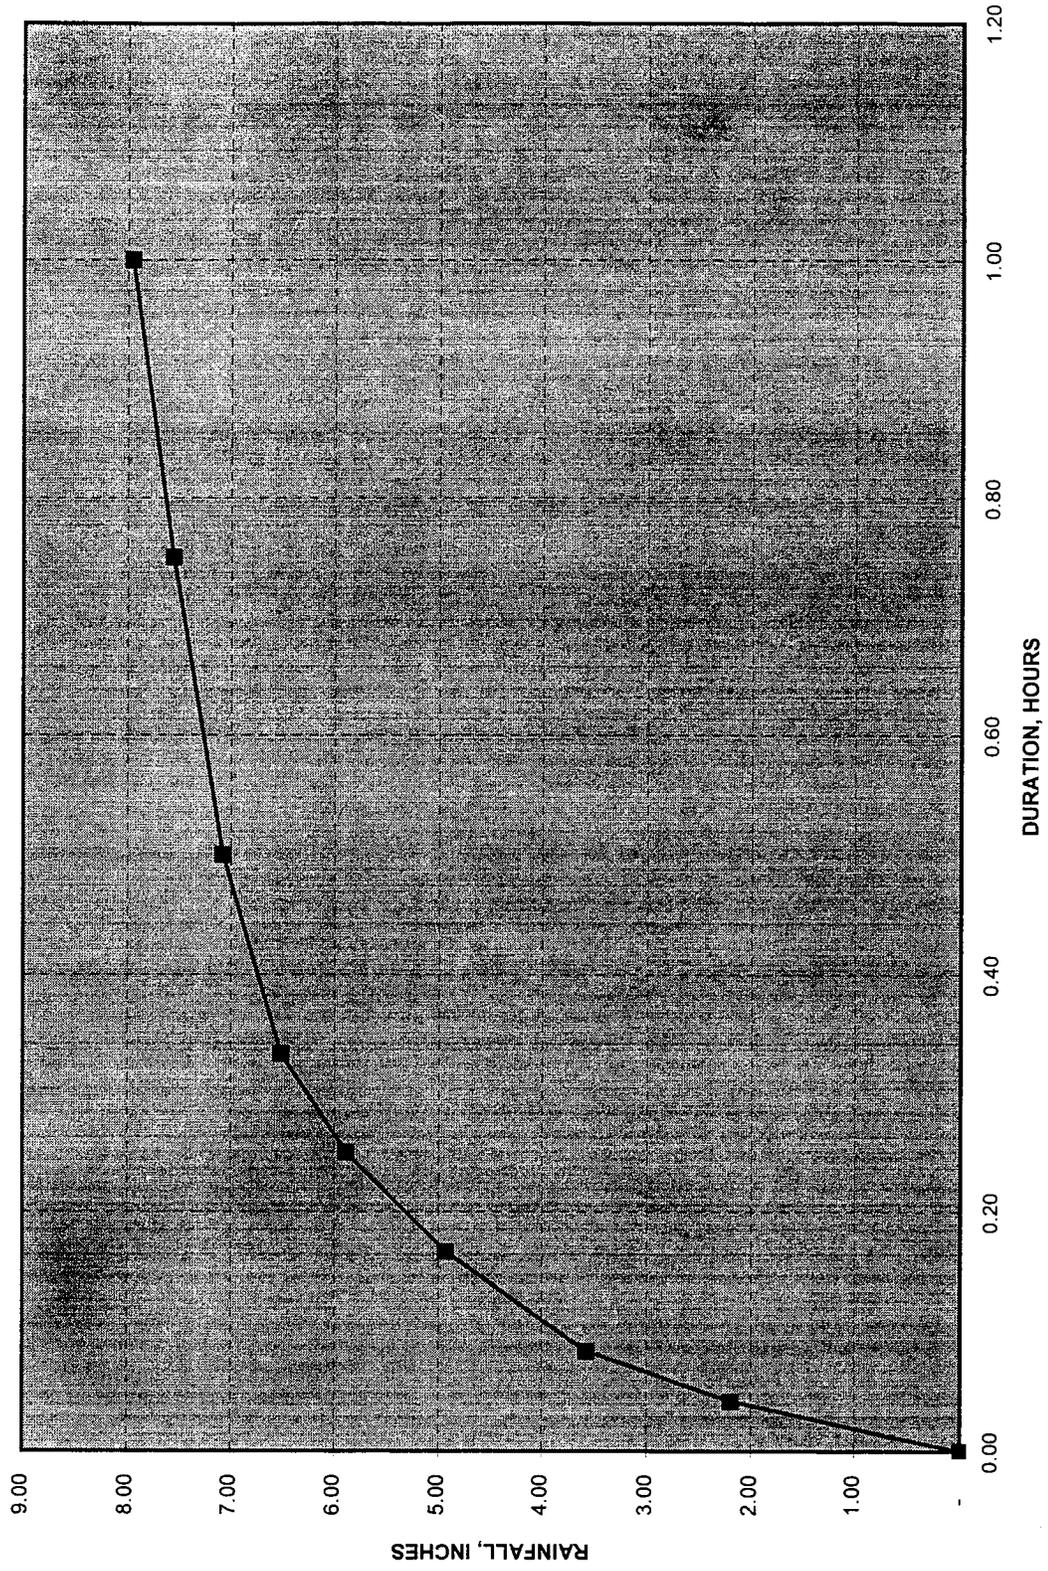
RAINFALL-DURATION CURVE FOR ONE-HOUR PMP AT WHITE MESA MILL
ATTACHMENT 9 - RESPONSE TO NRC COMMENTS 7/17/98
