## Union Pacific Railroad (UPRR) Causeway Opening Construction Progress Report #1

### Summary of Work through Dec. 12, 2015

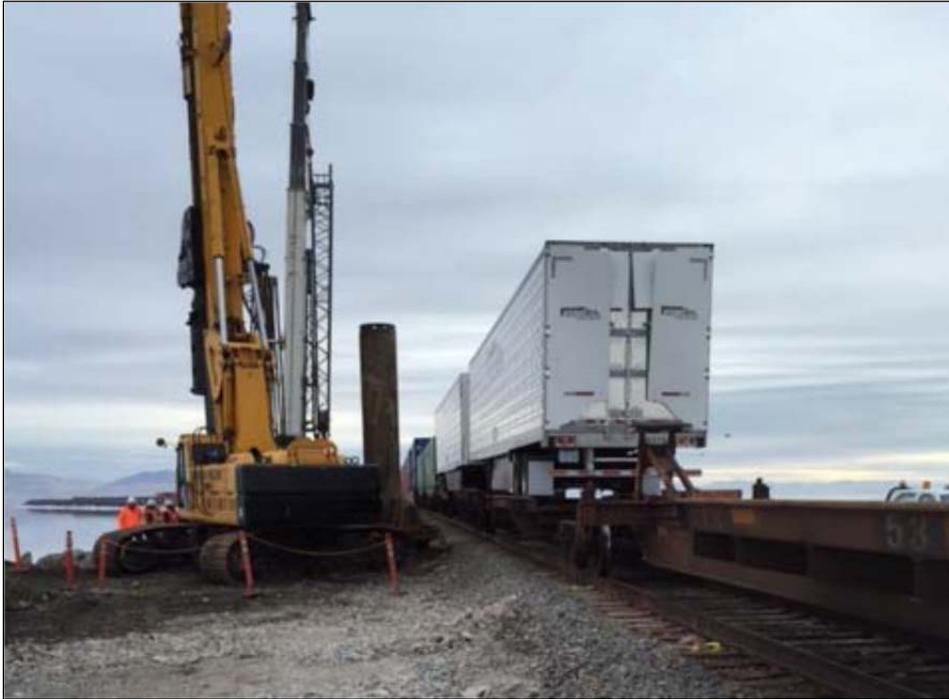
**Drilling Bent #7 pile #4 (week of Nov. 21, 2015)**

Pre-drilling piles is progressing slower than expected because the construction crew needs to drill deeper (about 74 feet) to reach consolidated lake bottom materials and because the construction crew has encountered unexpected materials.

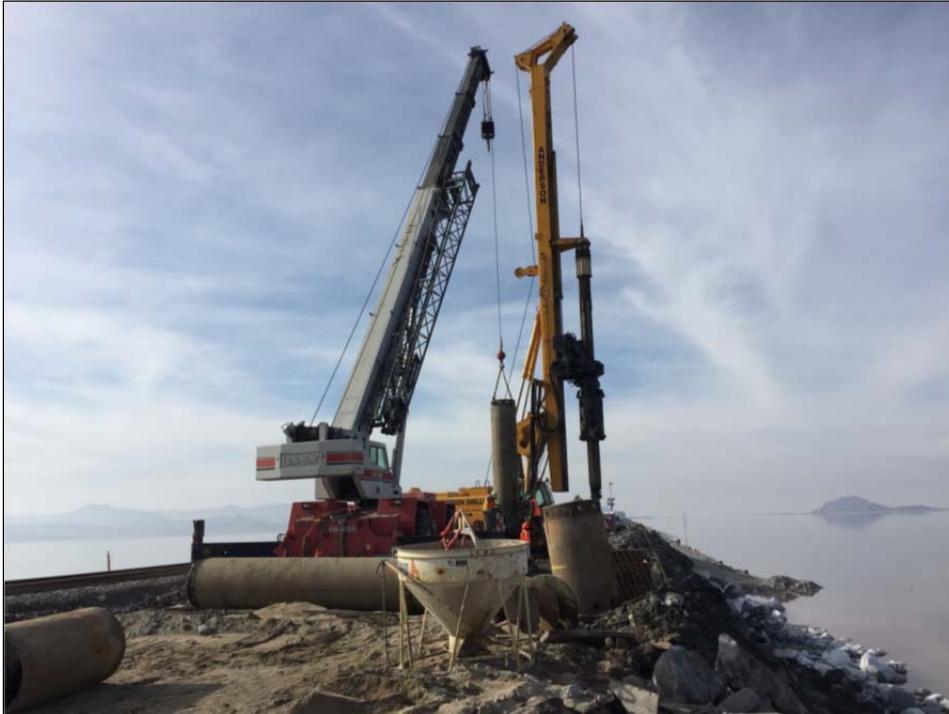
**Drilling Bent #5 pile #1 (week of Dec. 5, 2015)**

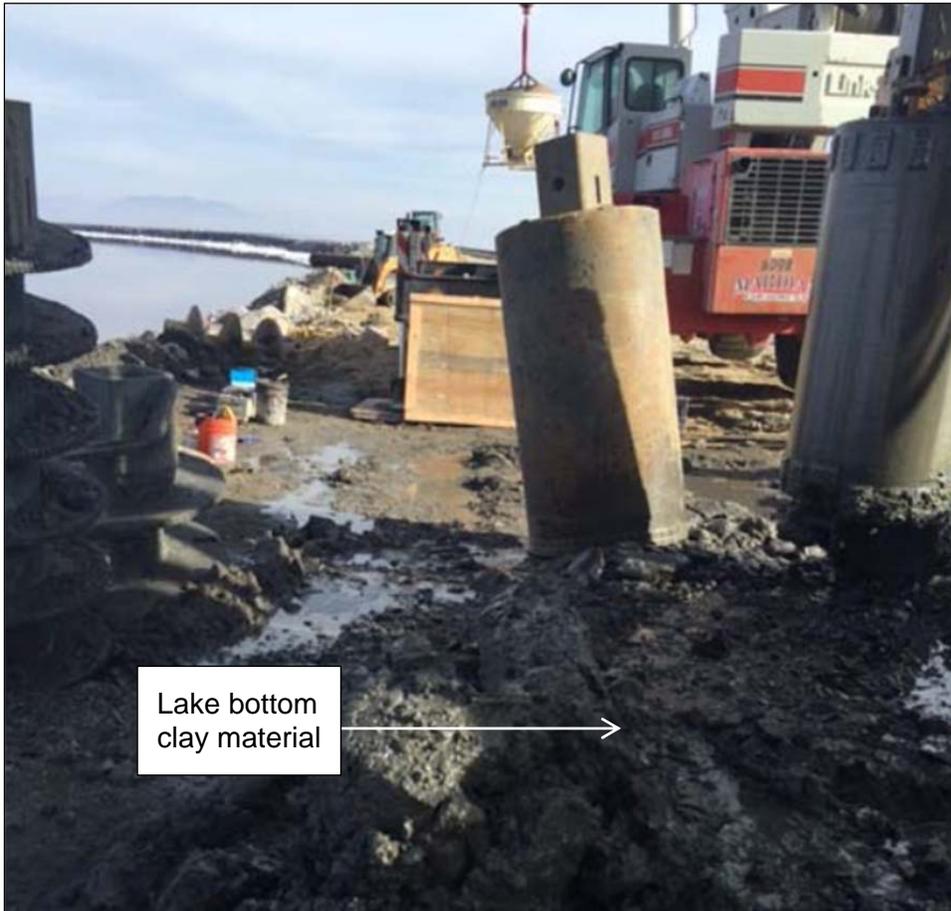
**Lake bottom clay material at 74 feet (Bent #6 pile #4)**

Lake bottom  
clay material →

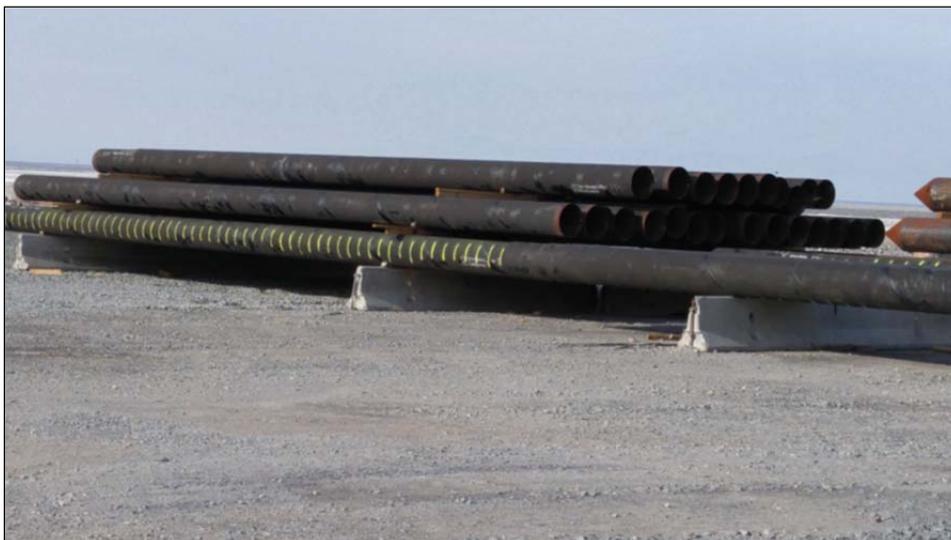
**Stockpiled pipe pile at Lakeside**

- Pre-drilling piles and setting 40-foot pipe pile sections – about 28% complete (15 of 49)
- Pile steel and reinforcing steel shipped to Lakeside

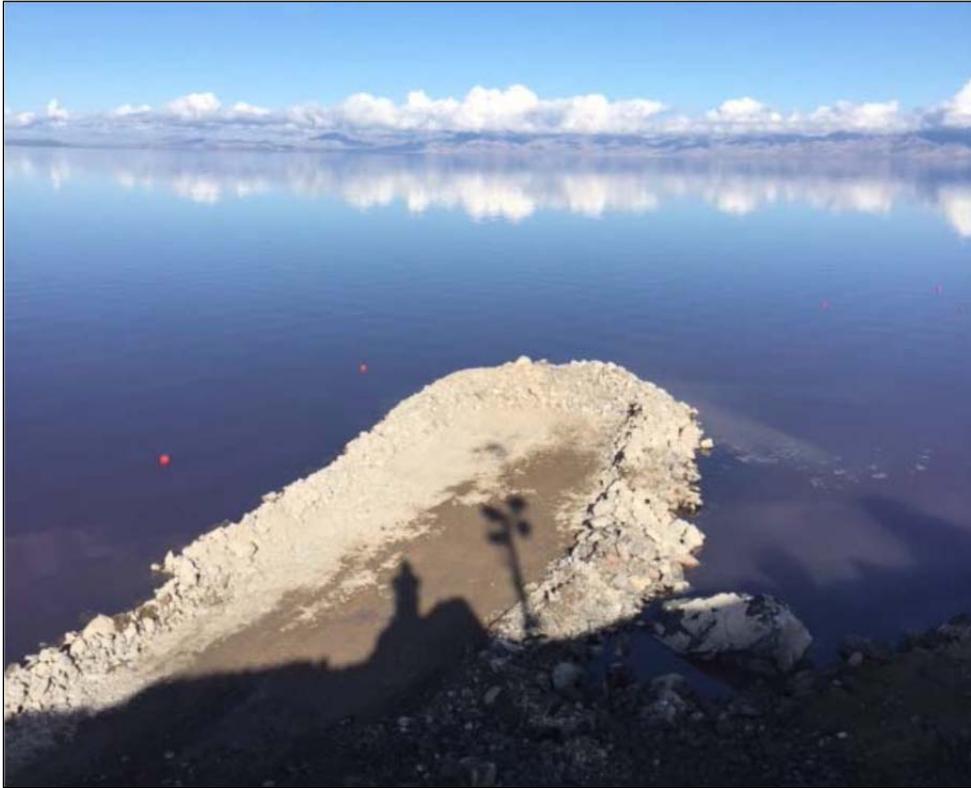
**Western control berm construction (looking north)**

- Began construction earlier than scheduled because of good weather and availability of core stone materials
- Surveyed and marked extents of control berms
- Began receiving and placing core stone for western control berm (about 10% complete)

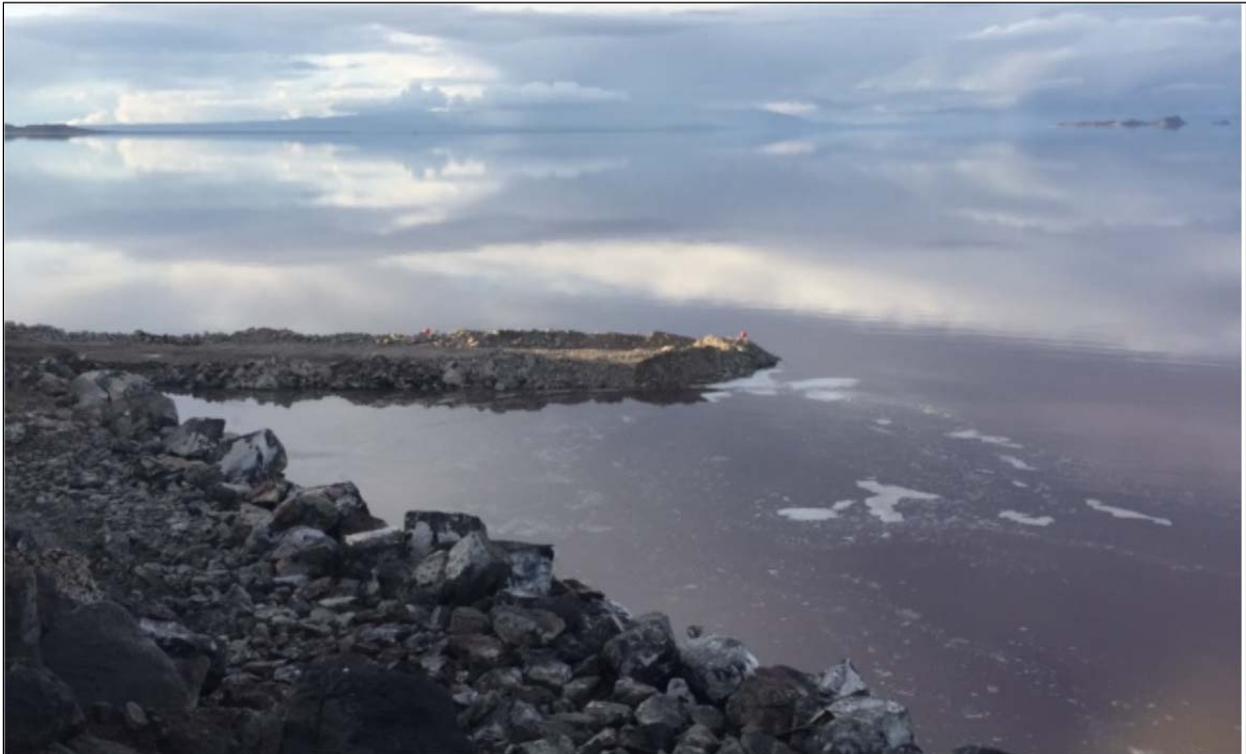
**Western control berm construction (looking west)**
